PROBLEMS, CAUSES, AND CURES

nwfa
National Wood
Flooring Association

Technical Publication No. C200 • Revised © 2018 | 3rd Edition

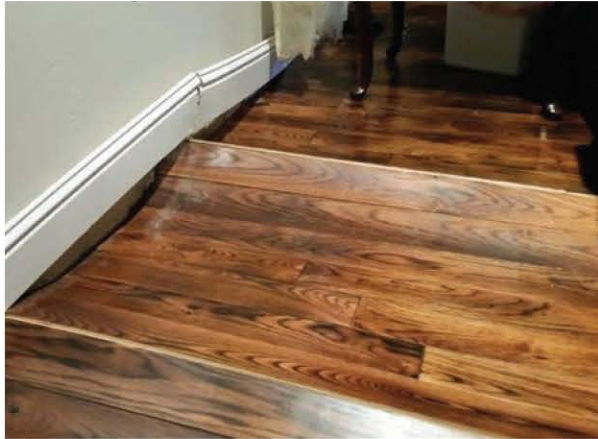
Buckling

DEFINITION: The wood flooring has separated or lifted from the subfloor.

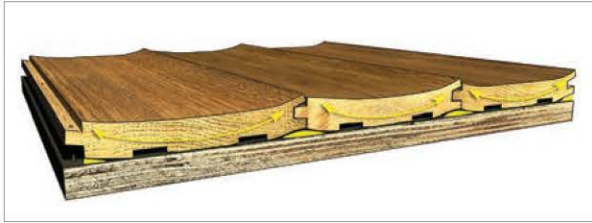
Cupping

DEFINITION: A concave or dished appearance of individual boards with the edges of the board raised higher than the center. This is also a type of warp.

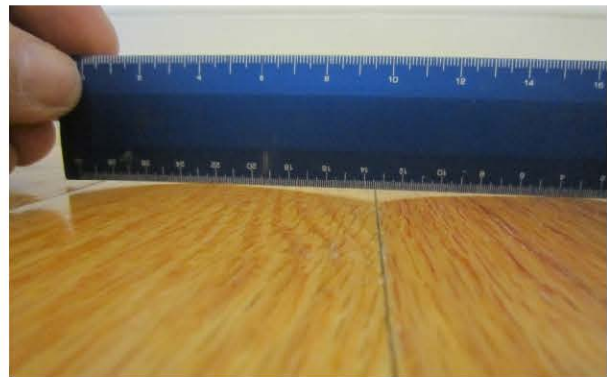
Crowning

DEFINITION: A convex or crowned appearance of individual boards with the center of the board higher than the edges. This can also be a type of warp.

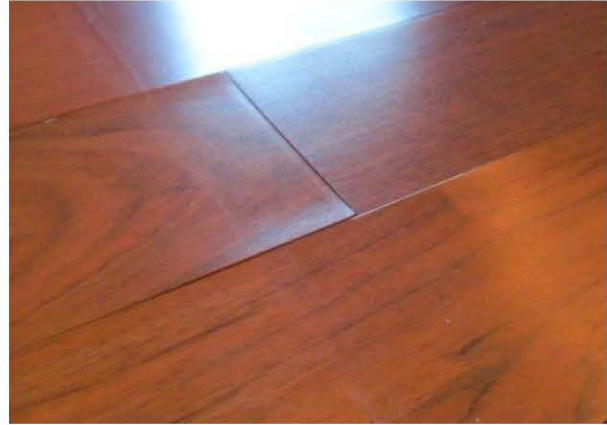
Dry Cupping

DEFINITION: A concave or dished appearance of individual engineered flooring planks with the edges raised higher than the center.

- When relative humidity levels remain below the manufacturer's recommendations for long enough, engineered planks can begin to dry cup. When this happens, the wear layer loses moisture and begins to shrink across its outer face, which can exert enough force on the core material to pull the edges of the plank (often the groove side) upward. This causes a cupped appearance across the width of the board.

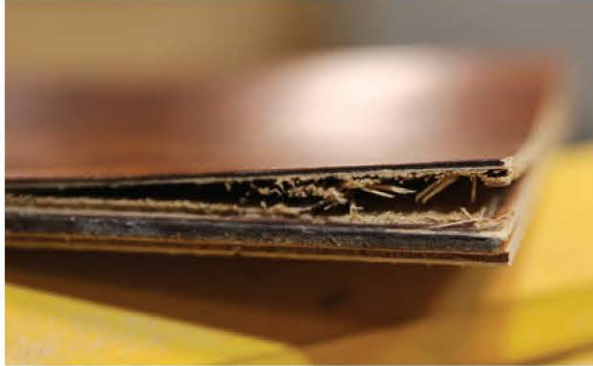
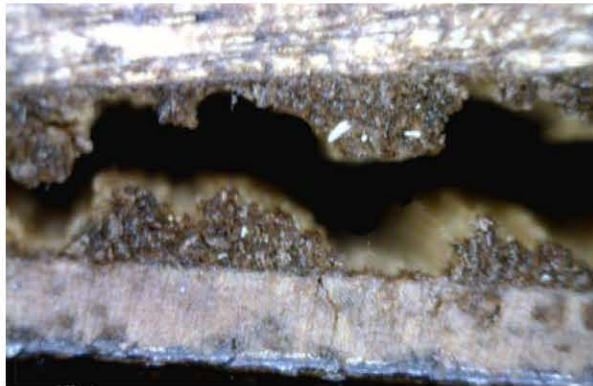
Wood Shear (Engineered Flooring)

DEFINITION: External stresses exceeding the strength of the wood fibers within an individual plank of engineered flooring, resulting in the wood fibers being torn apart. When examining this type of failure in an engineered wood flooring plank, wood fibers will be visible at the point of separation, remaining bonded to the adhesive layer.

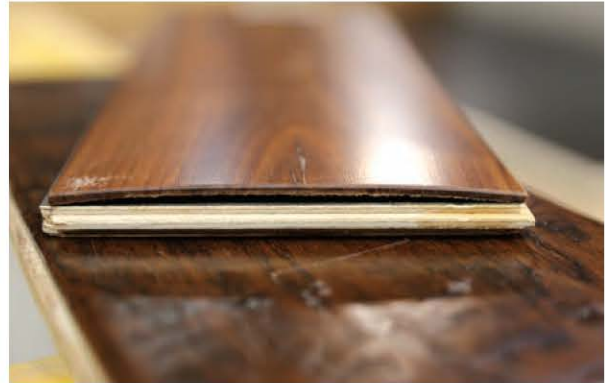
Delamination/ Glue-Line Separation (Engineered Flooring)

DEFINITION: Engineered flooring is manufactured by adhering several layers/plies together. The separation of two layers/plies within a piece of engineered flooring due to the lack of an adhesive bond is typically identified as a clean separation at the glue-line. Adhesive bond failure is unrelated to inadequate relative humidity levels.

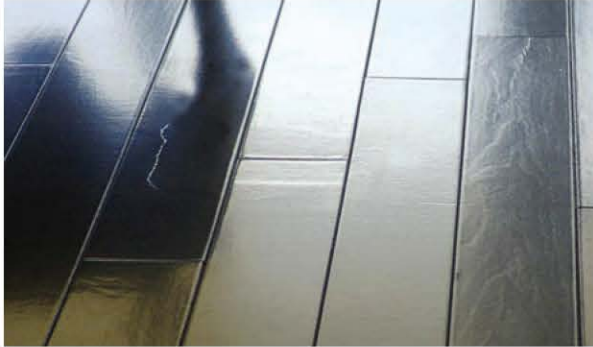
Telegraphing Core Material (Engineered Flooring)

DEFINITION: Visible patterns on the surface of the wood floor plank that resembles variations in the engineered flooring core material.

- A gain or loss in moisture, causing wood fillet/finger block core materials to change dimension, which can then telegraph to the surface of the plank.
- Skips, voids, missing/open knots, or overlaps within the core material, that telegraphs to the surface of the plank.

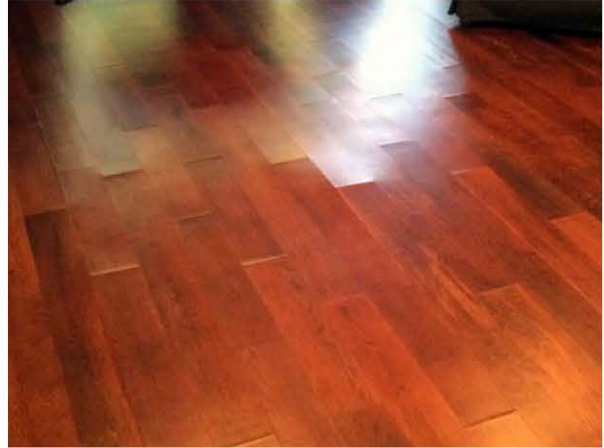
Endlift/Ski (Engineered Flooring)

DEFINITION: A condition where the ends of installed engineered wood flooring boards deviate from the flat plane and appear raised or curved upward.

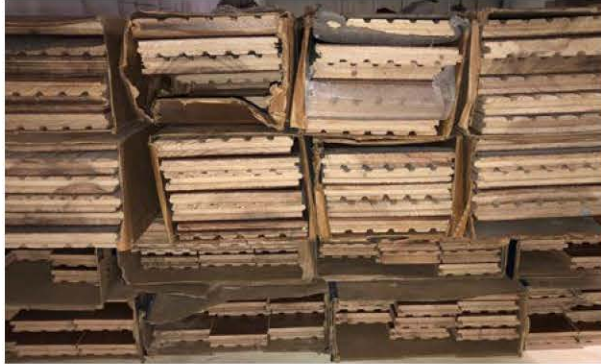
End-Swell/Flared-Ends (Solid Flooring)

DEFINITION: A condition where the ends of solid wood flooring boards deviate from the flat plane and/or parallel plane, and may appear wider or thicker than the rest of the board.

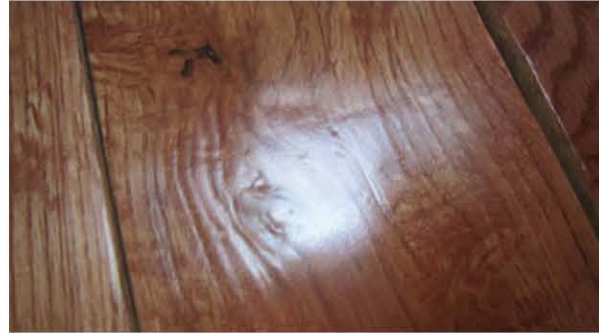
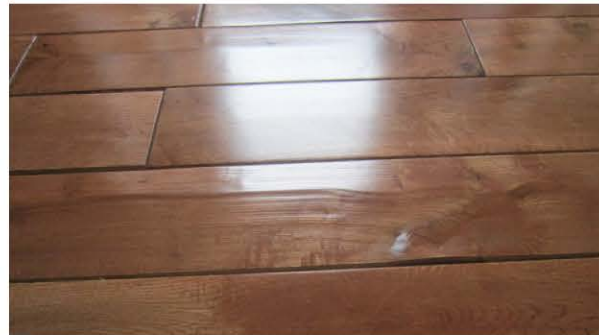
Reaction or Juvenile Wood

DEFINITION: Natural and unique features, properties, and growth patterns in wood that cause it to appear and perform non-traditionally, resulting in distortions from non-uniform swelling and shrinking.

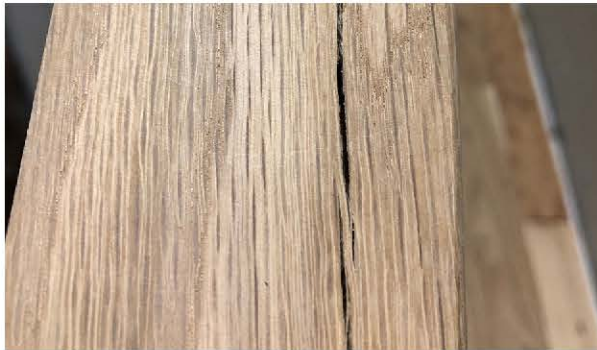
Surface-Checks - Surface checks are separations in the wood fibers that usually occur in, or adjacent to, the wood rays on the faces of plainsawn (flatsawn) boards. These separations occur during the early phases of the drying process where the external and internal stresses cause the wood to tear itself apart.

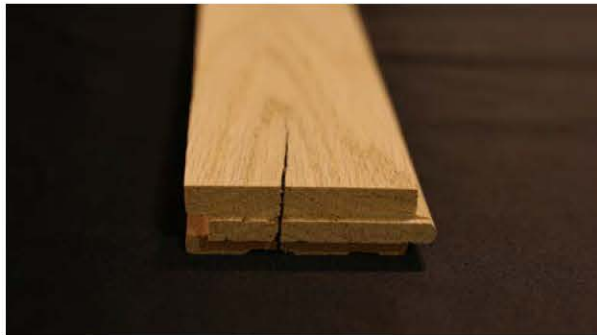
End-Checks - Like surface checks, end checks occur in, or adjacent to, the wood rays, but on the ends of the boards rather than the face. These separations occur due to the normal movement of moisture along the length of the boards, where the ends of the boards dry more rapidly leading to stress fractures on the ends of the boards.

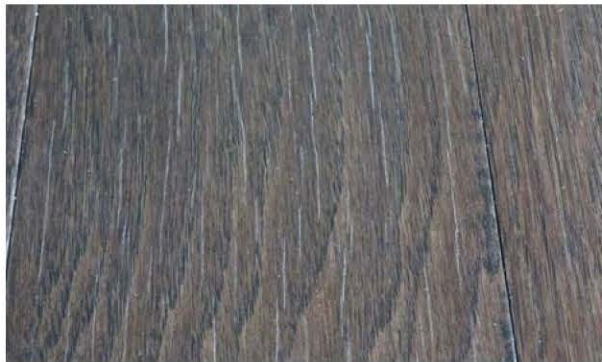
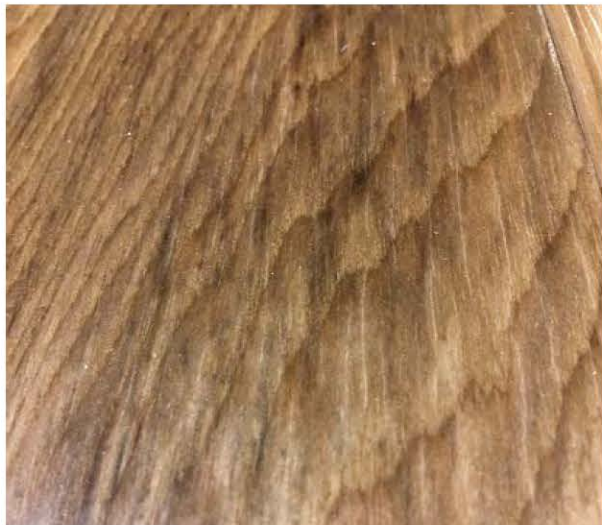
Lathe Checks (Rotary Peeled/Sliced Engineered Flooring)

DEFINITION: In engineered flooring with rotary peeled or sliced face veneers, as the knife separates the veneer from the log, the separated sheet of wood is laid flat where stresses can occur in the region near the knife edge. If the strength of the wood is exceeded, this stress is relieved by separations (or checks) of the wood fibers parallel to the grain of the veneer at the knife edge. The knife edge of the veneer is known as the open (or loose) side, and the opposite side of the veneer is known as the closed (or tight) side. Lathe checks are not normally visible on the face of the finished board.

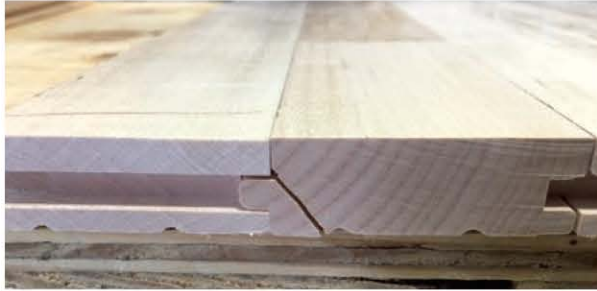
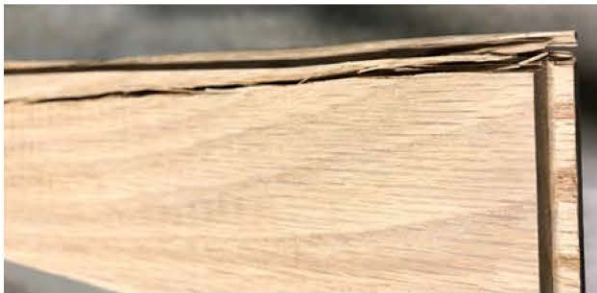
Splits/Cracks

DEFINITION: A tearing apart or rupturing of the wood that may run at various angles to the growth rings.

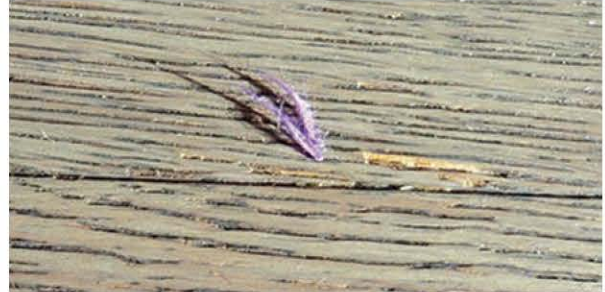
Slivers/Splinters

DEFINITION: Sharp fragment of wood separated/fractured away from the edge or face of the board protruding from the floor.

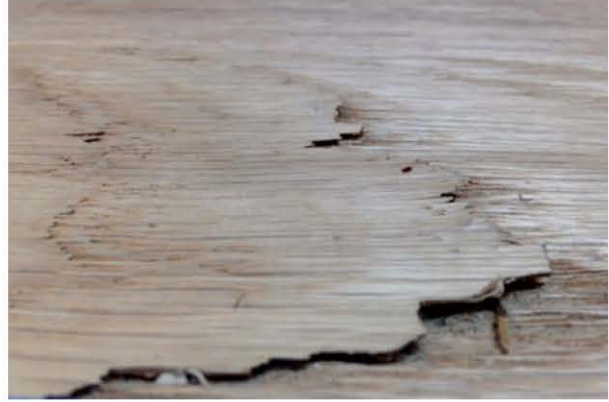
Shake (Ring Shake/Ruptured Grain)

DEFINITION: A separation of the wood's fibers along the grain (parallel to the growth rings), that usually occurs between the rings of annual growth.

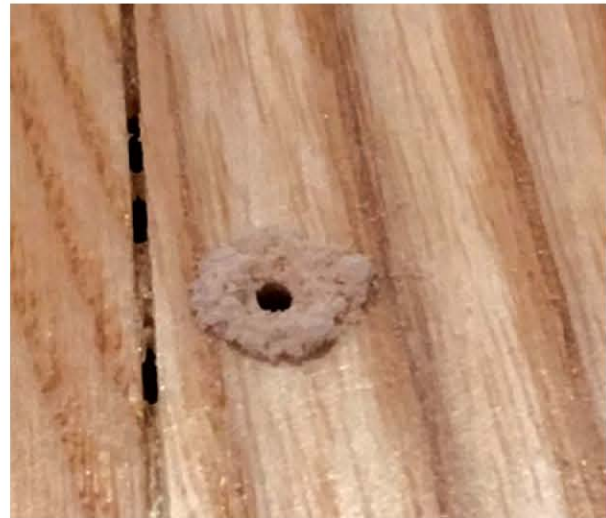
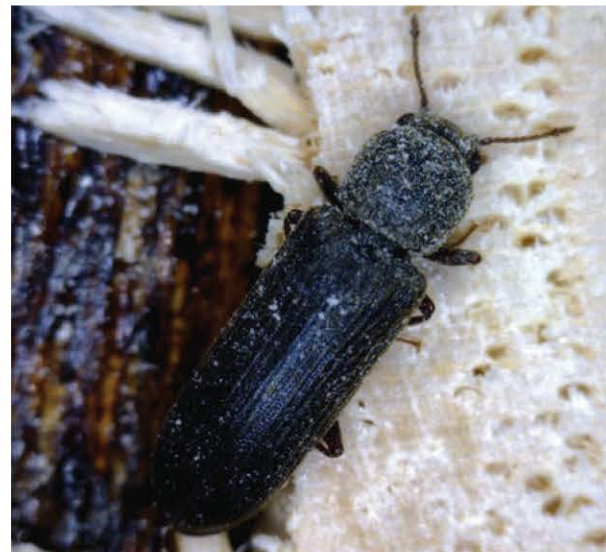
- **Powderpost (Lyctid/Anobiid) Beetle** - The larvae of wood-eating insects bore in and feed on the wood fibers causing damage to both hardwoods and softwoods. Properly kiln-dried lumber will normally eliminate powderpost beetles, but infestations can occur at any point after the kiln-drying process, including during storage, transport, or from other wood products.

- Infestation often occurs long before, but can even occur after the wood floor is installed. Female beetles lay their eggs within the pores of the bare, unfinished wood. The larvae feed on the wood, creating tunnels that fill with a powdery substance called frass. Later, when the larvae mature, they exit the wood, creating small pinholes, generally measuring 1mm-3mm (1/16"). In active infestations, the holes will be surrounded by this frass (light-colored powder). This frass material is very fine and will feel like talcum powder when rubbed between two fingers. The presence of an actual beetle, beetle larvae, or frass is the only way to absolutely confirm an active infestation.

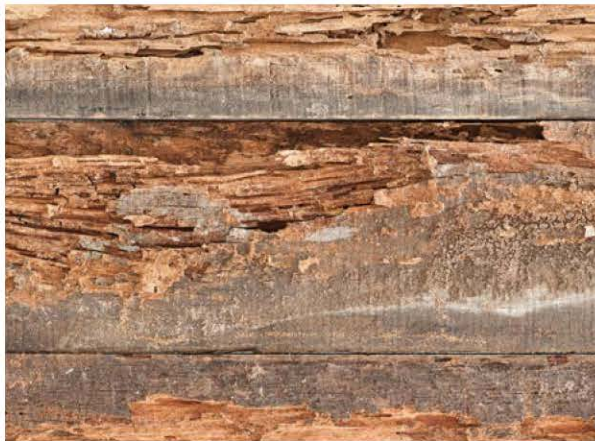
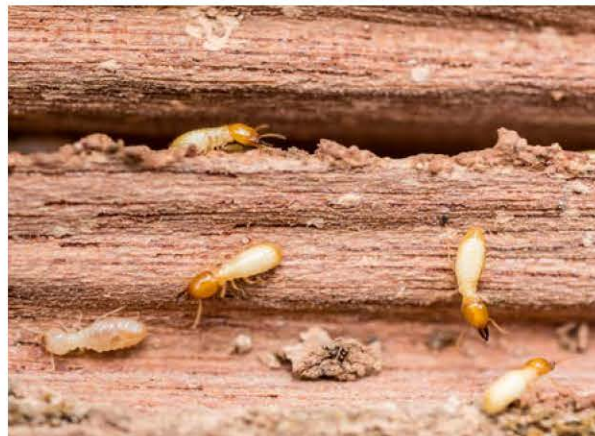
- **Termites** - Termites are attracted to areas where moisture accumulates in and around your home, including damp basements, laundry rooms, bathrooms, and leaky foundation walls.
 - Termites will eat any kind of wood including mulch, rotting wood, new wood, painted wood, and treated wood.
 - Stagnant, moist air in the home provides the perfect breeding ground for termites.
 - Termite-damaged wood is usually hollowed out along the grain, with bits of dried mud or soil lining the feeding galleries. Wood damaged by moisture or other types of insects will not have this appearance.
 - Termite infestations are a site-specific condition.

- Improperly dried or stored lumber.
- Lyctid Powderpost Beetles are usually brought into the house in wood products that contains eggs or larvae that may have been in furniture, firewood, untreated reclaimed lumber, joists or framing, molding, trim, wood paneling, cabinets, or even the pallets used to transport the flooring.
- Termites and Anobiid Powderpost Beetles normally prefer to infest wood that is damp; therefore, infestations usually begin in moist, poorly ventilated areas such as in unconditioned crawl spaces or basements.

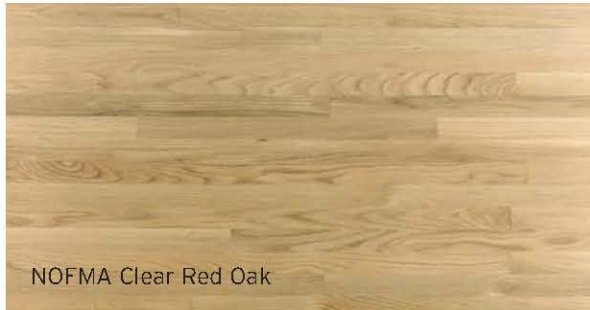
NOFMA Clear Red Oak

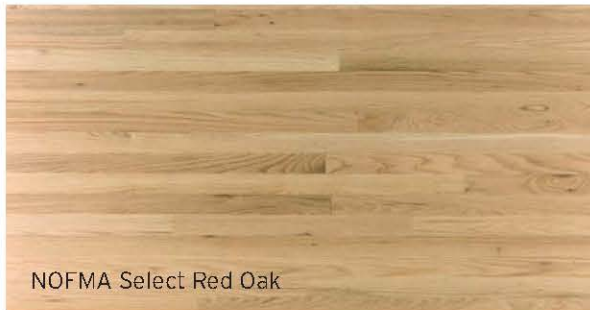
NOFMA Select Red Oak

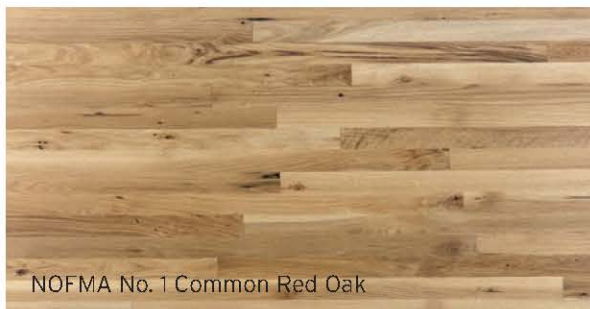
NOFMA No. 1 Common Red Oak

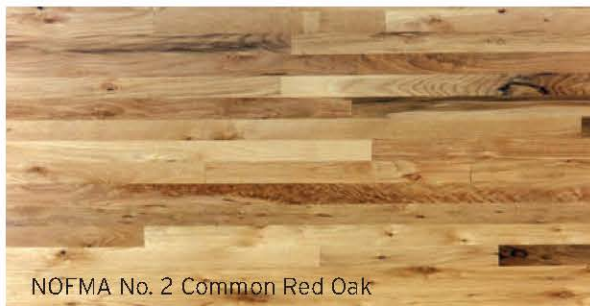
NOFMA No. 2 Common Red Oak

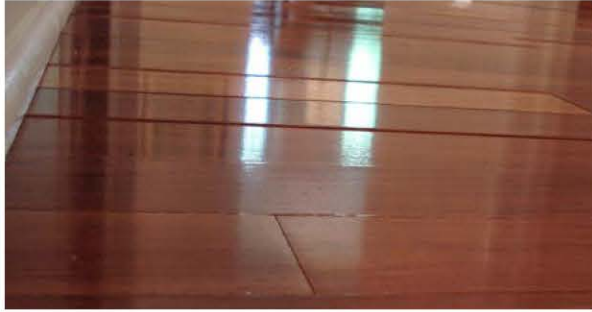
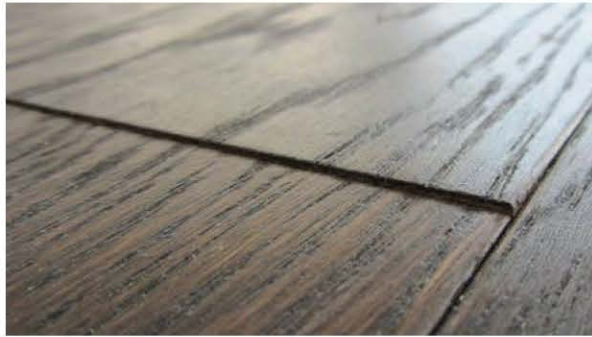
Overwood/Underwood

DEFINITION: A vertical offset that exists between two adjoining installed floorboards.

- Manufacturing defect. Can be determined with destructive testing or on uninstalled wood flooring boards. Solid and engineered wood flooring manufactured tolerances outside of the applicable industry manufacturing standards (NWFA/NOFMA, HPVA, or similar).

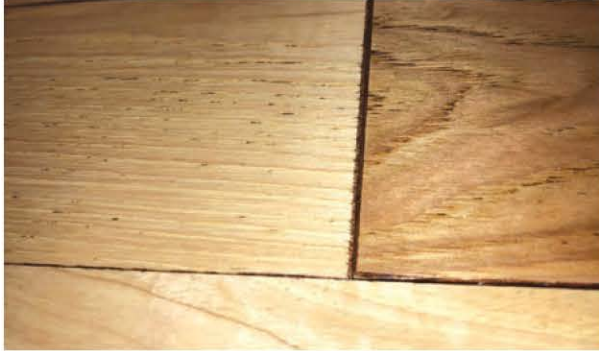
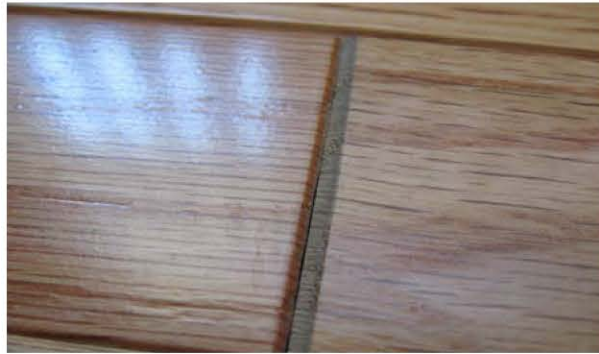
Uneven Bevels

DEFINITION: Bevels within an installed or uninstalled wood floor appear inconsistent in width, depth, shape, profile, or size.

- Mis-milled flooring.
- Flooring installed from different product lines/ manufacturers/runs.
- Normal and within grade for flooring installed (such as hand scraped/distressed/reclaimed).
- An existing floor with bevels that was resanded and resulted in uneven bevels.
- Installer manipulated material.

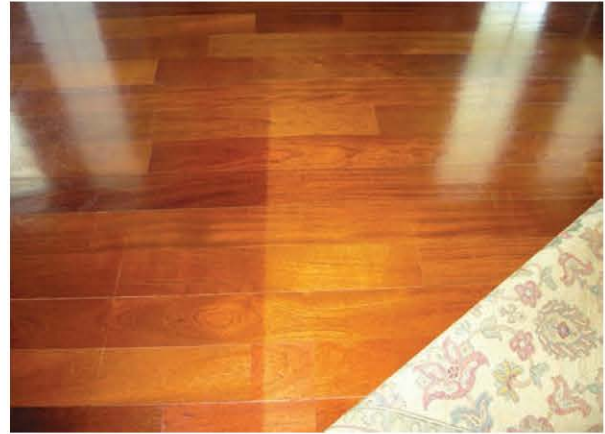
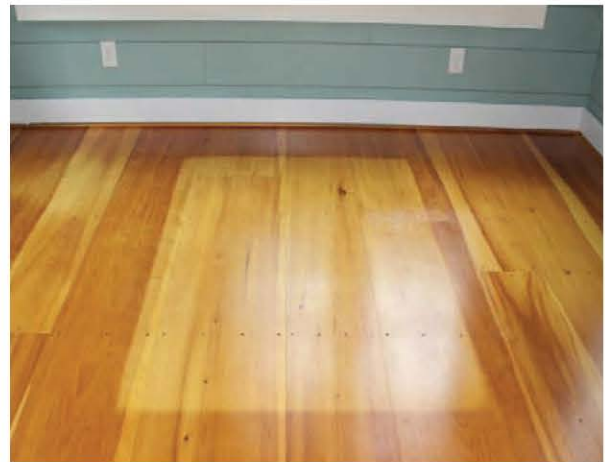
Wood Discoloration

DEFINITION: The wood itself changes color over time (darkens or lightens).

- Wood changes color through oxidation and/or photochemical exposure, which is a change that cannot be prevented. This is a naturally occurring phenomenon. All woods will change color, but some more drastically than others. This is a natural change, and should be taken into account when selecting flooring from sample boards.

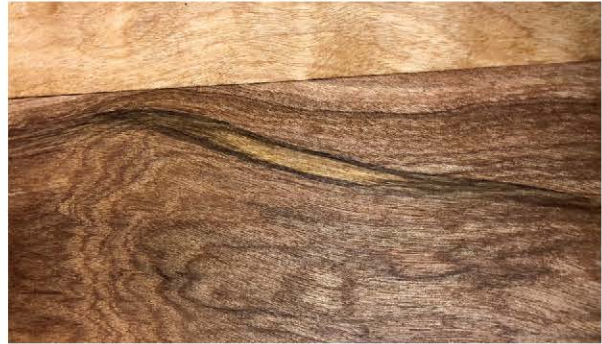
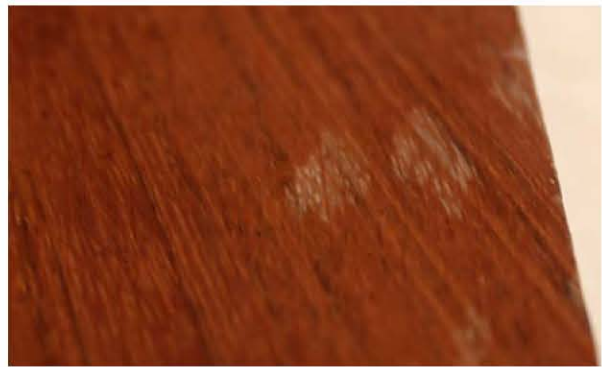
Mineral Streaks/Deposits

DEFINITION: A discolored line, spot, or band in the wood that may range in color from light gray to tan, olive green, brown, purple, blue, or black. Mineral streaks/deposits are naturally occurring and they are often considered to add value and appeal to the wood.

- The source of these mineral streaks/deposits is often undetermined, and is considered a naturally occurring characteristic of living trees. These deposits may develop as the tree absorbs and deposits minerals from the surrounding soil such as limestone, sulfur, nitrogen, phosphorus, potassium, silica, gypsum, or any other mineral found in the region where the tree was grown.
- Some mineral deposits such as silica are often mistaken for chemical stains in some imported species, because of how they may appear as spots or blotches.
- Some mineral streaks may be caused by normal cell physiology occurring from wounds caused by insects, animals, weather, or logging.

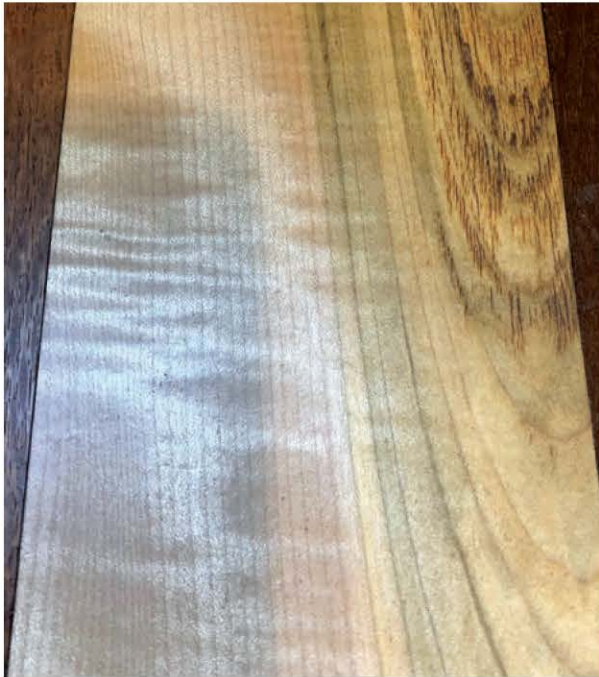
Sap Stains (Blue-Stain or Brown-Stain)

DEFINITION: A discoloration in the sapwood. Sapwood itself is the active wood near the outside of the living tree. It is often lighter in color than the heartwood of the tree. Sapwood color variation is normal and acceptable in all grades, and must not be confused with sap stain.

- Sap stain is caused by the growth of certain fungi on the surface and in the interior of the wood when the moisture content and surrounding conditions are prime for this fungal growth. The wood may become prone to this fungi in standing or fallen timber, or during seasoning prior to the kiln-drying process.
- This discoloration is often known as Blue-Stain or Brown-Stain due to the color of the fungi. In kiln-dried lumber, this fungus is not living, does not cause decay, is not a mold, will not spread, is not a health concern, and will not affect the structural integrity or the strength of the wood.

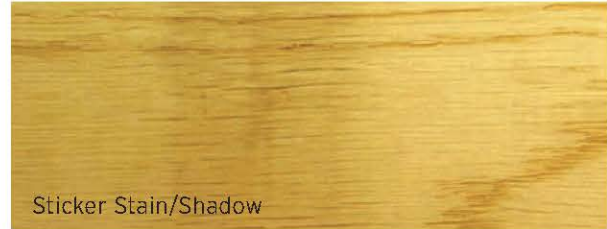
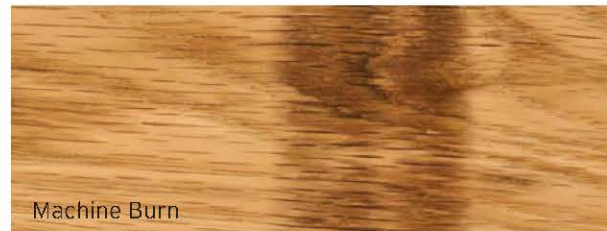
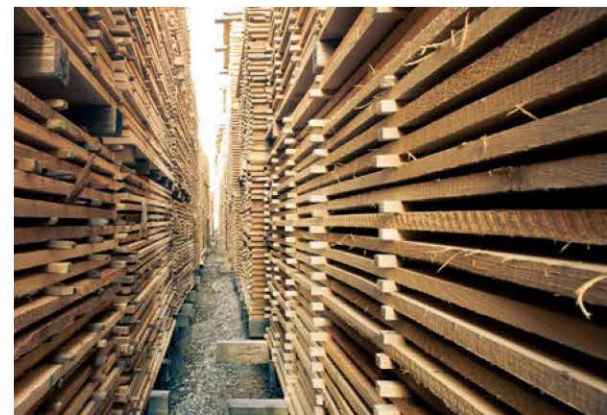
Sticker Stains/Shadow

DEFINITION: A discoloration on the face of a board associated with the location of the stacker sticker. Sticker stain should not be confused with machine burn, which may look similar, but will often sand out.

- Stickers are thin strips or boards used to separate the layers of lumber stacked in a pile in order to permit air circulation during seasoning. These stickers can leave a brown or blue stain that develops in seasoning lumber where it has been in direct contact with the boards.
- Sticker stain discoloration is the result of naturally occurring chemicals within the wood (drying wood and/or stickers) that occur during the drying process.
- Seldom, if ever, will there be any fungi associated with sticker stains.

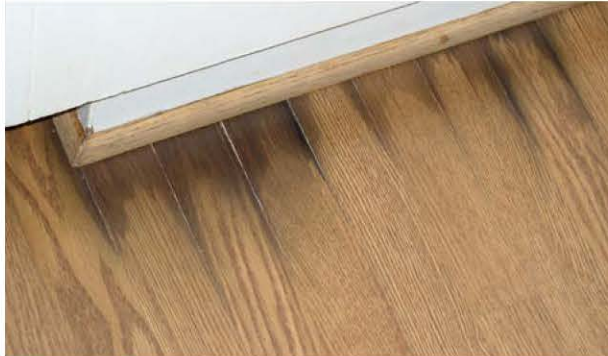
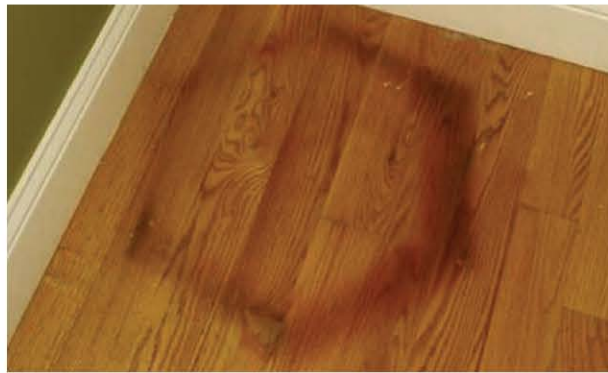
Moisture Stains

DEFINITION: The wood or finish changes color with exposure to moisture.

- Moisture from below can cause dark staining, or a white haze between seams and on the surface of the wood.
- Topical moisture (incompatible maintenance products, spills, steam, etc.) can cause blushing or damage to the finish itself.

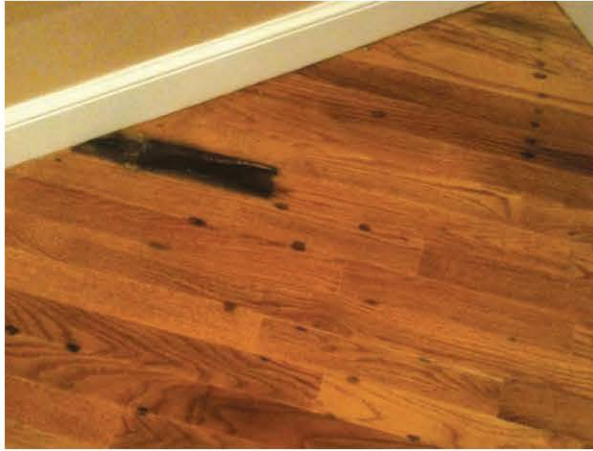
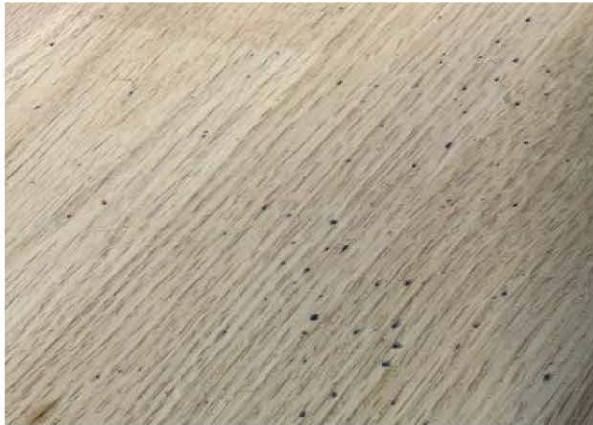
Iron Stains

DEFINITION: A result of a chemical reaction between wood tannins, water, and iron.

- A chemical reaction between extractives in the wood and iron in steel products, such as nails, screws, and other fasteners and appendages.
- Floor scraper filings/shavings left on the flooring surface that reacts with water or water-based products.
- Residual from some types of abrasives left on the flooring surface that reacts with water-based products.
- In extreme moisture condition cases, substrate exposure to moisture leaching into the wood floor from below (iron fasteners or from within the slab).
- Metal containers or objects (such as paint or watering cans) in direct contact with the floor, which have been exposed to moisture.

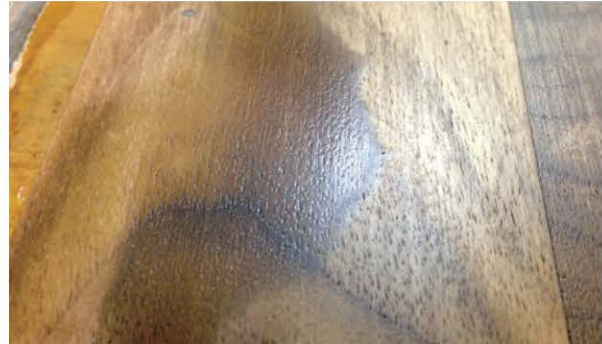
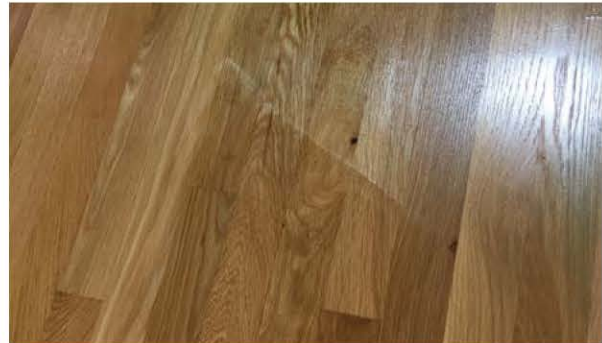
Tannic Acid Discoloration/ Tannin-Pull

DEFINITION: Tannic acid includes various naturally occurring soluble astringent complex phenolic substances found in trees (and plants) as a way of protecting the tree from insects, fire, and bacteria. High levels of tannic acid present in woods like oak, walnut, and mahogany can produce a dark discoloration when coming in contact with some products used in the finishing and maintenance of wood floors.

- Tannic acid is water-soluble and may discolor when it comes in contact with iron and water, which usually appears as a bluish/grey discoloration on the wood.
- Tannic acid discolors when it comes in contact with materials that are alkaline by nature, such as ammonia. Most water-based finishes are manufactured with pH adjusters (such as ammonia), which can cause a green/brown discoloration on the surface of the wood, and may also partially bleed into the finish.
- Unevenly applied water-based coatings, especially heavy spots, puddles or streaks.
- Not using or improper application of a tannin-blocking sealer.
- Application of a top-coat over a sealer that has not adequately dried.

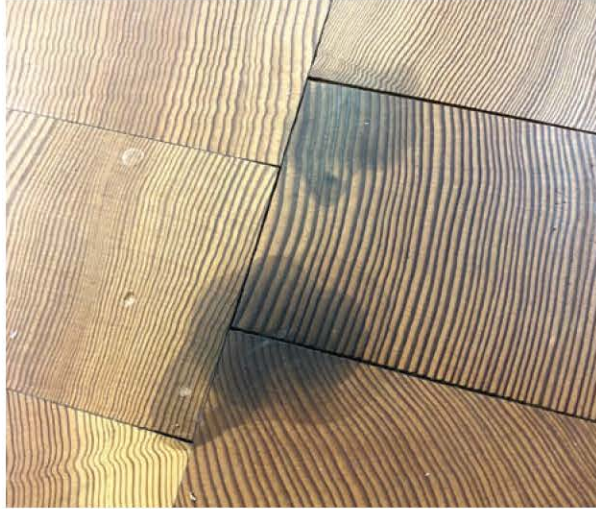
Chemical Stains

DEFINITION: Irregular shaped spots or discolorations on areas of the finished floor caused by reactive chemicals and/or air pollution.

- Household chemical spills or cleaning products (nail polish remover, ammonia, chlorine, mustard, iodine, oil, milk, ethyl alcohol, acetic acid, etc.) reaction with wood floor finishes.

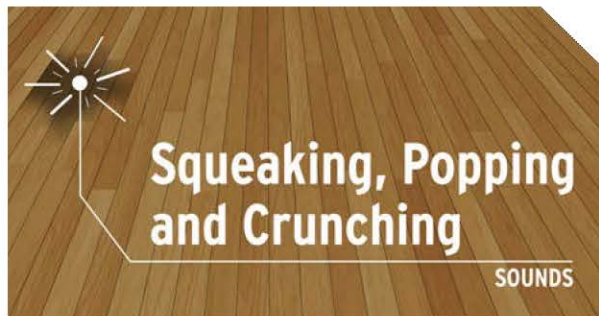
Squeaking/Popping/ Crunching Sounds

DEFINITION: Audible squeaking, popping, or crunching noises in an installed wood floor or within the floor system. Squeaks are not a direct concern with the installed wood floor as long as movement accompanying the audible squeak does not affect the performance of the installation. An occasional squeak within any properly installed wood floor system is not abnormal.

- Old age of the floor and/or structure.
- Wood flooring installed while not in equilibrium with the end-use environment. A change in temperature/humidity that causes the wood floor to change moisture content, and ultimately change dimension of the flooring and tongue and groove match, can result in audible noises, squeaks, pops, or crunching sounds.

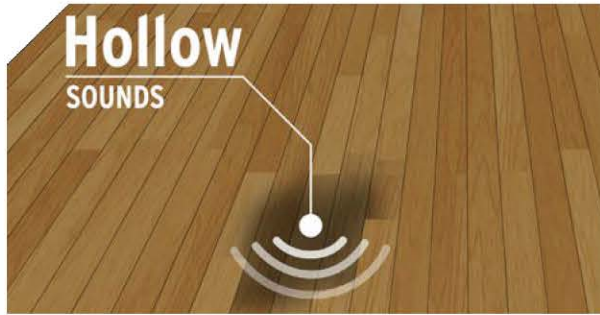
Hollow Sounds

DEFINITION: An audible hollow sound in the installed wood flooring. When no deflection is present, this may be considered normal with many installation methods provided that the installation followed proper installation procedures. Hollow sounds are not a direct concern with the performance of an installed wood floor as long as there is not movement accompanying the audible hollow sound.

- Nail-down wood floors:
 - A void in the flooring itself (wormholes, shake, bark pockets, engineered flooring core voids, etc.).
 - Slight imperfections or voids in the subfloor.

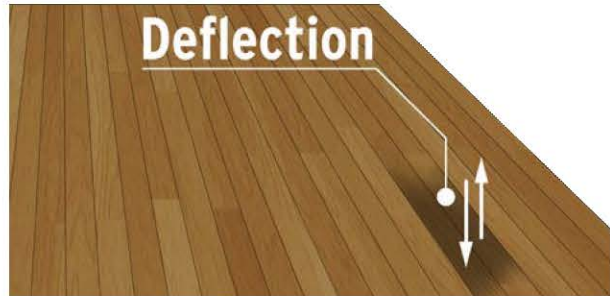
Deflection

DEFINITION: Isolated areas in an installed floor system that exhibit vertical (up and down) movement when pressure is applied.

- A void in the flooring itself (wormholes, shake, bark pockets, engineered flooring core voids, etc.) resulting in vertical movement.
- Mis-milled flooring/loose tongue and groove engagement (outside of manufacturing tolerances at the time material was manufactured).

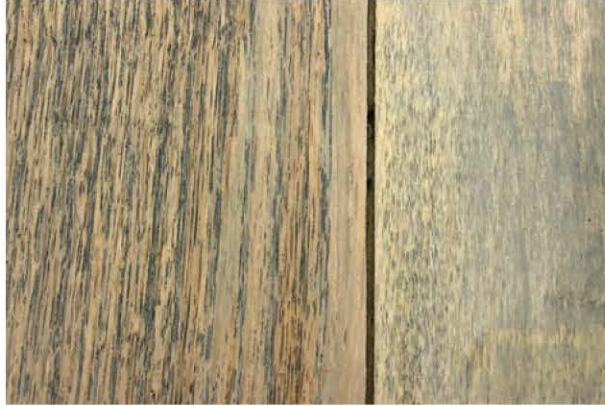
Seasonal/Normal Gaps

DEFINITION: Gaps that appear between individual boards, opening and closing with seasonal humidity changes. Wider boards can experience wider gaps. Gap size is directly related and proportional to the board width.

- Most normal gaps are caused by seasonal fluctuations in relative humidity. The floor expands with high humidity and contracts with periods of low humidity. This type of expansion and contraction is considered to be normal and expected with wood floors when exposed to seasonal variations.
- When wood flooring is installed during dry seasons where relative humidity is not maintained, it is normal to leave internal expansion spaces/gaps (washer rows) within the floor to accommodate for seasonal humidity changes.

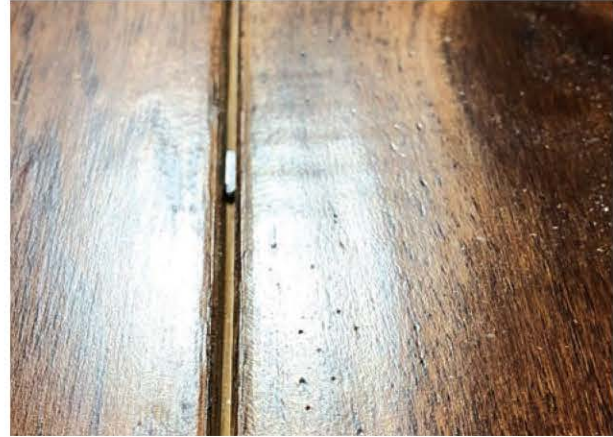
Abnormal Gaps

DEFINITION: Gaps between abutting wood floor boards in the installed floor that were not intentionally placed and remain with seasonal fluctuations in moisture and humidity.

- Flooring not installed tightly together.
- Debris between the boards during installation.
- Solid wood flooring installed at higher moisture content than what the normal, in-service conditions can support.

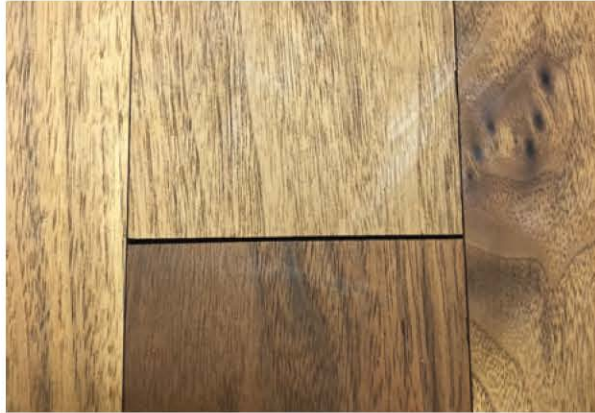
End-Gaps

DEFINITION: A separation that occurs on the ends of two abutting wood floor boards.

- Loss/gain of moisture in engineered flooring.
 - Due to the construction of engineered flooring, each layer shrinks and swells in different directions and at different rates than the adjoining layers. It is common for it to shrink/swell in its length when exposed to changes in moisture content.

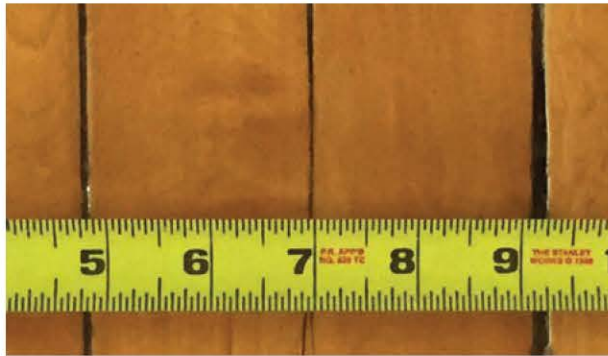
Compression-Set

DEFINITION: A generally uniform appearance of gaps between wood floor boards that directly coincides with the narrowing/crushing of individual board edges as a result of permanent cellular damage. The appearance of a compression-set floor may be similar to gaps from other causes, such as flooring that was milled and installed with high moisture content. When they are at the same moisture content at which they were milled, compression-set boards will be narrower than the milled width and may exhibit slightly raised edges along the board edges.

- Exposure to substantial moisture causing excessive expansion, and resulting in damage to board edges, followed by lower moisture levels and subsequent contraction of the affected boards.
- Once the wood fibers have been damaged, they may be unable to regain their original dimensions.
- The compression can become exaggerated by debris becoming embedded in the gaps between boards.
- Filling seasonal gaps during the dry season can cause compression-set when the floor expands again during the more-humid months.

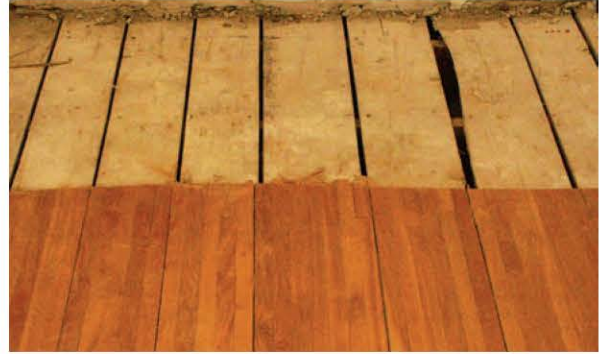
Panelization

DEFINITION: A generally uniform appearance of gaps or peaks in the surfaces of the wood floor that directly coincide with movement in the subfloor material beneath it.

- Moisture-related subfloor issues.
- Acclimation related issues:
 - Moisture content of the wood floor and subfloor are not aligned at the time of installation.

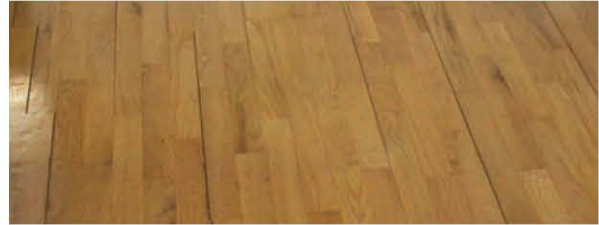
DEFINITION: A condition where localized gaps develop between flooring boards while adjacent groupings of boards remain tightly bonded together with no apparent separations. These gaps will sometimes exhibit wood fractures along the gap as a result of the finish bond tearing away small pieces of wood from the adjoining plank. Sidebonding should not be confused with panelization. (See Panelization.)

- When installed wood flooring shrinks due to a loss of moisture, and the edges of individual boards have become adhered to one another due to:
 - Finish (most common with water-based finishes) that has seeped between the boards, drying and forming a permanent bond adjoining/gluing boards together.
 - Glue that has been used on the tongue and groove during installation, adhering the planks together.
- Not using a sealer, either water-based or oil-based (sealer, stain, or polyurethane), as recommended by the finish manufacturer, prior to applying the rest of the finish system.
- With recoat scenarios in which cracks are present or unfilled, finish will fill the voids and potentially result in sidebonding.

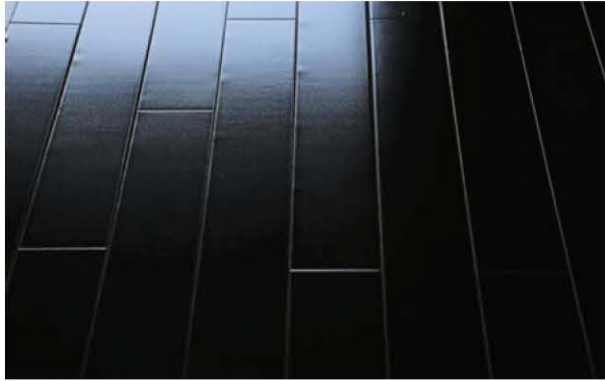
Telegraphing Fastener/Dimpling

DEFINITION: Dimples or bumps along the nailing surface of the finished flooring, directly related to fastener location and/or installation method.

- Improper fastener used for the wood installed (the wrong gauge staple or cleat).
- Underdriven fasteners (not seated properly) in the nail pocket of the flooring displacing the wood fibers as a result of incorrect air compressor pressure settings.

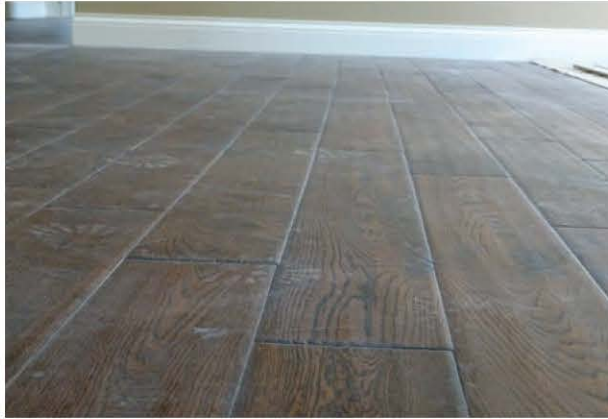
Crooked Installation Discrepancies

DEFINITION: An installed wood floor appearing bowed or out-of-square within the room in which it is installed. No wood floor installation is perfectly straight, parallel, or perpendicular to walls or fixtures. When the straightness of the installed floor takes away from the overall appearance of the floor within the structure, an aesthetic remedy may be necessary. The performance and structural integrity of the wood floor is not normally affected with any floor that has been installed out-of-square or out-of-a-straight-line.

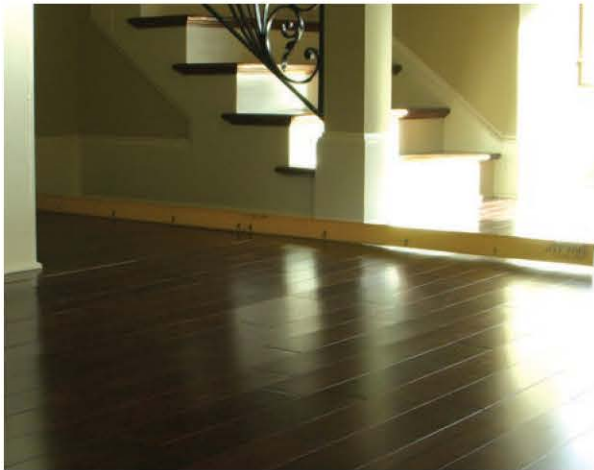
DEFINITION: The installed wood floor system appears to be uneven, wavy, or out of flat. Wood floors may be installed over out-of-level subfloors, but should fall within NWFA floor flatness tolerances. Subfloor flatness cannot be quantifiably measured when a floor covering is in place over it (without potentially extensive destructive testing), however, may give a good indication of what is happening below.

It is the responsibility of the flooring installer to assess substrate flatness, moisture requirements, and panel thickness/joist span combinations prior to installation. Reference NWFA Wood Flooring Installation Guidelines, and the flooring manufacturer installation instructions, for applicable tolerances. Gradual variations in subfloor flatness may not affect the performance of the installed wood floor, but may be considered unacceptable when overwood, vertical movement, slight gapping, squeaking, or noisy floors are present.

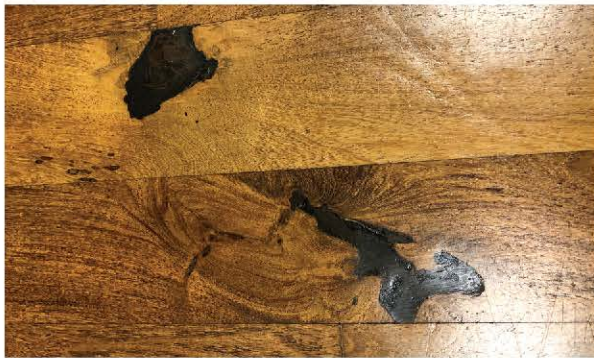
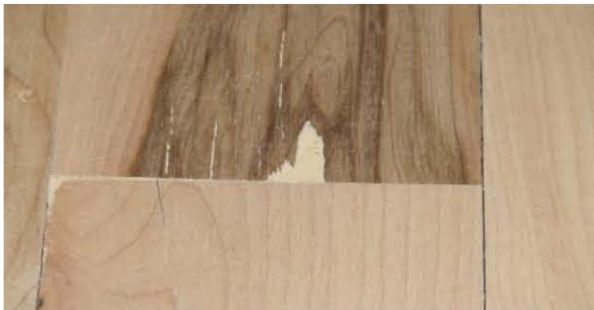
Filler Color Variation

DEFINITION: The wood filler from one area of the floor is different from the overall color tone of the floor. No two trees from the same species are identical, no two boards from the same tree are identical, and color and grain patterns can vary even within one individual plank of wood. Wood filler will never perfectly match, nor is it designed to match every board within a wood floor.

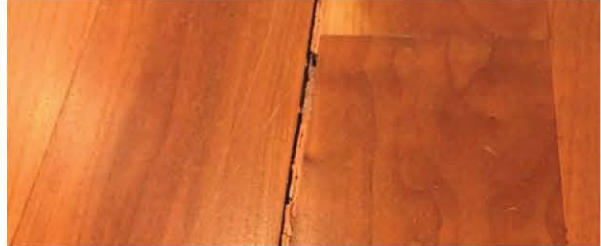
Popped Filler

DEFINITION: Wood floor filler that has become loose or no longer fills the void it was once in.

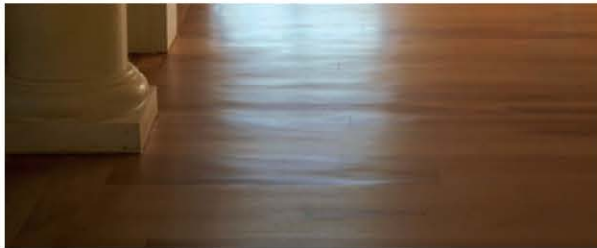
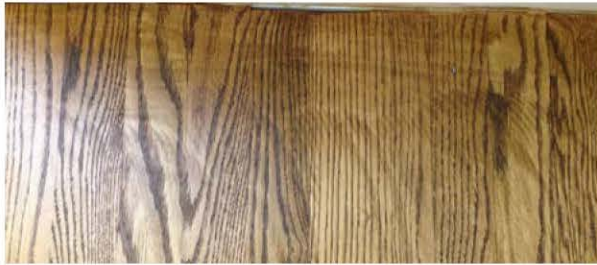
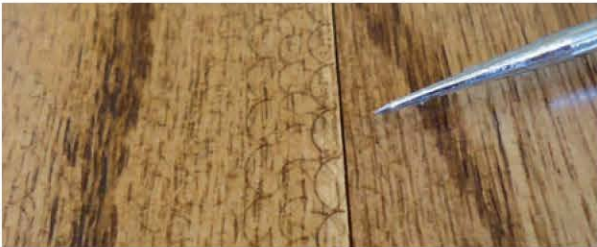
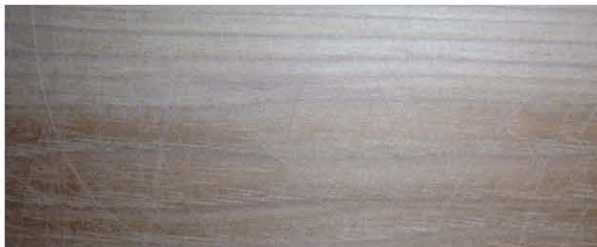
Sanding Marks

DEFINITION: Sanding imperfections seen as drum marks, side cuts, sanding scratches, or swirl marks. Sanding marks should be viewed from a standing position on the floor being assessed, in ambient lighting conditions. Glare from a direct light source must not be used during evaluation. Inspection may take place from floor level and/or with assistance of magnification in order to determine causes of irregularities, but not to determine acceptability.

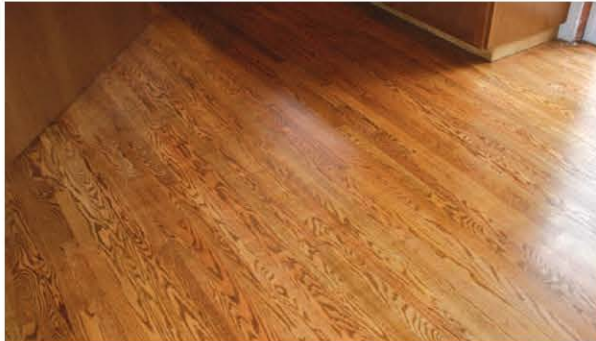
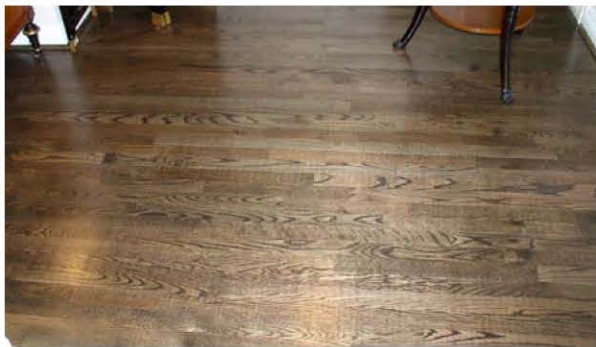
Chatter

DEFINITION: Slight unintentional indentations causing a ripple-like wave effects or “bars” that run perpendicular to the wood’s grain direction on the surface of a wood floor which can become visibly pronounced in direct lighting. The width of these “bars” can range from just a few millimeters to nearly an inch from peak to peak, and can occur in limited regions or can span the entire floor.

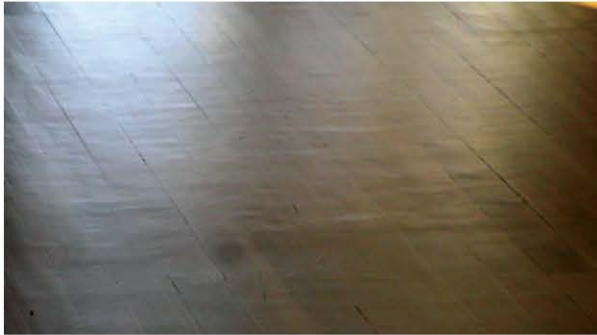
DEFINITION: Indentations, usually repeating undulations, visible on a site-sanded wood floor surface, most often visible after a finish has been applied. The width of these irregularities typically range from one inch to three inches or more, and can occur in limited regions or can span the entire floor. Wave can sometimes be in conjunction with, or confused with, dishout.

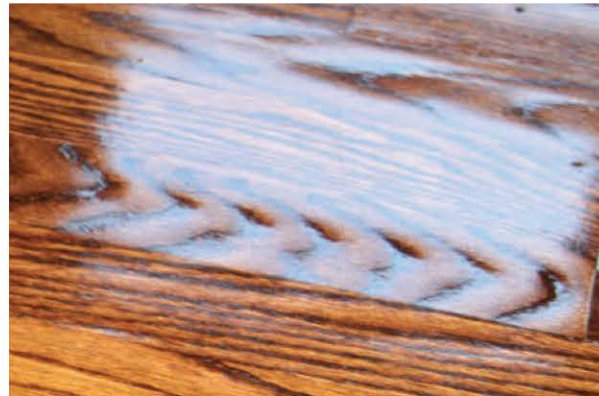
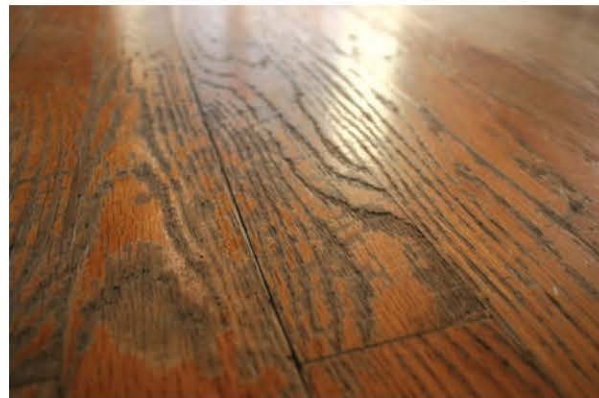
Dishout/Shellout

DEFINITION: Undulations in the surface of individual boards or within the wood floor, resulting from softer areas having been worn, hollowed, or sanded to a lower level than harder adjacent areas.

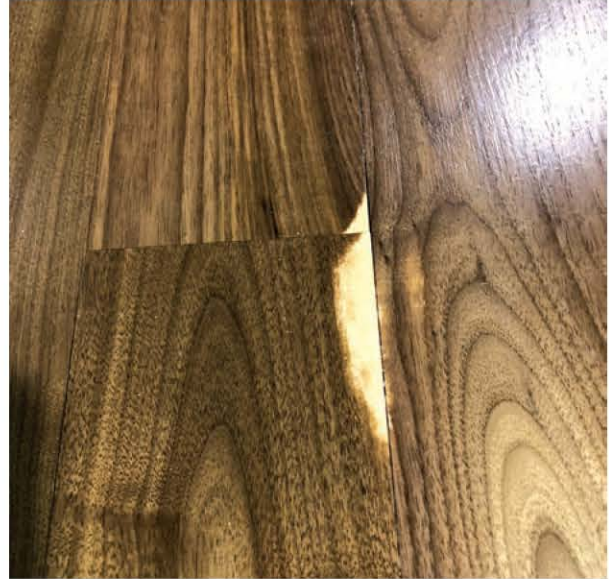
Veneer Sand-Through

DEFINITION: The top/wear layer veneer (lamina) of engineered flooring has been completely sanded through to the core layer.
