PROBLEMS, CAUSES, AND CURES

nwfa
National Wood
Flooring Association

Technical Publication No. C200 • Revised © 2018 | 3rd Edition

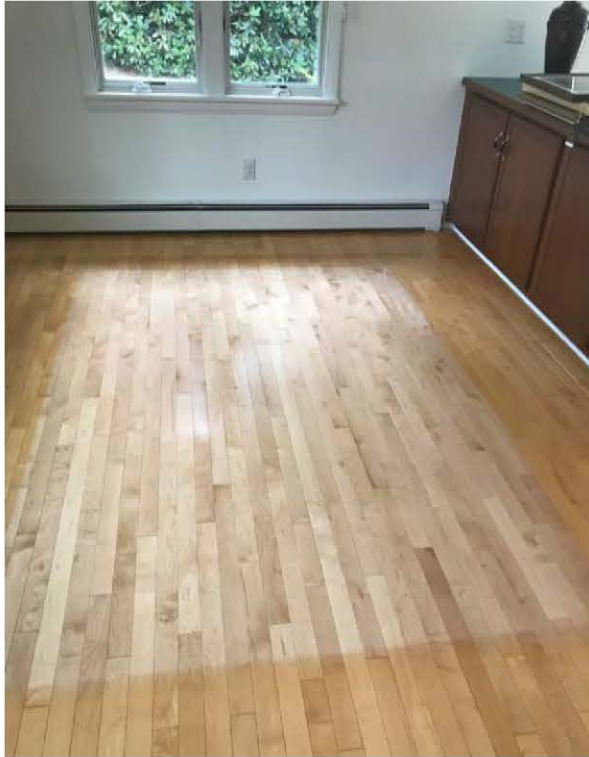
Finish/Colorant Discoloration

DEFINITION: The finish or colorant systems changes color.

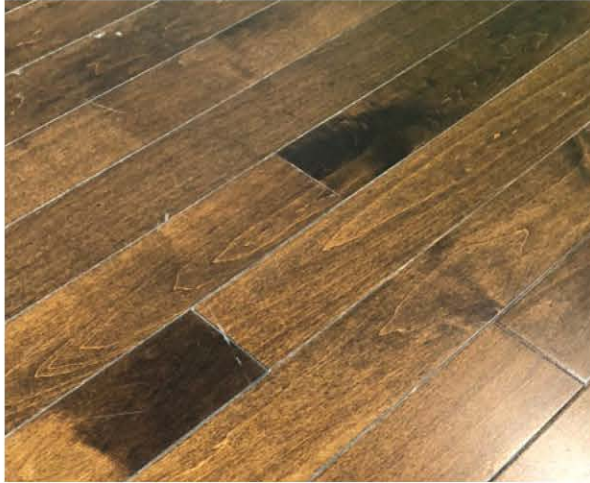
Blotchy Stain/Colorant

DEFINITION: The appearance of an inconsistent stain or colorant from one area of a finished floor to another. Stained/colored floors should be uniform in color. Color tones may vary from board to board or within individual boards due to natural variances within the wood.

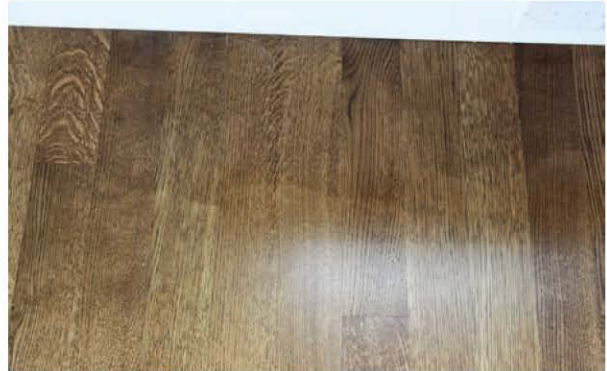
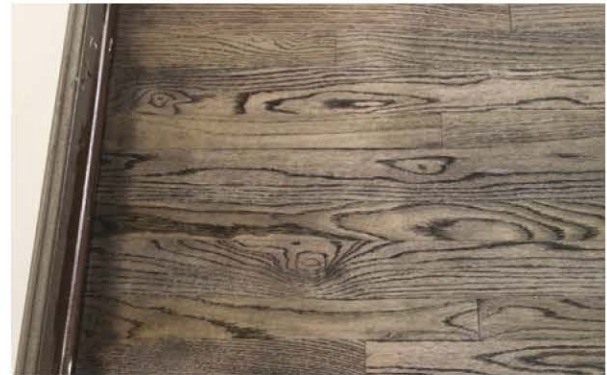
Picture Framing/Halo

DEFINITION: The edges of the room appear to be a slightly different color than the rest of the room.

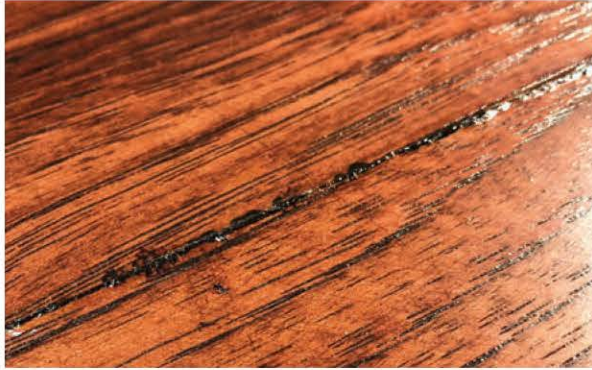
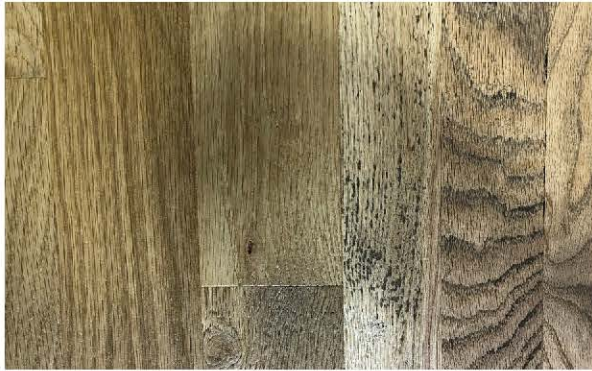
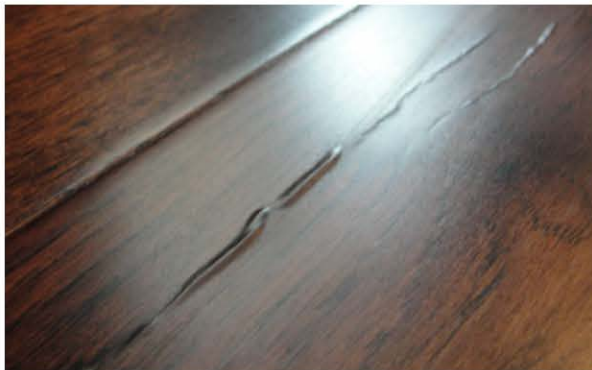
Stain Bleed Back

DEFINITION: A staining phenomenon occurring after the initial application of the stain, where the stain seeps back to the surface of the wood. This may happen at board seams, with open-grain species, tight grain, knots, or burls.

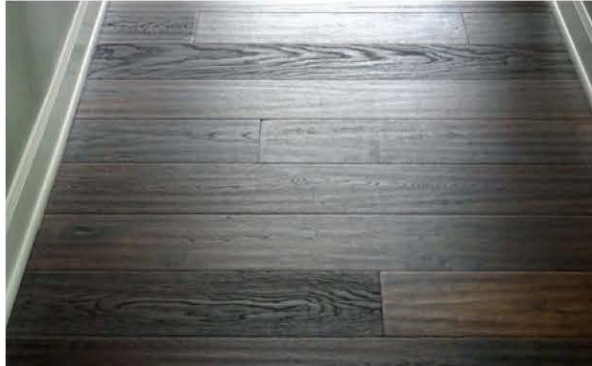
Finish Film-Thickness Discrepancy

DEFINITION: A discrepancy in the depth of the film of finish applied to a wood floor. Mil/film thickness of finish can be evaluated, but should not determine acceptability.

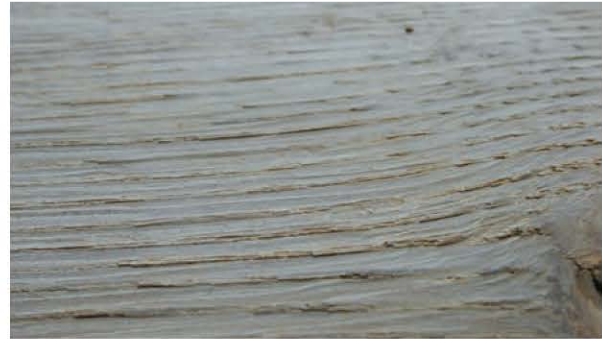
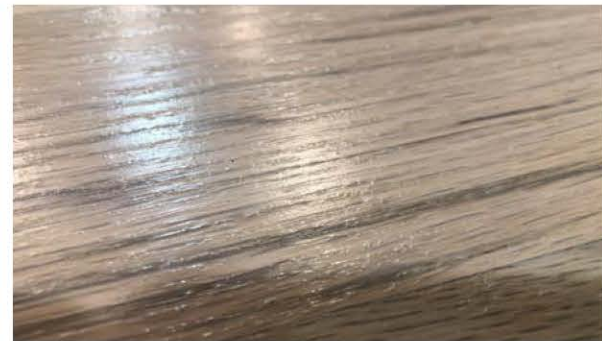
Roughness/Grain-Raise

DEFINITION: The surface of the wood floor feels rough to the touch.

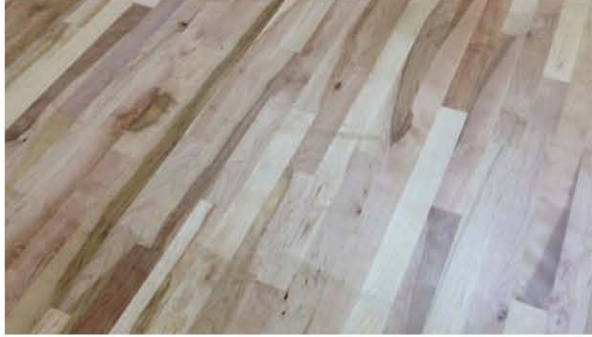
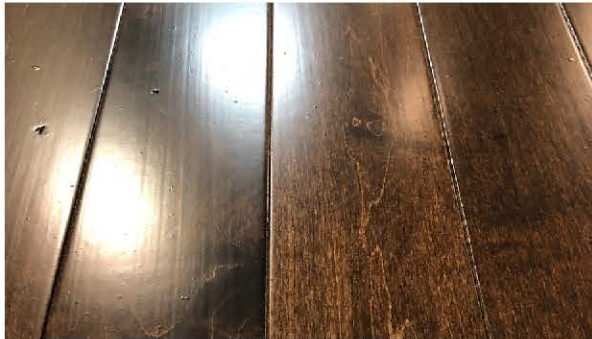
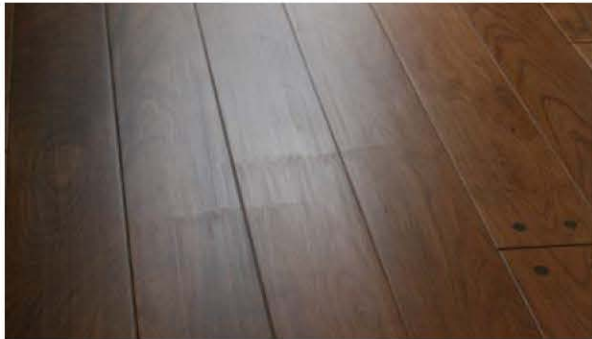
Applicator/Finish Streaks

DEFINITION: Visible ridges, lines, or marks left on the wood floor, representing the application tool used from any stage of the finishing process.

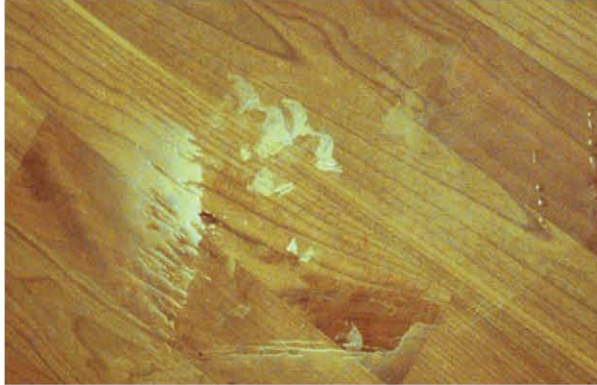
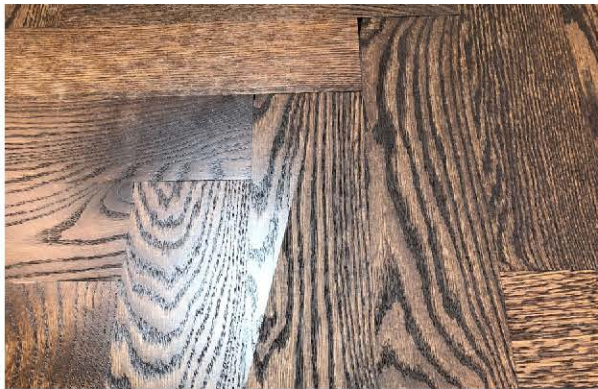
Holidays/Skips

DEFINITION: An exposed area of uncoated wood or the undercoating, when the intention was to coat the entire area.

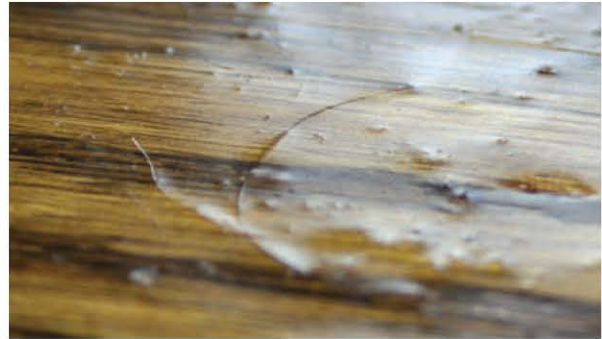
Debris in Finish

DEFINITION: A raised bump in the film of finish often consisting of dust, hair, applicator fibers, foreign contaminants, solid finish particles, or other artifacts. Due to the nature of most coating environments, minimal amounts of debris within reason can be expected in any coat of finish.

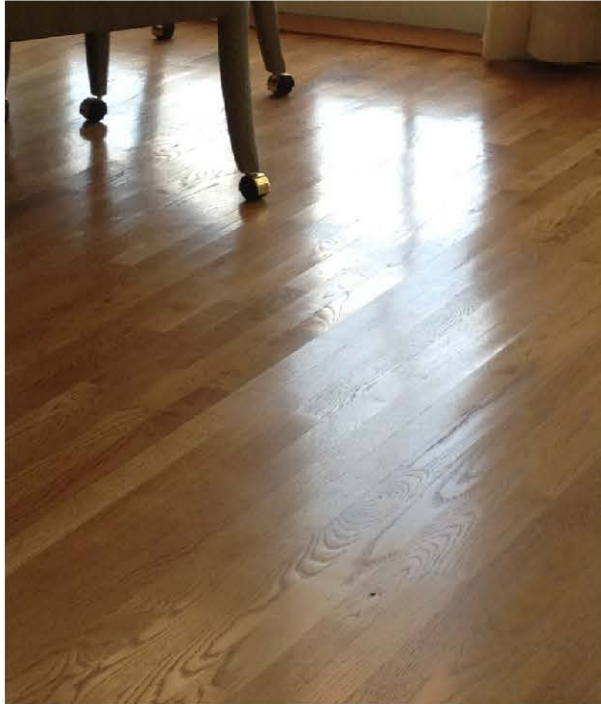
Uneven Sheen/Gloss Levels

DEFINITION: The sheen or gloss level of the final coat of finish varies from one area of the floor to another. As film-forming finish products decrease in gloss, they increase in amounts of matting agents. Lower sheen products have the most matting agent, and thus, can more-easily manifest uneven sheen levels. Sheen/gloss levels should not be assessed until all final coats have been applied and are fully cured.

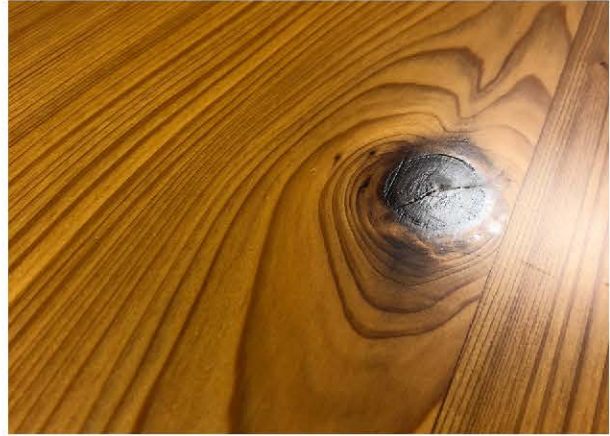
Sticky Board Syndrome

DEFINITION: Wood floor finishes that do not dry, adhere, cure properly, or appear the same on specific areas of a board or individual boards.

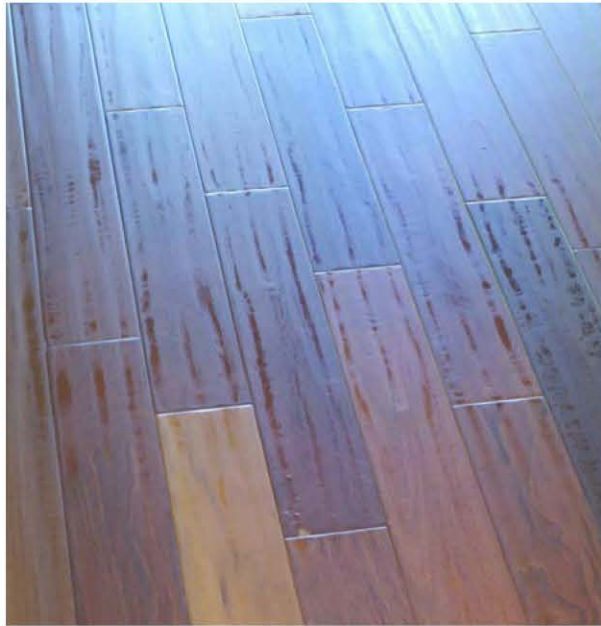
Cloudy Finish

DEFINITION: An unintended white, milky, or cloudy appearance of an otherwise transparent, clear finish.

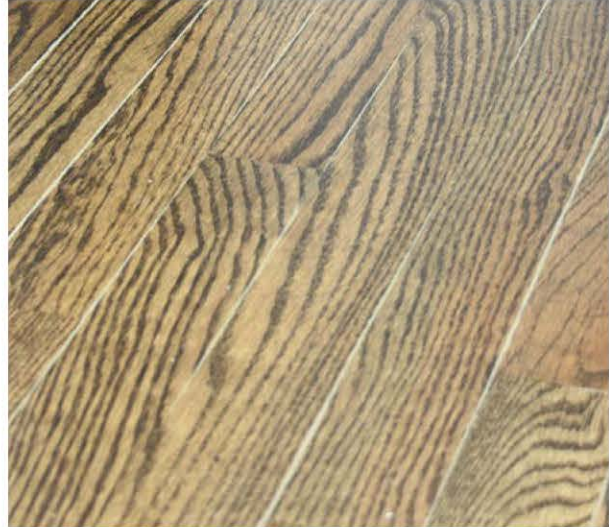
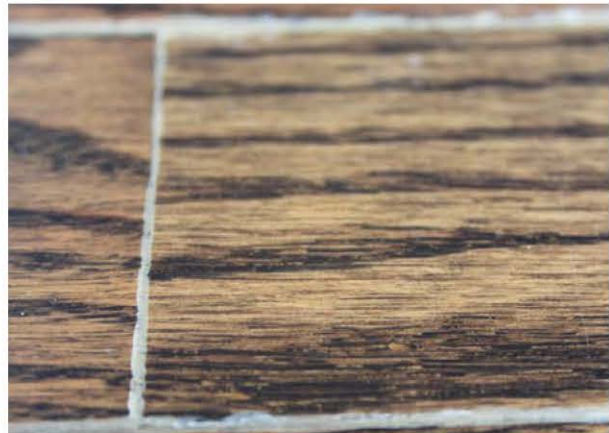
White Lines

DEFINITION: White lines appear between board edges of site-applied film-finishes.

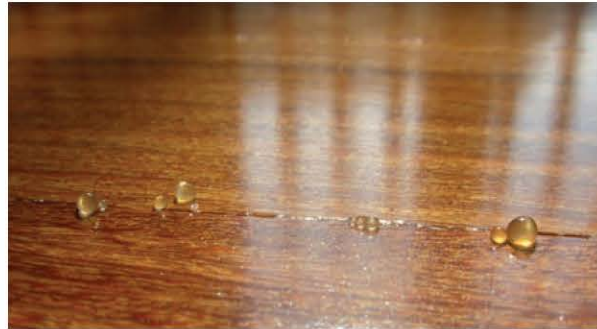
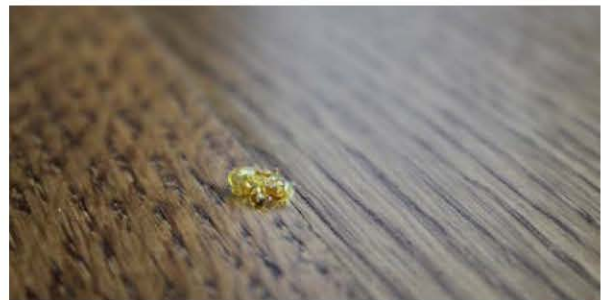
Poly Beads

DEFINITION: Small round balls that appear as beads, or “BBs” of finish, that form along the joints of the individual boards. They can be soft and sticky when first formed, and will become hard if left undisturbed. When these wet beads are stepped on, they can become unsightly smears along board edges.

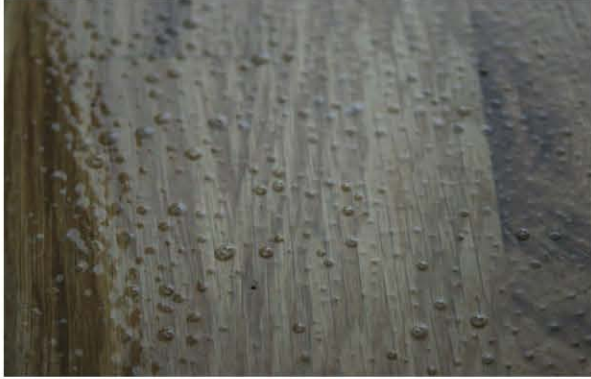
Bubbles

DEFINITION: Raised bumps, or air-filled bubbles visible in the film of the finish. These include both full bubbles and bubbles that have popped.

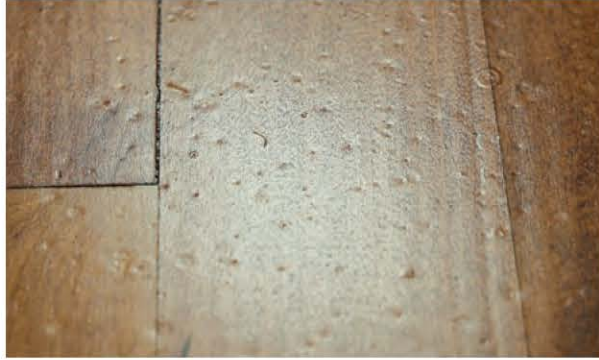
Pin Holes

DEFINITION: A visible finish imperfection where the surface of the finish film recedes from a very small area or areas of the surface.

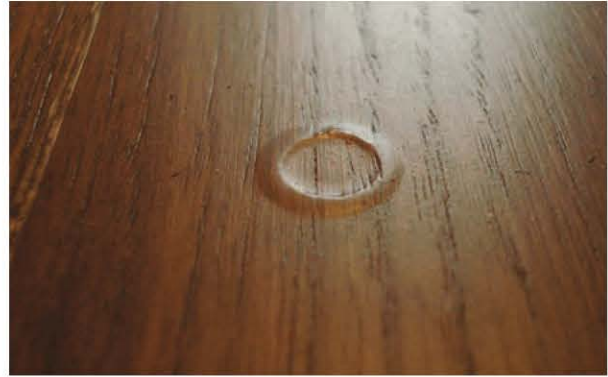
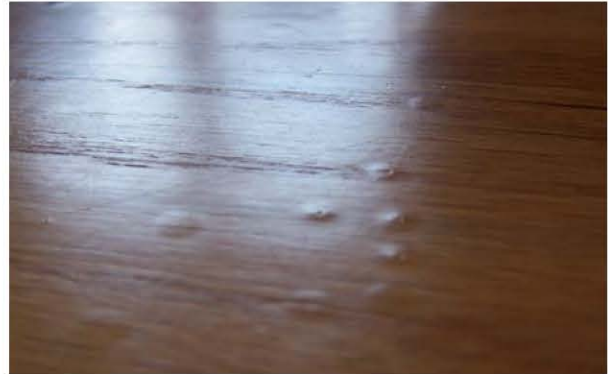
Craters/Fisheyes

DEFINITION: A visible finish imperfection that manifests by the crawling of wet finish film into a single area or pattern resembling small dimples or bowl-shaped depressions, sometimes accompanied by a particle in the center.

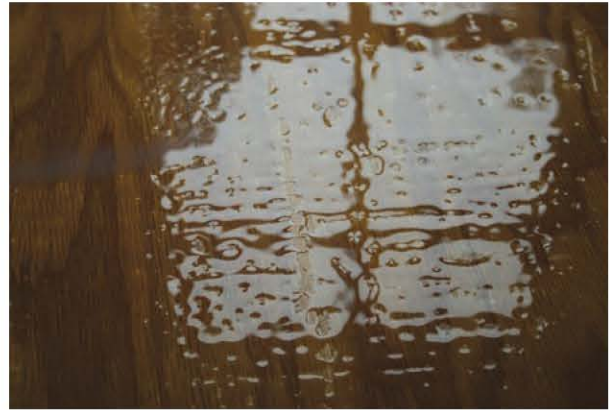
Crawling

DEFINITION: A visible finish imperfection where the finish film is repelled from areas of the surface, leaving the appearance of thin or uncoated affected areas. May be very long and oval shaped, and may vary in size.

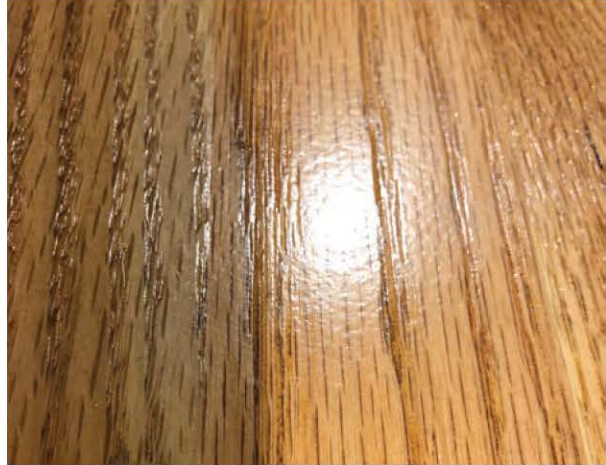
Orange Peel

DEFINITION: A visible finish imperfection where the surface of the dry finish film exhibits a flaw that resembles the texture of an orange peel.

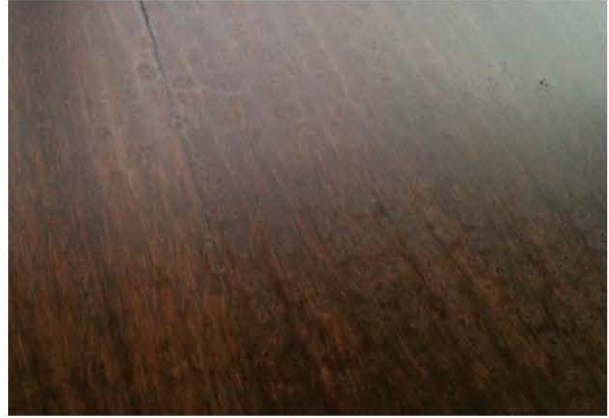
Benard Cells

DEFINITION: A visible finish imperfection resembling a pattern in the smooth finish film that resembles a clustering of "cells." They typically appear as less-glossy, often round, curvy, or geometrical (hexagonal, pentagonal) in shape, and may range in size from very small, up to 1". Benard cells are more common with lower sheen or pigmented finishes.

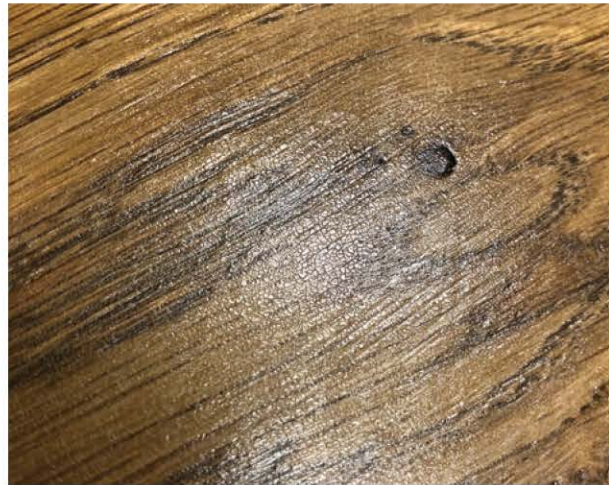
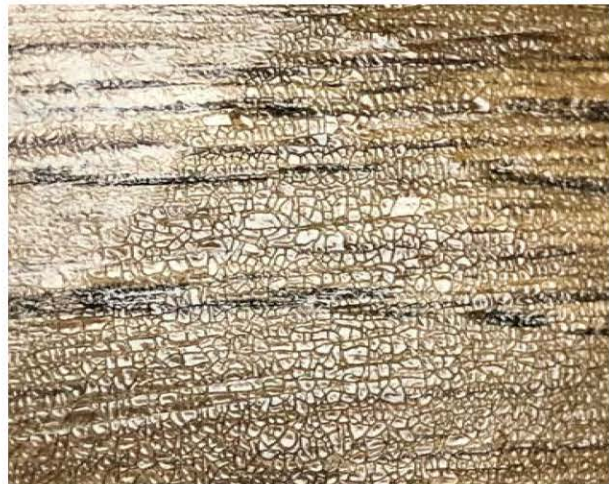
Crazing/Alligatoring

DEFINITION: A visible finish imperfection that appears as a network of very small, fine cracks or fissures in the surface of the finish film, which sometimes resembles the skin of an alligator or crocodile.

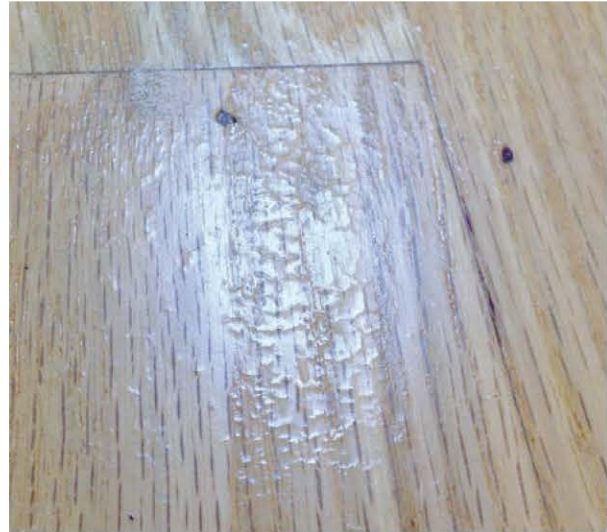
DEFINITION: A visible film-finish imperfection that appears as the skin of a dried prune. Wrinkling may happen with all types of film-finish, but is most common with oil-based urethanes.

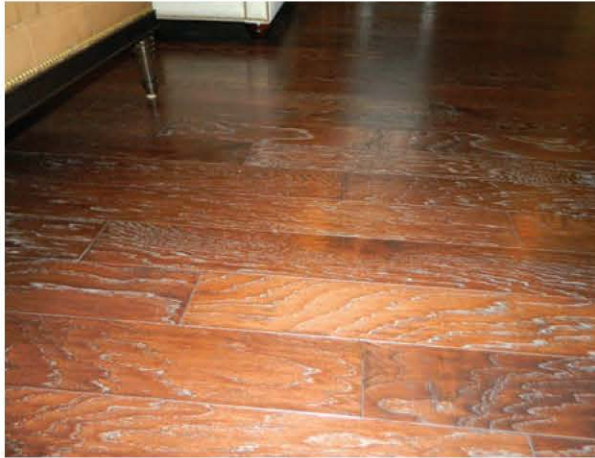
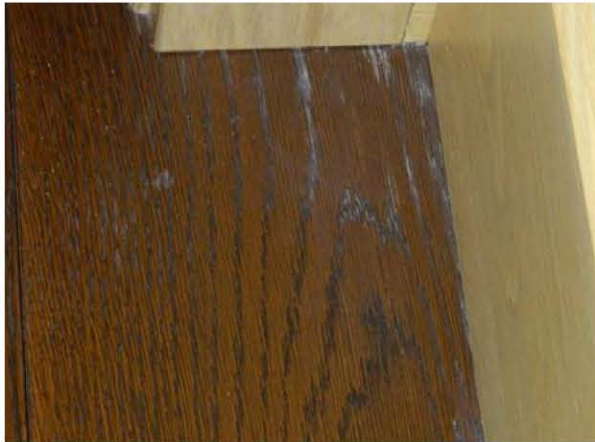
Open-Grain Contamination

DEFINITION: An accumulation of contaminants in open voids or characters, such as in textured wood, the soft grain/springwood, open knots, splits/checks, etc., on the surface of the installed floor.

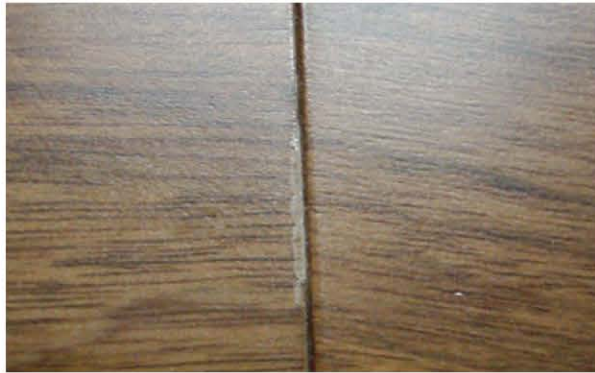
Finish Adhesion Failure

DEFINITION: The loss of film-finish adhesion to the flooring surface or between coating layers.

Chipping/Flaking Finish - The condition that occurs when a dried film of finish separates from the previously applied finish in the form of chips or flakes.

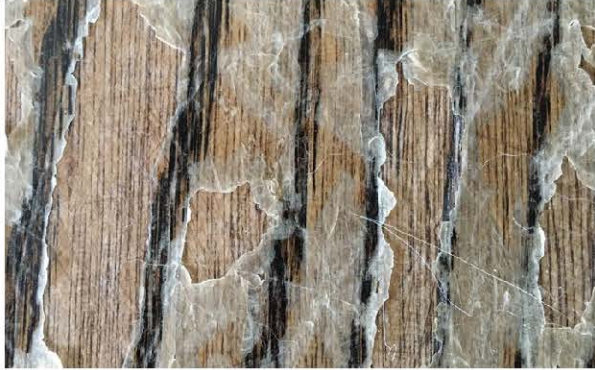
Finish Adhesion Failure

Peeling Finish - The condition that occurs when a dried film of finish separates from the underneath surface in the form of large pieces or sheets.

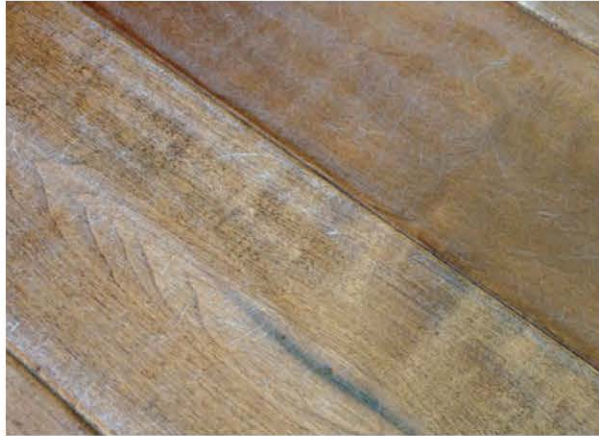
Finish Wear Discrepancies

DEFINITION: The performance of the surface coat of finish not meeting expectations.

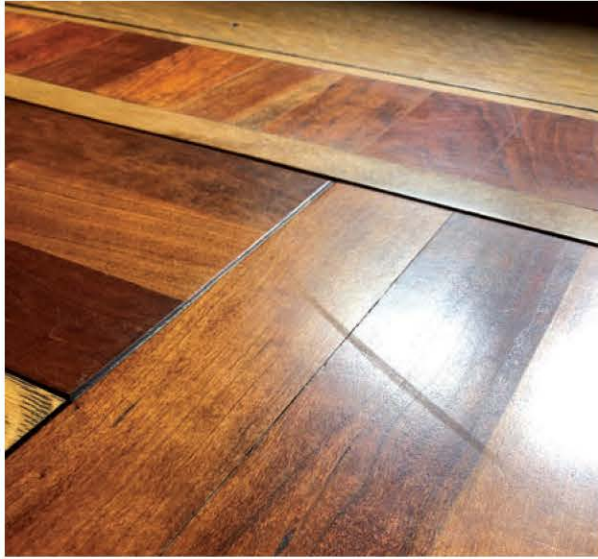
Scuffing

DEFINITION: Marks or abrasions left on a wood floor surface or finish.

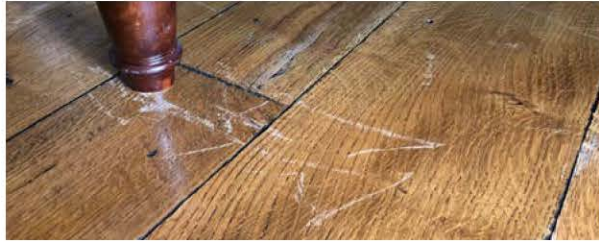
- **Scratches** - caused by applied horizontal and vertical forces.

- Finish systems may be marred or scuffed, either from chemicals or from heat generated by sliding objects across them. These may look like scratches, but are not.
- Surface scratches are typically only in the finish coats. A fingernail can't feel the ridge.
- Deep scratches are typically through the finish coats and have torn the wood fibers.
- Cross-grain scratches are deep scratches, and are oriented perpendicular to the direction of the flooring, often crossing multiple board widths and have a higher probability of exhibiting wood fiber tear. Deep scratches, usually termed "gouges," are typically through the finish coats and have torn the wood fibers.
- As scratch damage increases in severity, so does the likelihood that the damage will also include denting.
- **Indentations** - notches, grooves or depressions on the surface of the flooring.

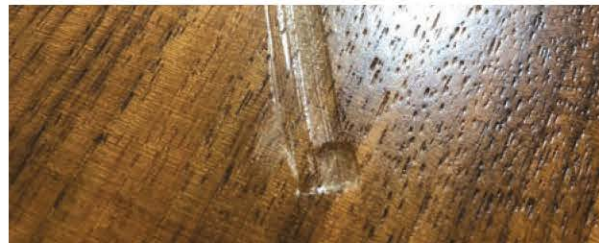
- Indentations are caused by applied vertical and/or horizontal forces on the flooring surface.
- When only vertical forces have been applied (dropping an object) these depressions are typically isolated to the shape of the portion of the dropped object that contacted the floor.
- Indentations may not always be accompanied with finish tear/fracture.

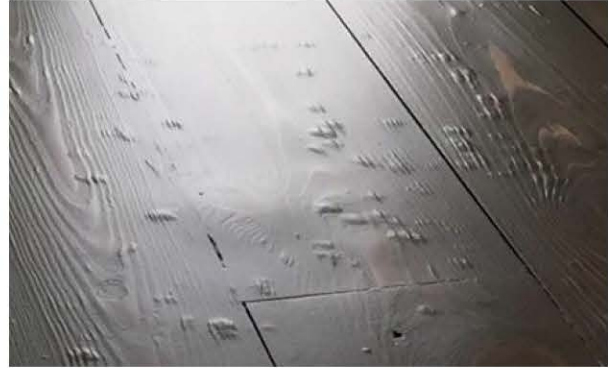
- **Wood bruises** - from a previous force or trauma to the surface of the boards that is not normally noticeable during the installation or handling of the product. This damage can become exposed with an increase in moisture, such as with the introduction of water through water-popping, water-based finishes, water-based stains, or similar reactive conditioners.

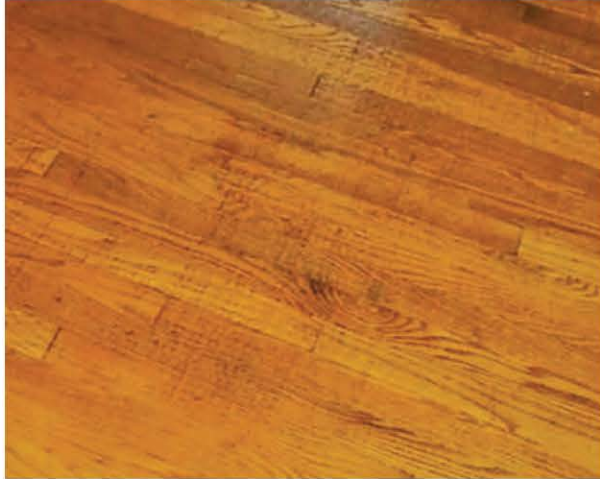
Surface Impressions

DEFINITION: A shape or pattern imprinted on the face of the board, which resembles an item or object that had been in direct contact with it.

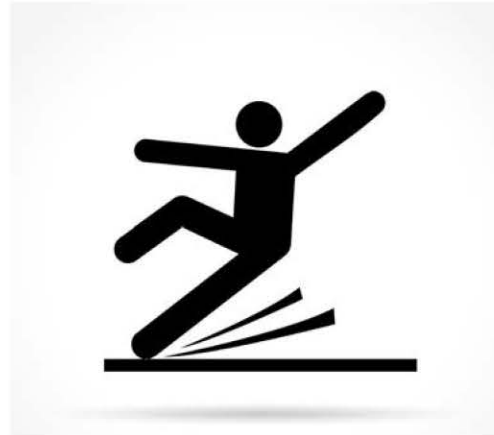
Slippery Floors

DEFINITION: The perception that the floor feels slippery. All wood floor finishes could be considered slippery with normal use. Most wood floor finishes are not usually considered to be slip-resistant, and some wood floor finishes feel slipperier than others.

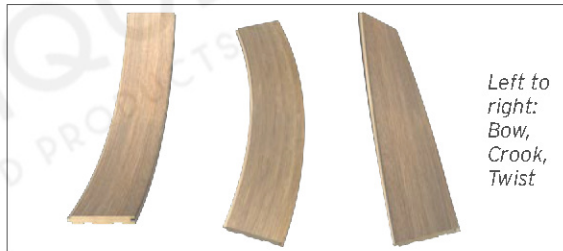
Warp

DEFINITION: Any variation of the intended shape of a piece of wood flooring from a true or flat plane.

Bow - A deviation in the lengthwise flatness of a board, measured end to end.

- Solid wood flooring: Bow occurs when one side of the floor board shrinks more in length than the other. It causes the lengthwise curvature of the plank that resembles a bow used in archery. Because longitudinal shrinkage in solid wood is minimal, bow is normally not an issue that affects installation.
- Engineered wood flooring: Bow occurs when the wear layer and the core begin to shrink in opposing lengthwise directions, forcing the uninstalled planks to bow. Manufacturer and industry standards (HPVA) dictate tolerances and milling requirements for the amount of bow allowed in an engineered wood floor at the time of manufacture. This may or may not coincide with uninstalled flooring at the jobsite due to change in moisture content as a result of jobsite conditions.

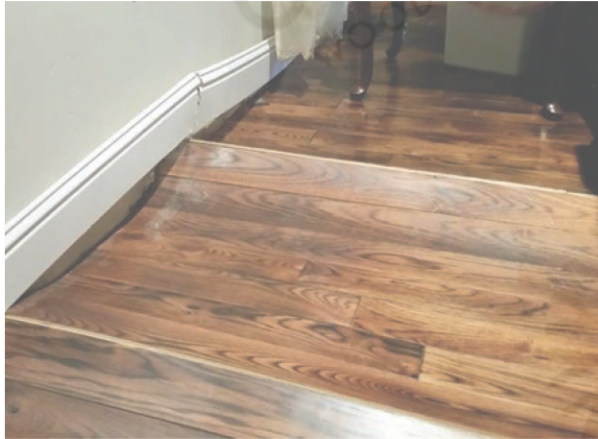
Buckling

DEFINITION: The wood flooring has separated or lifted from the subfloor.

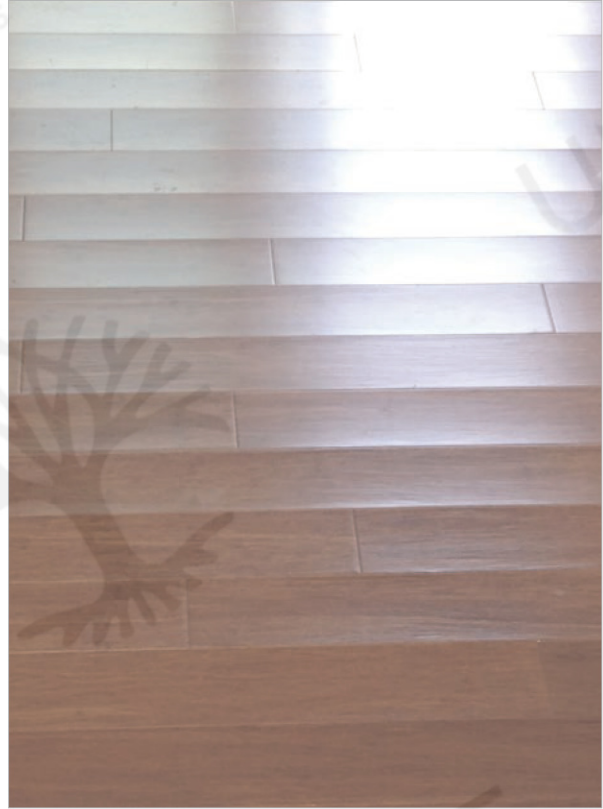
- Engineered flooring manufactured out of balance (core and wear layer having an unbalanced EMC).

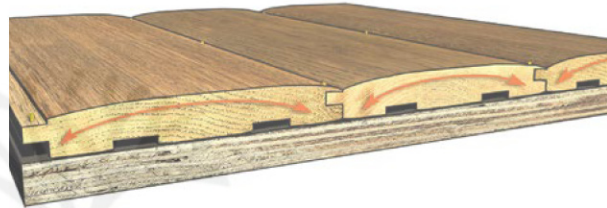
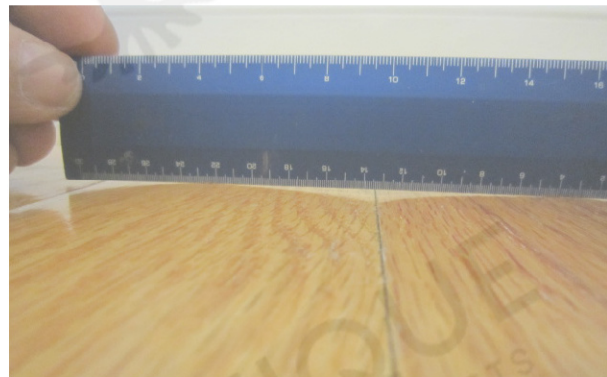
Crowning

DEFINITION: A convex or crowned appearance of individual boards with the center of the board higher than the edges. This can also be a type of warp.

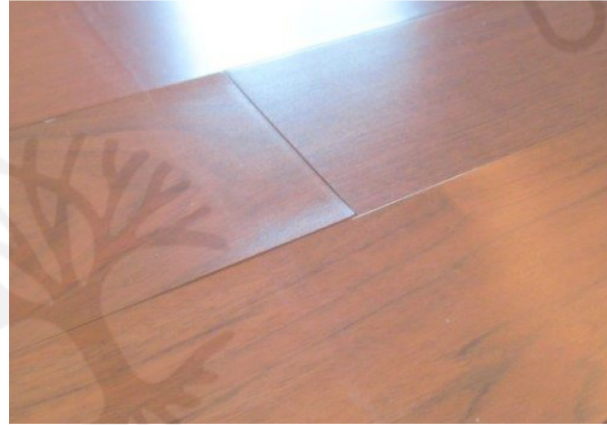
Dry Cupping

DEFINITION: A concave or dished appearance of individual engineered flooring planks with the edges raised higher than the center.

- When relative humidity levels remain below the manufacturer's recommendations for long enough, engineered planks can begin to dry cup. When this happens, the wear layer loses moisture and begins to shrink across its outer face, which can exert enough force on the core material to pull the edges of the plank (often the groove side) upward. This causes a cupped appearance across the width of the board.

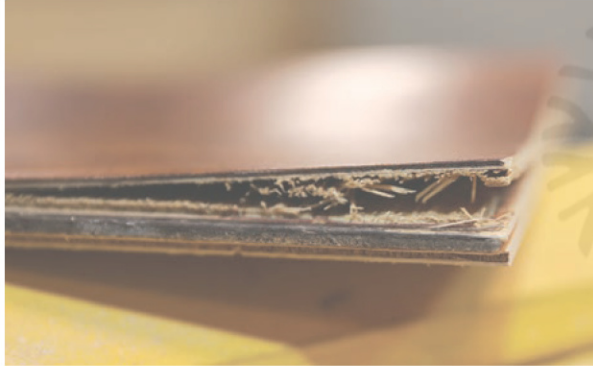
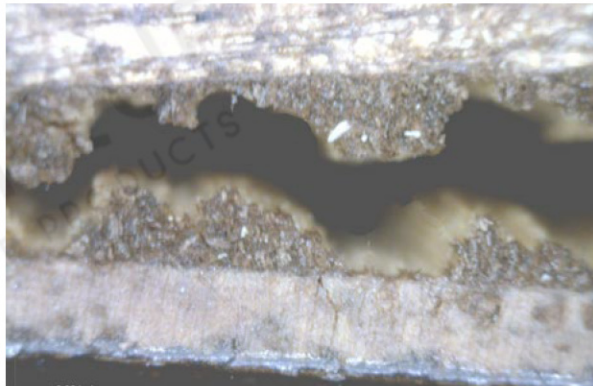
Wood Shear (Engineered Flooring)

DEFINITION: External stresses exceeding the strength of the wood fibers within an individual plank of engineered flooring, resulting in the wood fibers being torn apart. When examining this type of failure in an engineered wood flooring plank, wood fibers will be visible at the point of separation, remaining bonded to the adhesive layer.

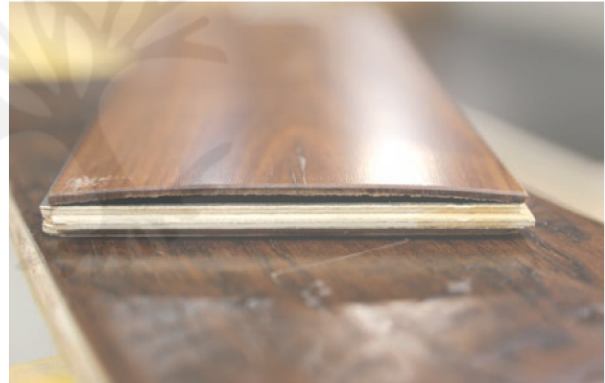
Delamination/ Glue-Line Separation (Engineered Flooring)

DEFINITION: Engineered flooring is manufactured by adhering several layers/plies together. The separation of two layers/plies within a piece of engineered flooring due to the lack of an adhesive bond is typically identified as a clean separation at the glue-line. Adhesive bond failure is unrelated to inadequate relative humidity levels.

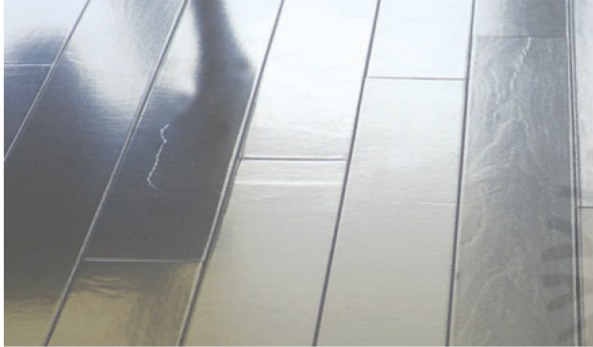
Telegraphing Core Material (Engineered Flooring)

DEFINITION: Visible patterns on the surface of the wood floor plank that resembles variations in the engineered flooring core material.

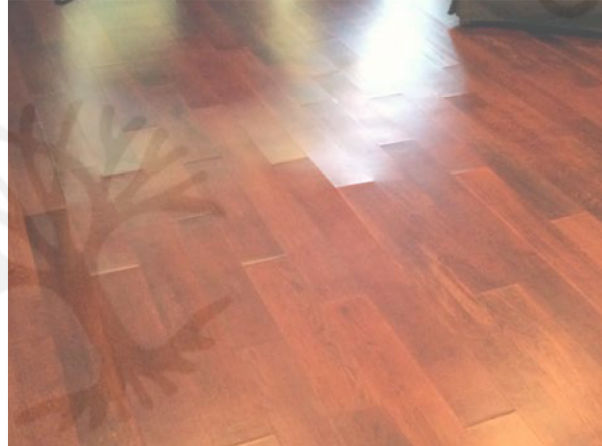
Endlift/Ski (Engineered Flooring)

DEFINITION: A condition where the ends of installed engineered wood flooring boards deviate from the flat plane and appear raised or curved upward.

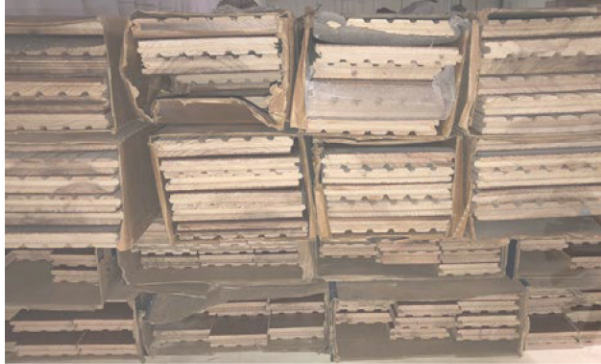
End-Swell/Flared-Ends (Solid Flooring)

DEFINITION: A condition where the ends of solid wood flooring boards deviate from the flat plane and/or parallel plane, and may appear wider or thicker than the rest of the board.

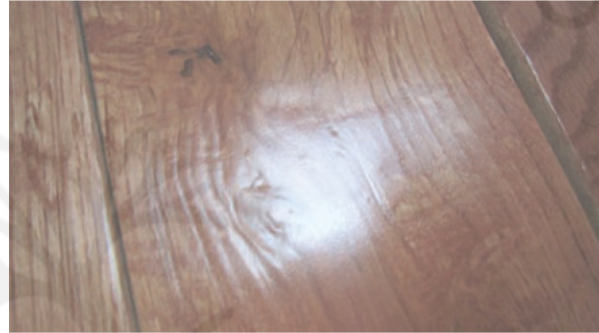
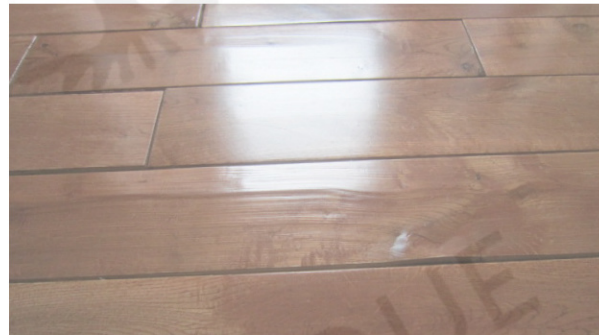
Reaction or Juvenile Wood

DEFINITION: Natural and unique features, properties, and growth patterns in wood that cause it to appear and perform non-traditionally, resulting in distortions from non-uniform swelling and shrinking.

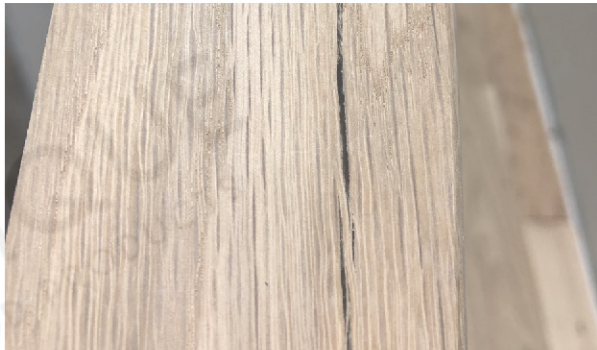
Surface-Checks - Surface checks are separations in the wood fibers that usually occur in, or adjacent to, the wood rays on the faces of plainsawn (flatsawn) boards. These separations occur during the early phases of the drying process where the external and internal stresses cause the wood to tear itself apart.

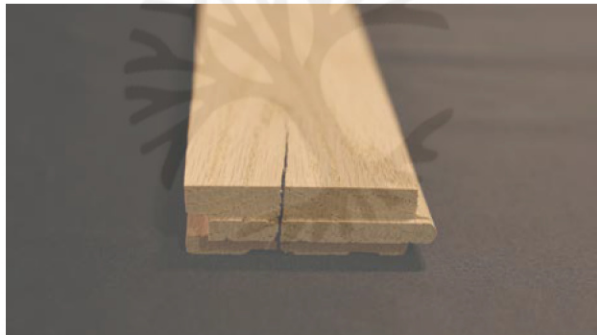
End-Checks - Like surface checks, end checks occur in, or adjacent to, the wood rays, but on the ends of the boards rather than the face. These separations occur due to the normal movement of moisture along the length of the boards, where the ends of the boards dry more rapidly leading to stress fractures on the ends of the boards.

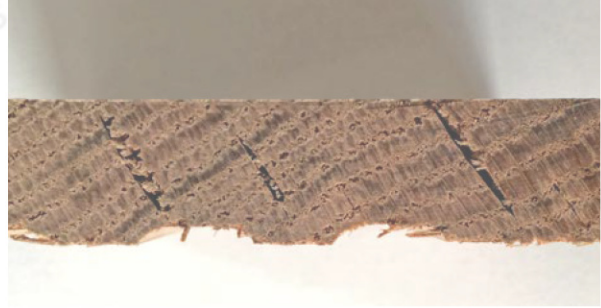
Internal Checks (Honeycomb) - An internal defect in the wood that may not be visible on the surface of the board, but occurs in the core (inner part of the board) of solid boards. These checks can become exposed when the boards are sanded or milled. They can also become exposed on the surface of the board with a loss in moisture or changes in RH after installation.

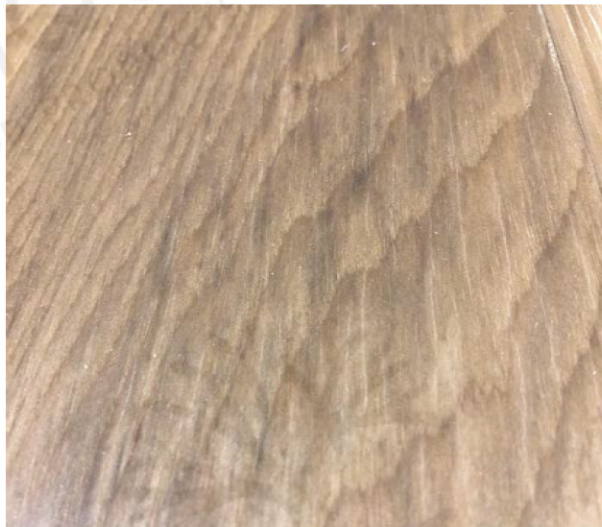
Lathe Checks (Rotary Peeled/Sliced Engineered Flooring)

DEFINITION: In engineered flooring with rotary peeled or sliced face veneers, as the knife separates the veneer from the log, the separated sheet of wood is laid flat where stresses can occur in the region near the knife edge. If the strength of the wood is exceeded, this stress is relieved by separations (or checks) of the wood fibers parallel to the grain of the veneer at the knife edge. The knife edge of the veneer is known as the open (or loose) side, and the opposite side of the veneer is known as the closed (or tight) side. Lathe checks are not normally visible on the face of the finished board.

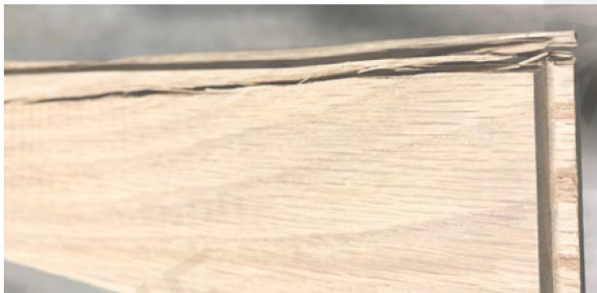
Splits/Cracks

DEFINITION: A tearing apart or rupturing of the wood that may run at various angles to the growth rings.

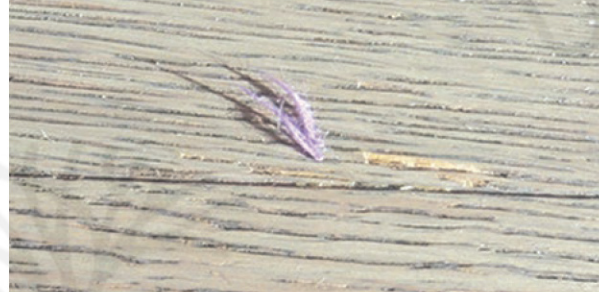
Slivers/Splinters

DEFINITION: Sharp fragment of wood separated/fractured away from the edge or face of the board protruding from the floor.

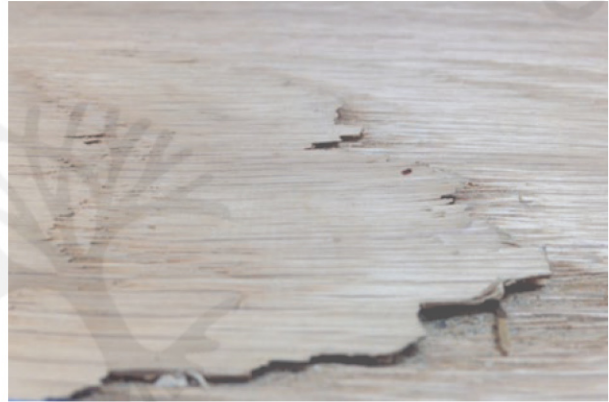
Shake (Ring Shake/Ruptured Grain)

DEFINITION: A separation of the wood's fibers along the grain (parallel to the growth rings), that usually occurs between the rings of annual growth.

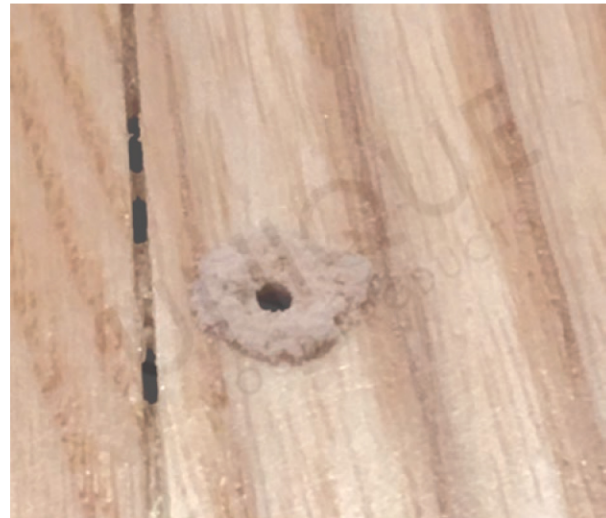
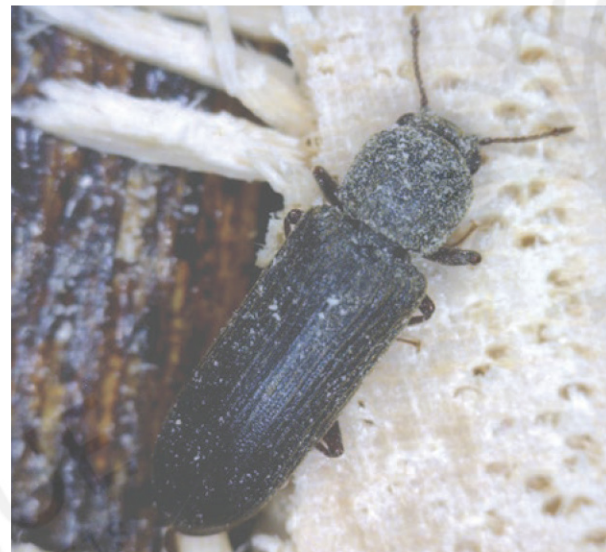
- **Powderpost (Lyctid/Anobiid) Beetle** - The larvae of wood-eating insects bore in and feed on the wood fibers causing damage to both hardwoods and softwoods. Properly kiln-dried lumber will normally eliminate powderpost beetles, but infestations can occur at any point after the kiln-drying process, including during storage, transport, or from other wood products.

- Infestation often occurs long before, but can even occur after the wood floor is installed. Female beetles lay their eggs within the pores of the bare, unfinished wood. The larvae feed on the wood, creating tunnels that fill with a powdery substance called frass. Later, when the larvae mature, they exit the wood, creating small pinholes, generally measuring 1mm-3mm (1/16"). In active infestations, the holes will be surrounded by this frass (light-colored powder). This frass material is very fine and will feel like talcum powder when rubbed between two fingers. The presence of an actual beetle, beetle larvae, or frass is the only way to absolutely confirm an active infestation.

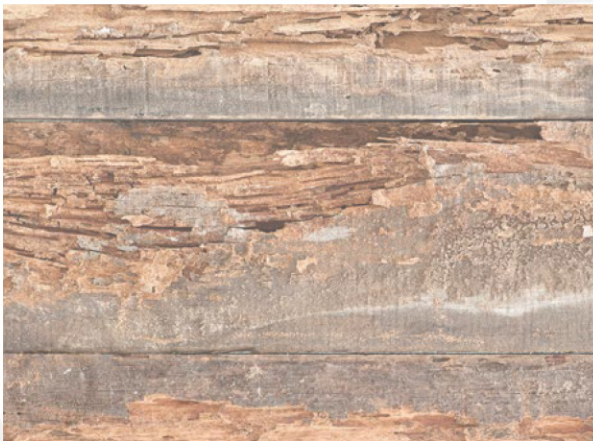
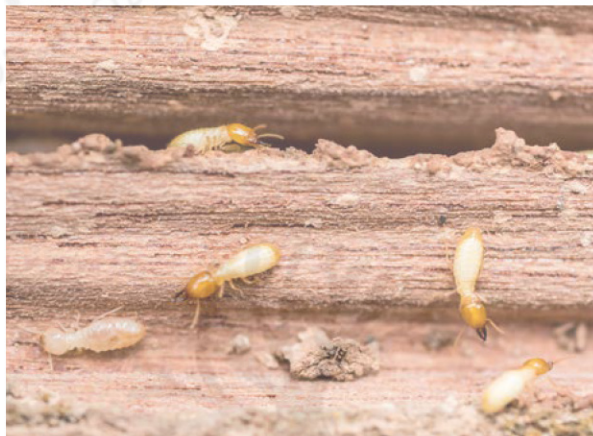
- **Termites** - Termites are attracted to areas where moisture accumulates in and around your home, including damp basements, laundry rooms, bathrooms, and leaky foundation walls.
 - Termites will eat any kind of wood including mulch, rotting wood, new wood, painted wood, and treated wood.
 - Stagnant, moist air in the home provides the perfect breeding ground for termites.
 - Termite-damaged wood is usually hollowed out along the grain, with bits of dried mud or soil lining the feeding galleries. Wood damaged by moisture or other types of insects will not have this appearance.
 - Termite infestations are a site-specific condition.

- Improperly dried or stored lumber.
- Lyctid Powderpost Beetles are usually brought into the house in wood products that contains eggs or larvae that may have been in furniture, firewood, untreated reclaimed lumber, joists or framing, molding, trim, wood paneling, cabinets, or even the pallets used to transport the flooring.
- Termites and Anobiid Powderpost Beetles normally prefer to infest wood that is damp; therefore, infestations usually begin in moist, poorly ventilated areas such as in unconditioned crawl spaces or basements.

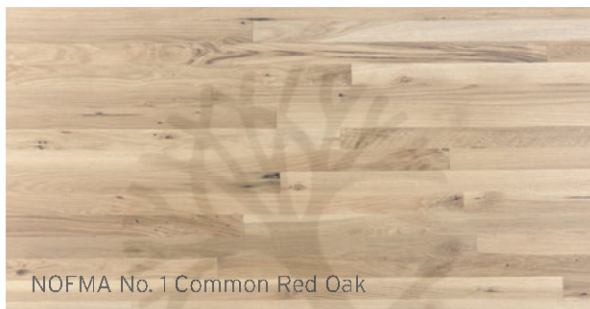
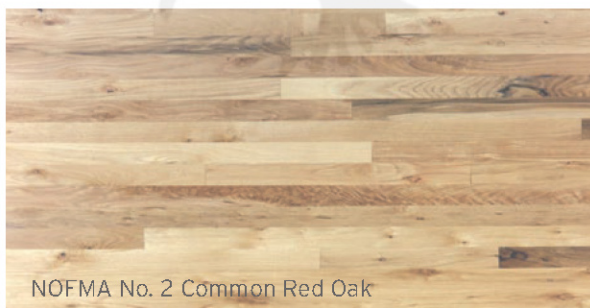
Grading Discrepancies

DEFINITION: A discrepancy in the designation of the aesthetic appearance and/or quality of a manufactured piece of wood flooring (knots, grain pattern, naturally occurring color variations, etc.). Grading tolerances for both solid and engineered wood flooring are manufacturer and product specific. There are many proprietary grades from one manufacturer to another that dictate aesthetic and physical characteristic tolerances within a designated grade.

- Unrealistic or unclear customer expectations.
- Objectionable boards that were not culled out during the installation process.
- Ordering mistake by the specifier, supplier, seller, buyer, contractor, installer, or end-user.
- Improperly labeled product.
- Improper grading at the mill.
- Grading variances from one manufacturer to another.
- Outdated or aged samples. Samples may also not show or describe all of the characteristics within the flooring grade.
- Some manufacturers may allow up to 5% of the shipped flooring to be below the product's labeled grade.

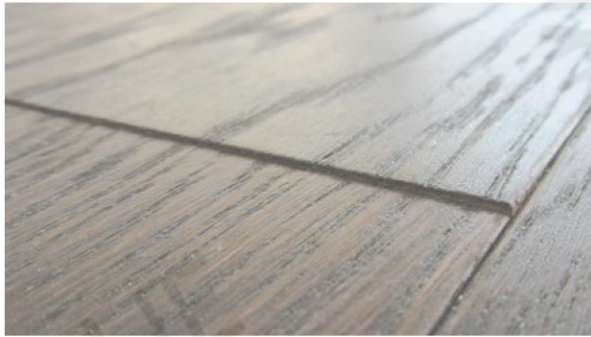
Overwood/Underwood

DEFINITION: A vertical offset that exists between two adjoining installed floorboards.

- Manufacturing defect. Can be determined with destructive testing or on uninstalled wood flooring boards. Solid and engineered wood flooring manufactured tolerances outside of the applicable industry manufacturing standards (NWFA/NOFMA, HPVA, or similar).

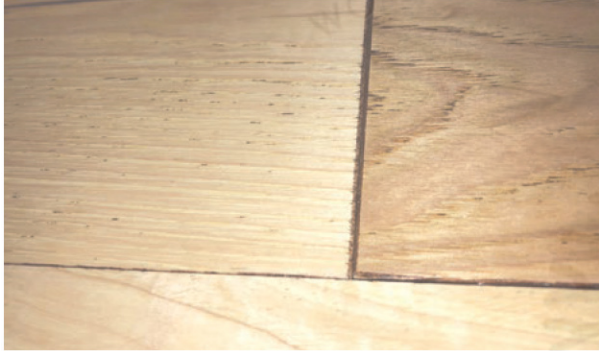
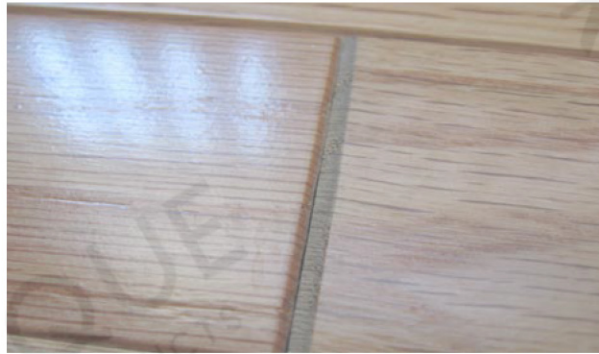
Uneven Bevels

DEFINITION: Bevels within an installed or uninstalled wood floor appear inconsistent in width, depth, shape, profile, or size.

- Mis-milled flooring.
- Flooring installed from different product lines/manufacturers/runs.
- Normal and within grade for flooring installed (such as hand scraped/distressed/reclaimed).
- An existing floor with bevels that was resanded and resulted in uneven bevels.
- Installer manipulated material.
