PROBLEMS, CAUSES, AND CURES

nwfa
National Wood
Flooring Association

Technical Publication No. C200 • Revised © 2018 | 3rd Edition

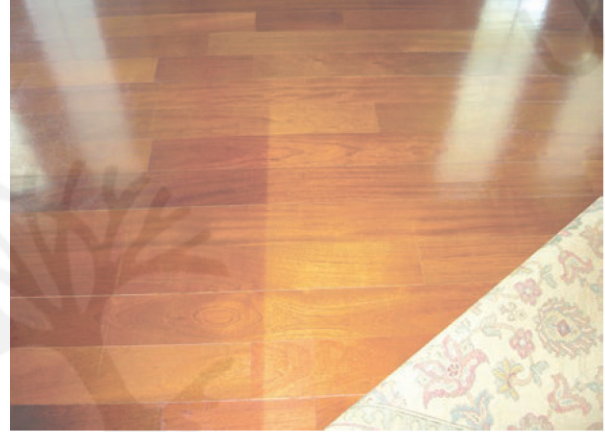
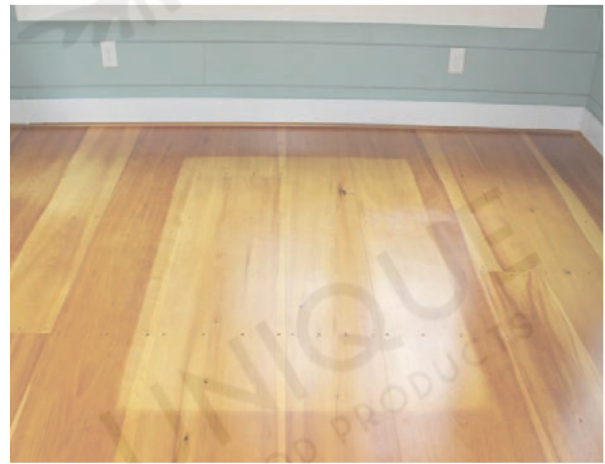
Wood Discoloration

DEFINITION: The wood itself changes color over time (darkens or lightens).

- Wood changes color through oxidation and/or photochemical exposure, which is a change that cannot be prevented. This is a naturally occurring phenomenon. All woods will change color, but some more drastically than others. This is a natural change, and should be taken into account when selecting flooring from sample boards.

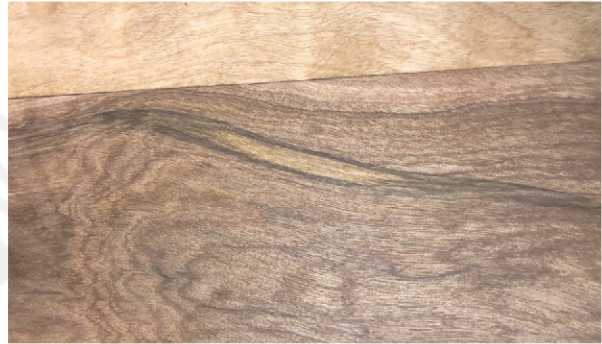
Mineral Streaks/Deposits

DEFINITION: A discolored line, spot, or band in the wood that may range in color from light gray to tan, olive green, brown, purple, blue, or black. Mineral streaks/deposits are naturally occurring and they are often considered to add value and appeal to the wood.

- The source of these mineral streaks/deposits is often undetermined, and is considered a naturally occurring characteristic of living trees. These deposits may develop as the tree absorbs and deposits minerals from the surrounding soil such as limestone, sulfur, nitrogen, phosphorus, potassium, silica, gypsum, or any other mineral found in the region where the tree was grown.
- Some mineral deposits such as silica are often mistaken for chemical stains in some imported species, because of how they may appear as spots or blotches.
- Some mineral streaks may be caused by normal cell physiology occurring from wounds caused by insects, animals, weather, or logging.

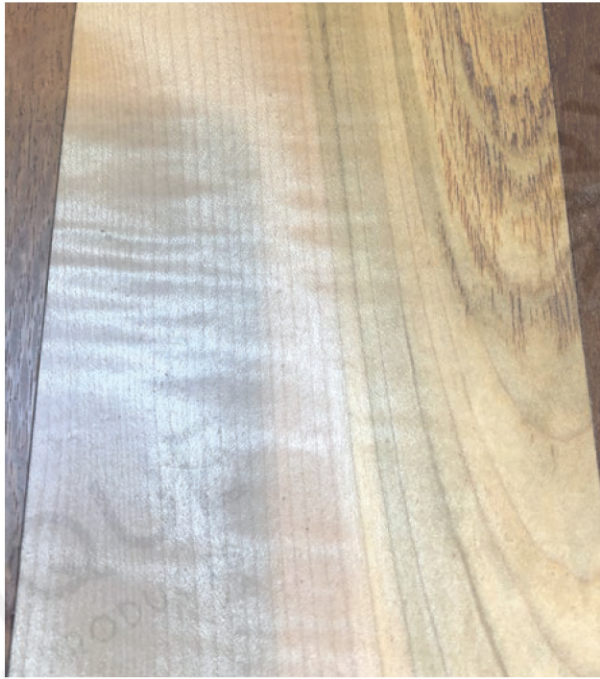
Sap Stains (Blue-Stain or Brown-Stain)

DEFINITION: A discoloration in the sapwood. Sapwood itself is the active wood near the outside of the living tree. It is often lighter in color than the heartwood of the tree. Sapwood color variation is normal and acceptable in all grades, and must not be confused with sap stain.

- Sap stain is caused by the growth of certain fungi on the surface and in the interior of the wood when the moisture content and surrounding conditions are prime for this fungal growth. The wood may become prone to this fungi in standing or fallen timber, or during seasoning prior to the kiln-drying process.
- This discoloration is often known as Blue-Stain or Brown-Stain due to the color of the fungi. In kiln-dried lumber, this fungus is not living, does not cause decay, is not a mold, will not spread, is not a health concern, and will not affect the structural integrity or the strength of the wood.

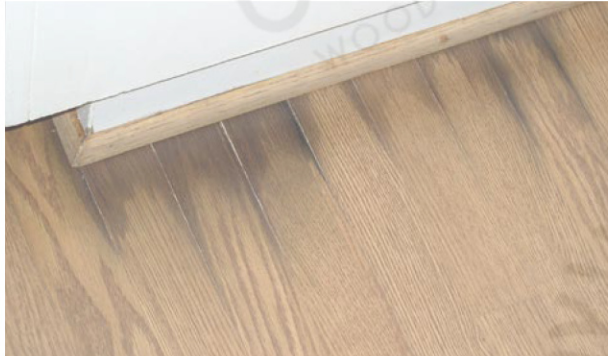
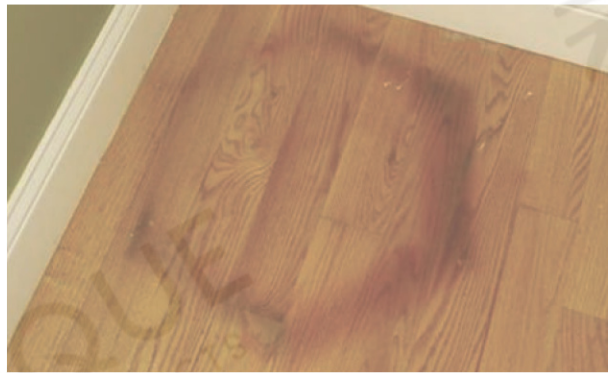
Moisture Stains

DEFINITION: The wood or finish changes color with exposure to moisture.

- Moisture from below can cause dark staining, or a white haze between seams and on the surface of the wood.
- Topical moisture (incompatible maintenance products, spills, steam, etc.) can cause blushing or damage to the finish itself.

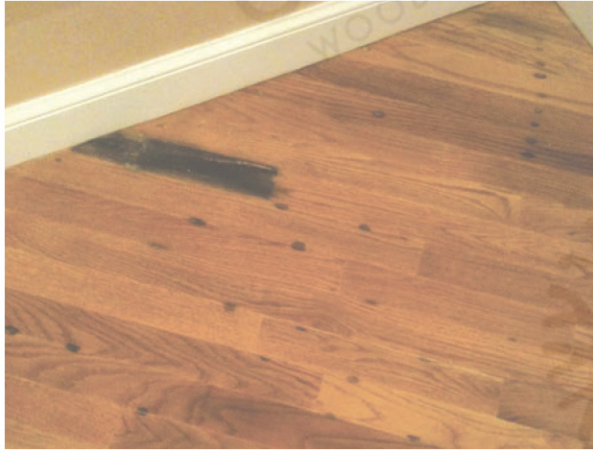
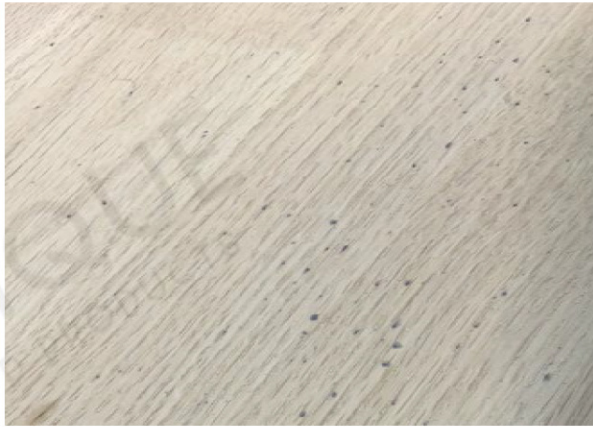
Iron Stains

DEFINITION: A result of a chemical reaction between wood tannins, water, and iron.

- A chemical reaction between extractives in the wood and iron in steel products, such as nails, screws, and other fasteners and appendages.
- Floor scraper filings/shavings left on the flooring surface that reacts with water or water-based products.
- Residual from some types of abrasives left on the flooring surface that reacts with water-based products.
- In extreme moisture condition cases, substrate exposure to moisture leaching into the wood floor from below (iron fasteners or from within the slab).
- Metal containers or objects (such as paint or watering cans) in direct contact with the floor, which have been exposed to moisture.

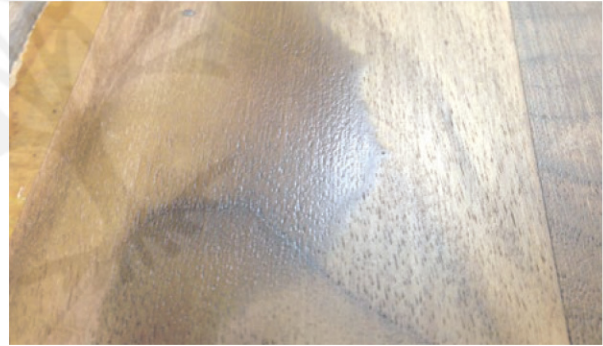
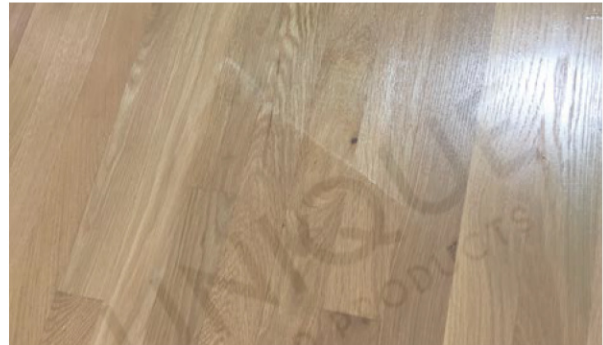
Tannic Acid Discoloration/ Tannin-Pull

DEFINITION: Tannic acid includes various naturally occurring soluble astringent complex phenolic substances found in trees (and plants) as a way of protecting the tree from insects, fire, and bacteria. High levels of tannic acid present in woods like oak, walnut, and mahogany can produce a dark discoloration when coming in contact with some products used in the finishing and maintenance of wood floors.

- Tannic acid is water-soluble and may discolor when it comes in contact with iron and water, which usually appears as a bluish/grey discoloration on the wood.
- Tannic acid discolors when it comes in contact with materials that are alkaline by nature, such as ammonia. Most water-based finishes are manufactured with pH adjusters (such as ammonia), which can cause a green/brown discoloration on the surface of the wood, and may also partially bleed into the finish.
- Unevenly applied water-based coatings, especially heavy spots, puddles or streaks.
- Not using or improper application of a tannin-blocking sealer.
- Application of a top-coat over a sealer that has not adequately dried.

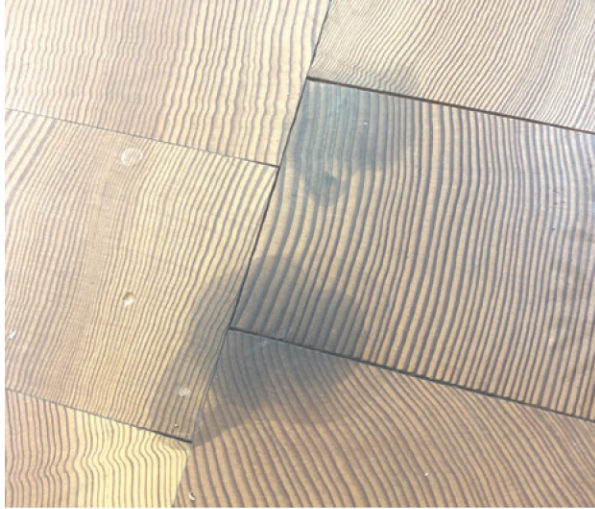
Chemical Stains

DEFINITION: Irregular shaped spots or discolorations on areas of the finished floor caused by reactive chemicals and/or air pollution.

- Household chemical spills or cleaning products (nail polish remover, ammonia, chlorine, mustard, iodine, oil, milk, ethyl alcohol, acetic acid, etc.) reaction with wood floor finishes.

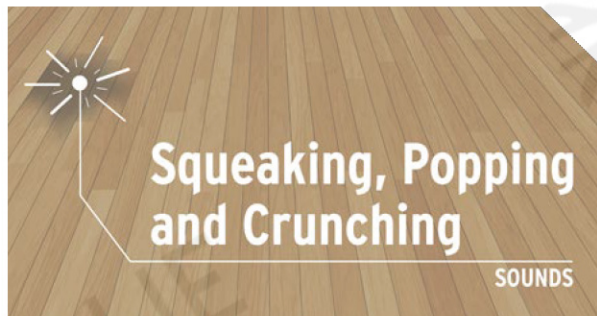
Squeaking/Popping/ Crunching Sounds

DEFINITION: Audible squeaking, popping, or crunching noises in an installed wood floor or within the floor system. Squeaks are not a direct concern with the installed wood floor as long as movement accompanying the audible squeak does not affect the performance of the installation. An occasional squeak within any properly installed wood floor system is not abnormal.

- Old age of the floor and/or structure.
- Wood flooring installed while not in equilibrium with the end-use environment. A change in temperature/humidity that causes the wood floor to change moisture content, and ultimately change dimension of the flooring and tongue and groove match, can result in audible noises, squeaks, pops, or crunching sounds.

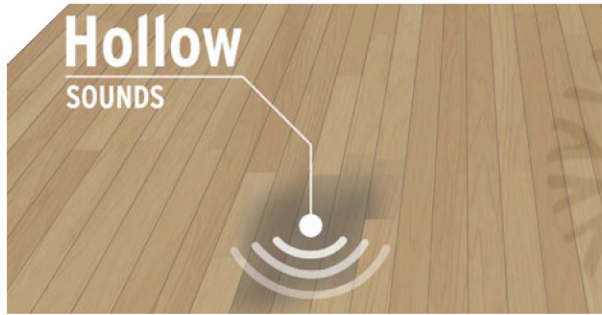
Hollow Sounds

DEFINITION: An audible hollow sound in the installed wood flooring. When no deflection is present, this may be considered normal with many installation methods provided that the installation followed proper installation procedures. Hollow sounds are not a direct concern with the performance of an installed wood floor as long as there is not movement accompanying the audible hollow sound.

- Nail-down wood floors:
 - A void in the flooring itself (wormholes, shake, bark pockets, engineered flooring core voids, etc.).
 - Slight imperfections or voids in the subfloor.

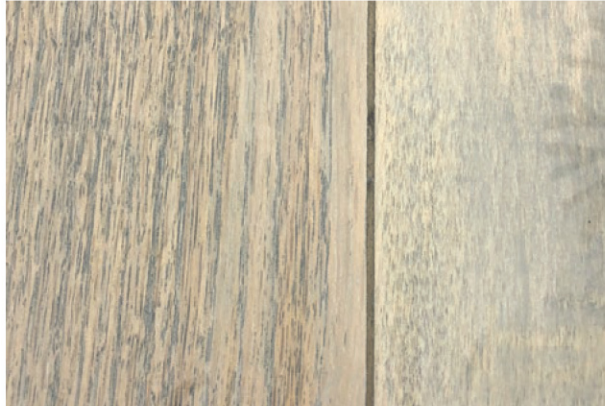
Seasonal/Normal Gaps

DEFINITION: Gaps that appear between individual boards, opening and closing with seasonal humidity changes. Wider boards can experience wider gaps. Gap size is directly related and proportional to the board width.

- Most normal gaps are caused by seasonal fluctuations in relative humidity. The floor expands with high humidity and contracts with periods of low humidity. This type of expansion and contraction is considered to be normal and expected with wood floors when exposed to seasonal variations.
- When wood flooring is installed during dry seasons where relative humidity is not maintained, it is normal to leave internal expansion spaces/gaps (washer rows) within the floor to accommodate for seasonal humidity changes.

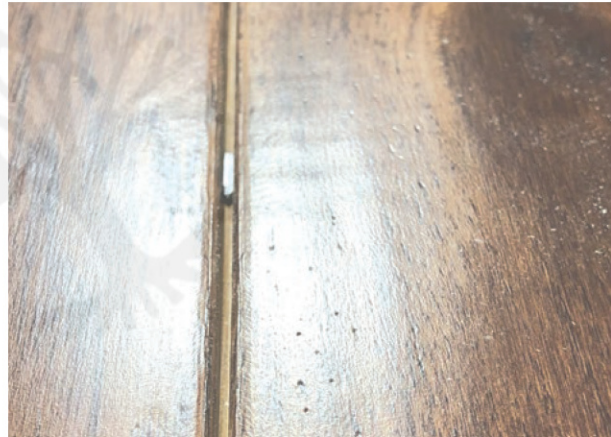
Abnormal Gaps

DEFINITION: Gaps between abutting wood floor boards in the installed floor that were not intentionally placed and remain with seasonal fluctuations in moisture and humidity.

- Flooring not installed tightly together.
- Debris between the boards during installation.
- Solid wood flooring installed at higher moisture content than what the normal, in-service conditions can support.

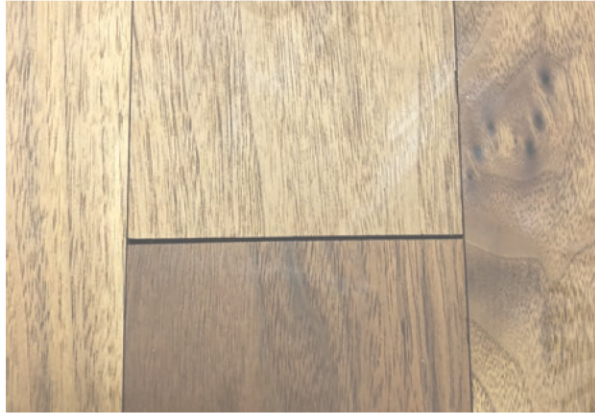
End-Gaps

DEFINITION: A separation that occurs on the ends of two abutting wood floor boards.

- Loss/gain of moisture in engineered flooring.
 - Due to the construction of engineered flooring, each layer shrinks and swells in different directions and at different rates than the adjoining layers. It is common for it to shrink/swell in its length when exposed to changes in moisture content.

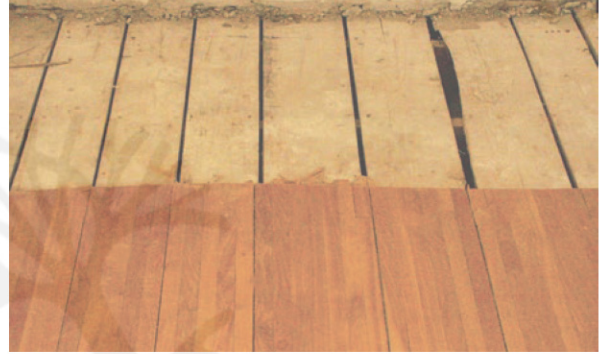
Panelization

DEFINITION: A generally uniform appearance of gaps or peaks in the surfaces of the wood floor that directly coincide with movement in the subfloor material beneath it.

- Moisture-related subfloor issues.
- Acclimation related issues:
 - Moisture content of the wood floor and subfloor are not aligned at the time of installation.

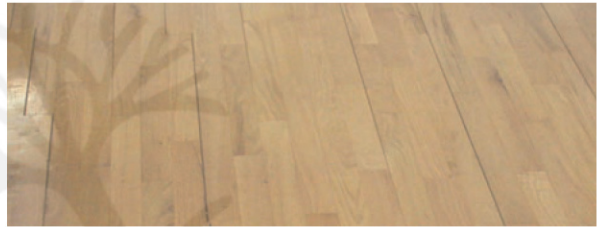
DEFINITION: A condition where localized gaps develop between flooring boards while adjacent groupings of boards remain tightly bonded together with no apparent separations. These gaps will sometimes exhibit wood fractures along the gap as a result of the finish bond tearing away small pieces of wood from the adjoining plank. Sidebonding should not be confused with panelization. (See Panelization.)

- When installed wood flooring shrinks due to a loss of moisture, and the edges of individual boards have become adhered to one another due to:
 - Finish (most common with water-based finishes) that has seeped between the boards, drying and forming a permanent bond adjoining/gluing boards together.
 - Glue that has been used on the tongue and groove during installation, adhering the planks together.
- Not using a sealer, either water-based or oil-based (sealer, stain, or polyurethane), as recommended by the finish manufacturer, prior to applying the rest of the finish system.
- With recoat scenarios in which cracks are present or unfilled, finish will fill the voids and potentially result in sidebonding.

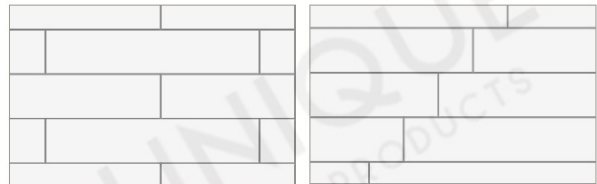
With 3/4" and greater strip or plank wood flooring installed over bare joists, solid board subfloors (1"x6"), "perpendicular car decking," sleepers/screeds, other non-continuous subfloor systems, or panel-type subfloors that do not meet NWFA minimum requirements, the layout of the entire floor, and end joint placement, are not only an appearance/aesthetic consideration, but also add a structural element to the finished installation. Stair-stepped and clustered end joints may reduce the ability of the flooring system to withstand the additional stresses created in these circumstances.

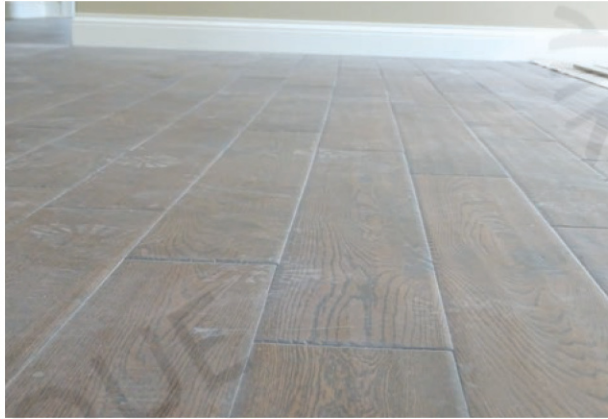
Crooked Installation Discrepancies

DEFINITION: An installed wood floor appearing bowed or out-of-square within the room in which it is installed. No wood floor installation is perfectly straight, parallel, or perpendicular to walls or fixtures. When the straightness of the installed floor takes away from the overall appearance of the floor within the structure, an aesthetic remedy may be necessary. The performance and structural integrity of the wood floor is not normally affected with any floor that has been installed out-of-square or out-of-a-straight-line.

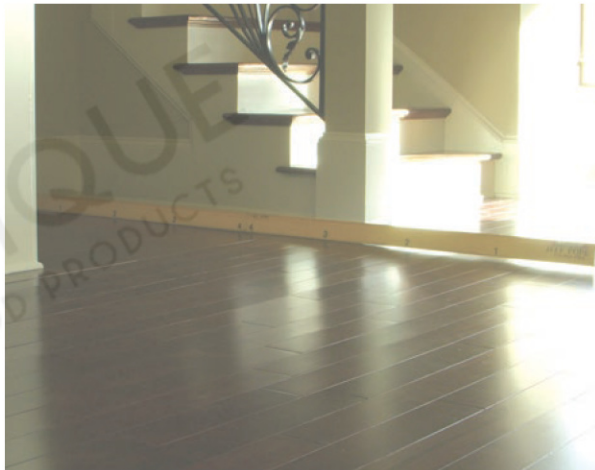
DEFINITION: The installed wood floor system appears to be uneven, wavy, or out of flat. Wood floors may be installed over out-of-level subfloors, but should fall within NWFA floor flatness tolerances. Subfloor flatness cannot be quantifiably measured when a floor covering is in place over it (without potentially extensive destructive testing), however, may give a good indication of what is happening below.

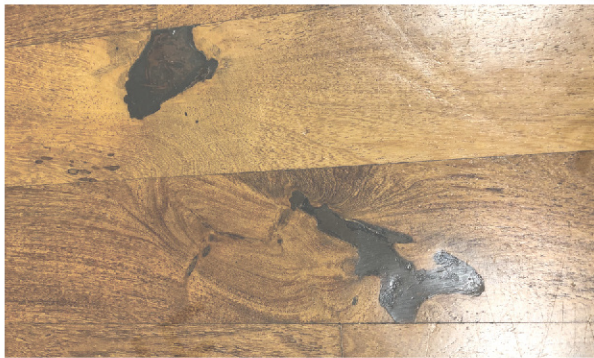
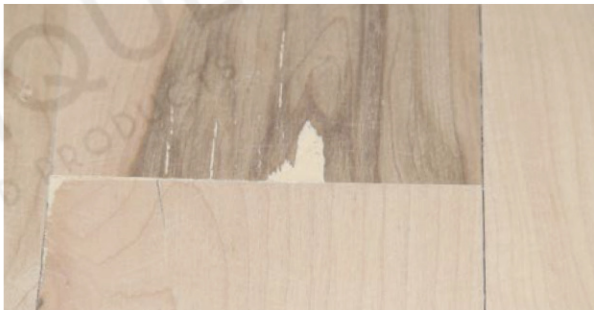
Filler Color Variation

DEFINITION: The wood filler from one area of the floor is different from the overall color tone of the floor. No two trees from the same species are identical, no two boards from the same tree are identical, and color and grain patterns can vary even within one individual plank of wood. Wood filler will never perfectly match, nor is it designed to match every board within a wood floor.

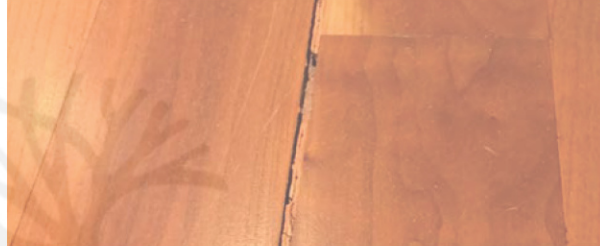
Popped Filler

DEFINITION: Wood floor filler that has become loose or no longer fills the void it was once in.

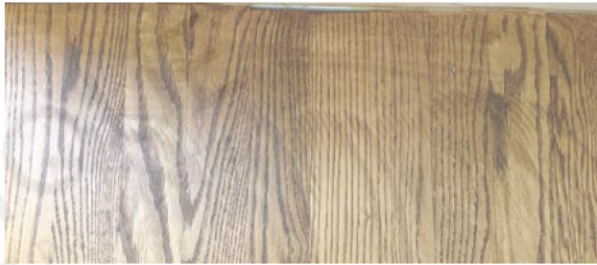
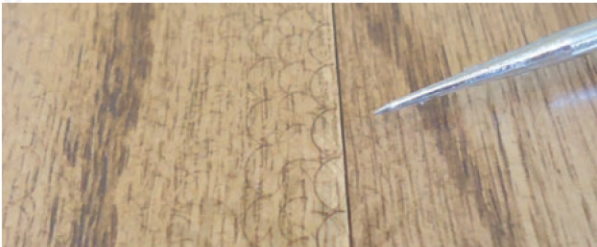
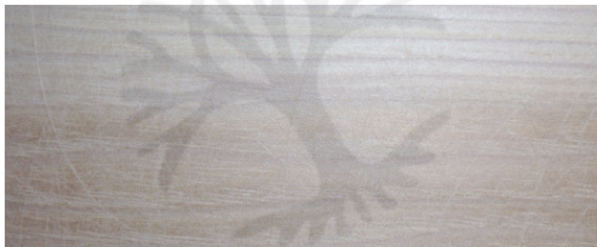
Sanding Marks

DEFINITION: Sanding imperfections seen as drum marks, side cuts, sanding scratches, or swirl marks. Sanding marks should be viewed from a standing position on the floor being assessed, in ambient lighting conditions. Glare from a direct light source must not be used during evaluation. Inspection may take place from floor level and/or with assistance of magnification in order to determine causes of irregularities, but not to determine acceptability.

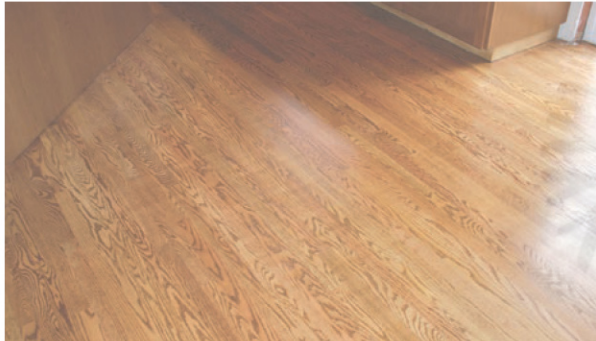
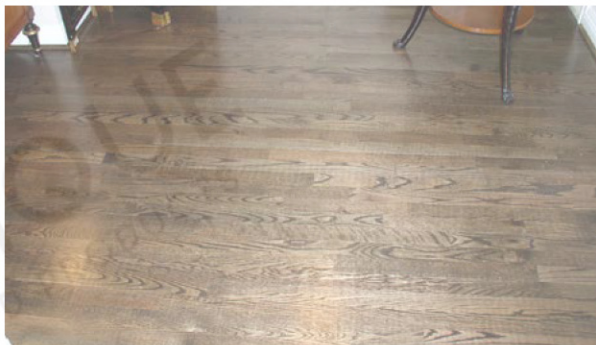
Chatter

DEFINITION: Slight unintentional indentations causing a ripple-like wave effects or “bars” that run perpendicular to the wood’s grain direction on the surface of a wood floor which can become visibly pronounced in direct lighting. The width of these “bars” can range from just a few millimeters to nearly an inch from peak to peak, and can occur in limited regions or can span the entire floor.

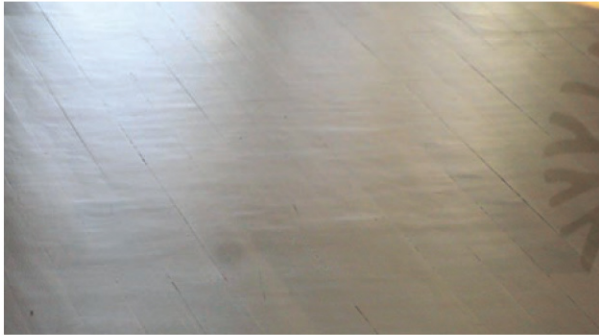
DEFINITION: Indentations, usually repeating undulations, visible on a site-sanded wood floor surface, most often visible after a finish has been applied. The width of these irregularities typically range from one inch to three inches or more, and can occur in limited regions or can span the entire floor. Wave can sometimes be in conjunction with, or confused with, dishout.

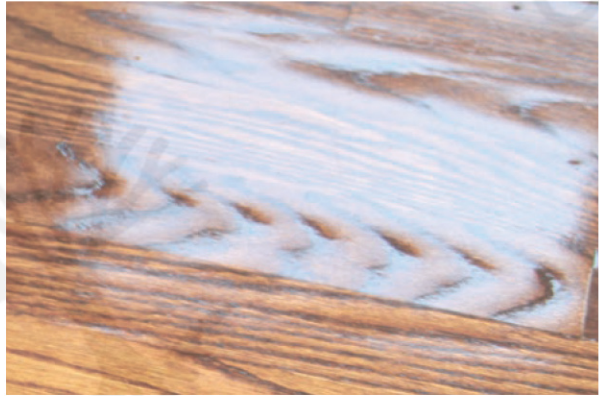
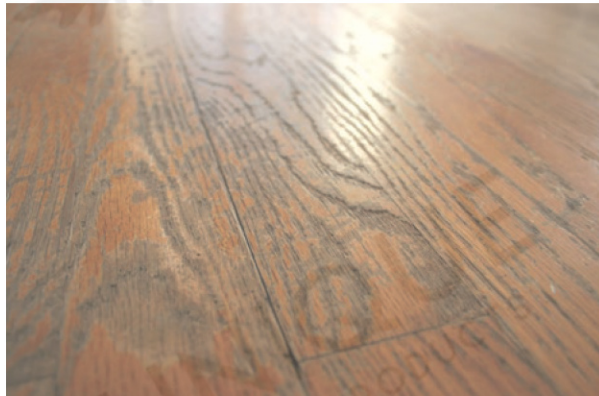
Dishout/Shellout

DEFINITION: Undulations in the surface of individual boards or within the wood floor, resulting from softer areas having been worn, hollowed, or sanded to a lower level than harder adjacent areas.

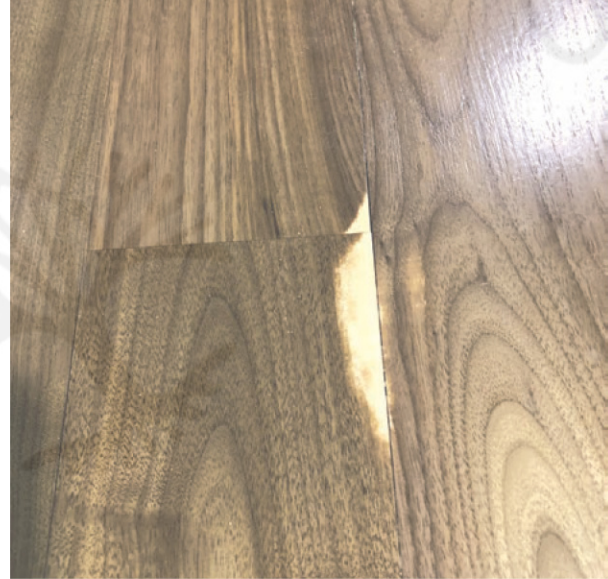
Veneer Sand-Through

DEFINITION: The top/wear layer veneer (lamina) of engineered flooring has been completely sanded through to the core layer.

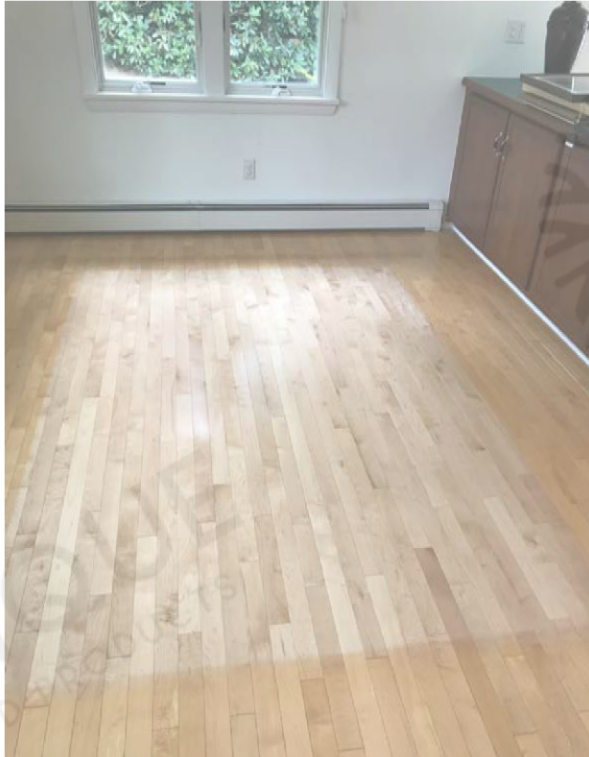
Finish/Colorant Discoloration

DEFINITION: The finish or colorant systems changes color.

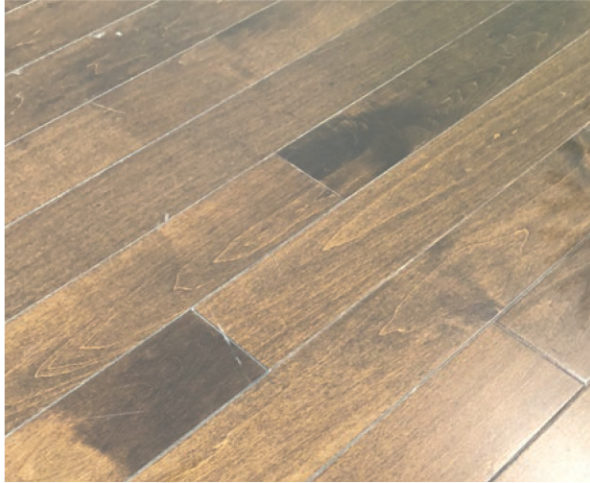
Blotchy Stain/Colorant

DEFINITION: The appearance of an inconsistent stain or colorant from one area of a finished floor to another. Stained/colored floors should be uniform in color. Color tones may vary from board to board or within individual boards due to natural variances within the wood.

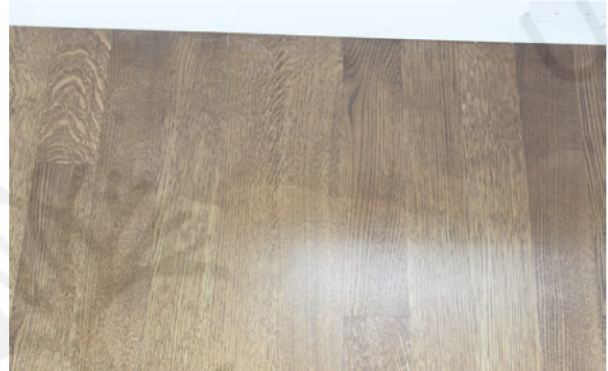
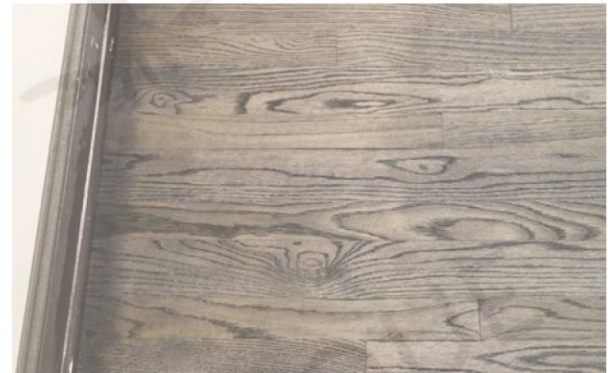
Picture Framing/Halo

DEFINITION: The edges of the room appear to be a slightly different color than the rest of the room.

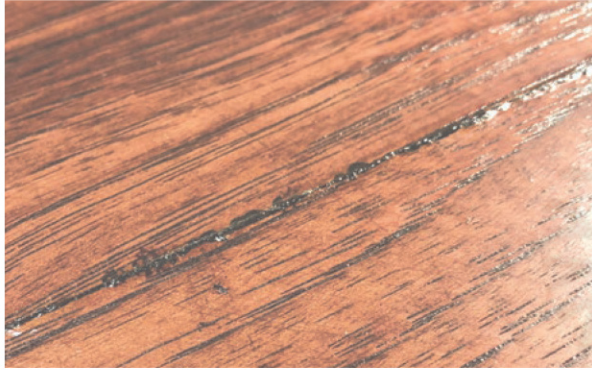
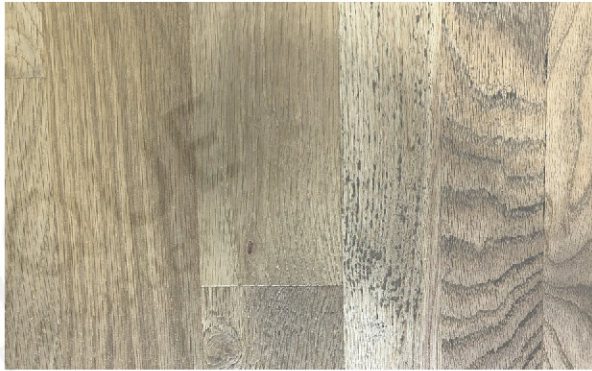
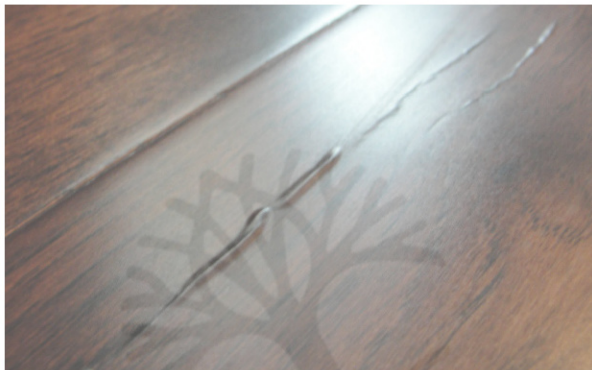
Stain Bleed Back

DEFINITION: A staining phenomenon occurring after the initial application of the stain, where the stain seeps back to the surface of the wood. This may happen at board seams, with open-grain species, tight grain, knots, or burls.

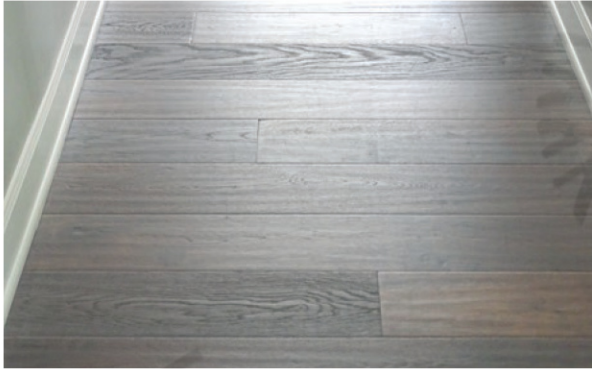
Finish Film-Thickness Discrepancy

DEFINITION: A discrepancy in the depth of the film of finish applied to a wood floor. Mil/film thickness of finish can be evaluated, but should not determine acceptability.

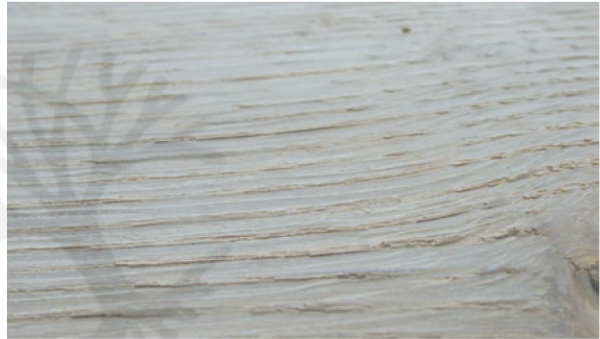
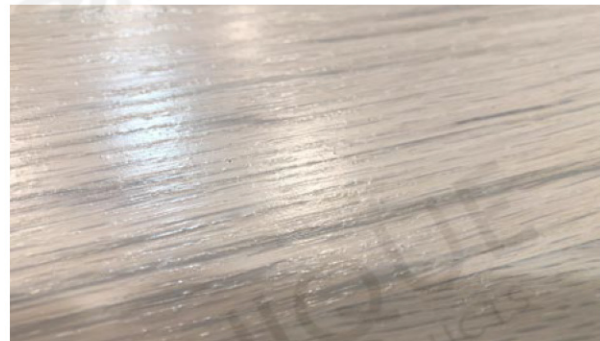
Roughness/Grain-Raise

DEFINITION: The surface of the wood floor feels rough to the touch.

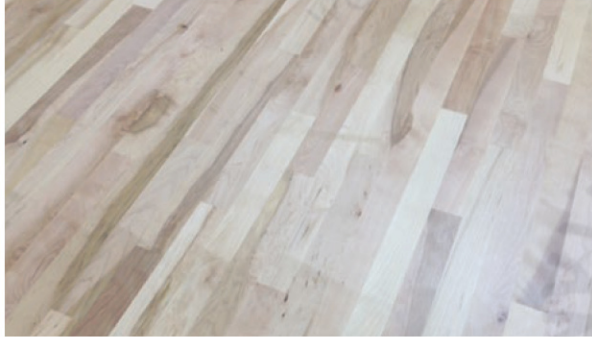
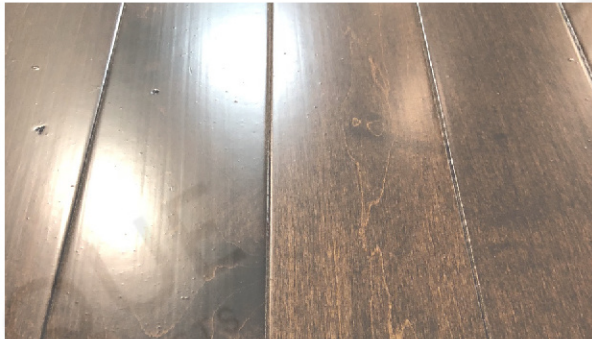
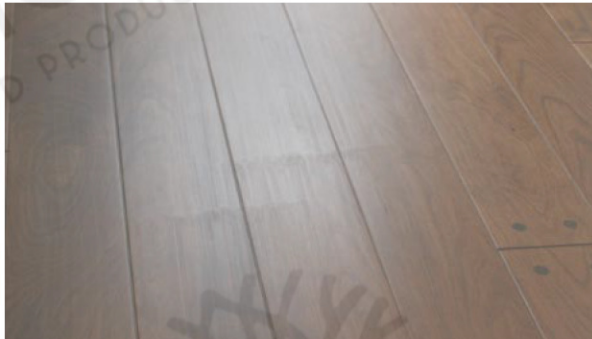
Applicator/Finish Streaks

DEFINITION: Visible ridges, lines, or marks left on the wood floor, representing the application tool used from any stage of the finishing process.

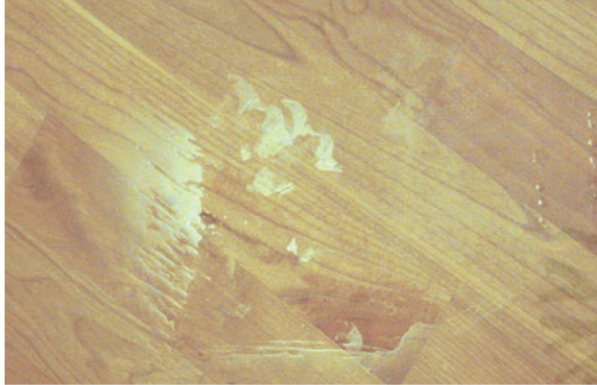
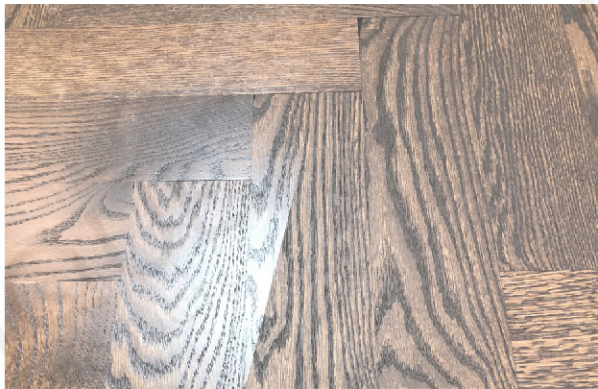
Holidays/Skips

DEFINITION: An exposed area of uncoated wood or the undercoating, when the intention was to coat the entire area.

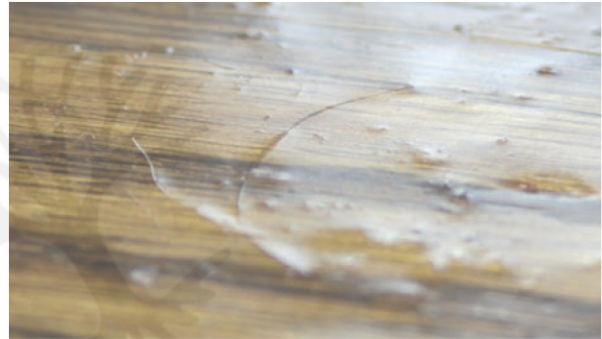
Debris in Finish

DEFINITION: A raised bump in the film of finish often consisting of dust, hair, applicator fibers, foreign contaminants, solid finish particles, or other artifacts. Due to the nature of most coating environments, minimal amounts of debris within reason can be expected in any coat of finish.

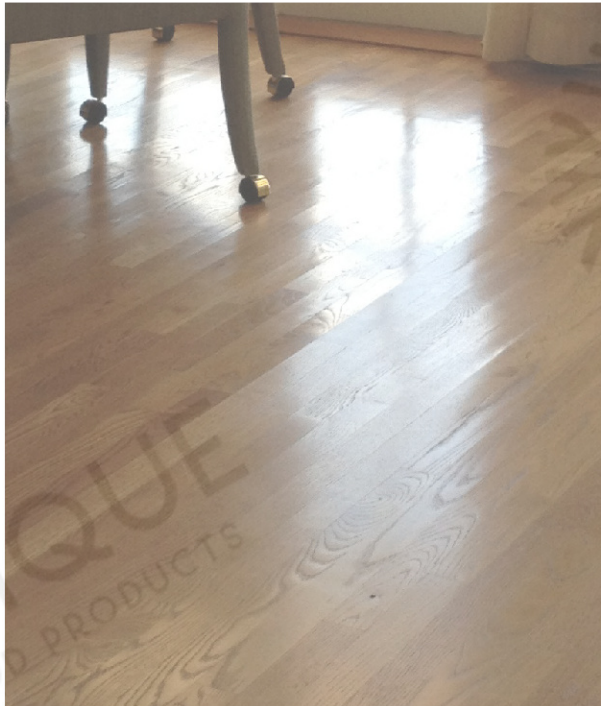
Uneven Sheen/Gloss Levels

DEFINITION: The sheen or gloss level of the final coat of finish varies from one area of the floor to another. As film-forming finish products decrease in gloss, they increase in amounts of matting agents. Lower sheen products have the most matting agent, and thus, can more-easily manifest uneven sheen levels. Sheen/gloss levels should not be assessed until all final coats have been applied and are fully cured.

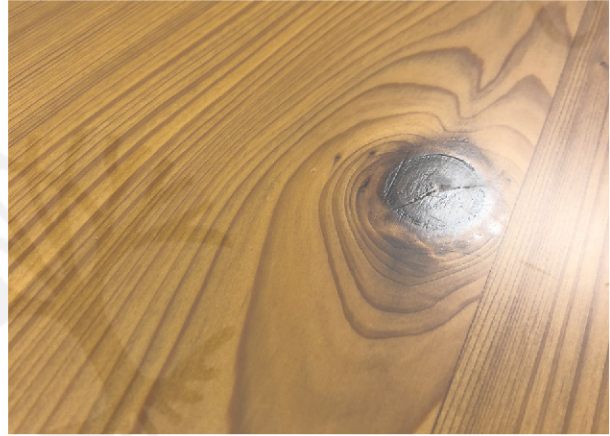
Sticky Board Syndrome

DEFINITION: Wood floor finishes that do not dry, adhere, cure properly, or appear the same on specific areas of a board or individual boards.

- Species with high concentrations of tannic acid, a pH imbalance, natural oils, or sap from a variety of species may adversely affect the finish's ability to properly dry and cure.
- Knots on species such as pine or Australian cypress affecting the ability of the finish to properly dry and cure.
- Contamination within the wood or between boards affecting the ability of the finish to properly dry and cure.
- Insufficiently cured UV finishes (factory-finished or site-finished).

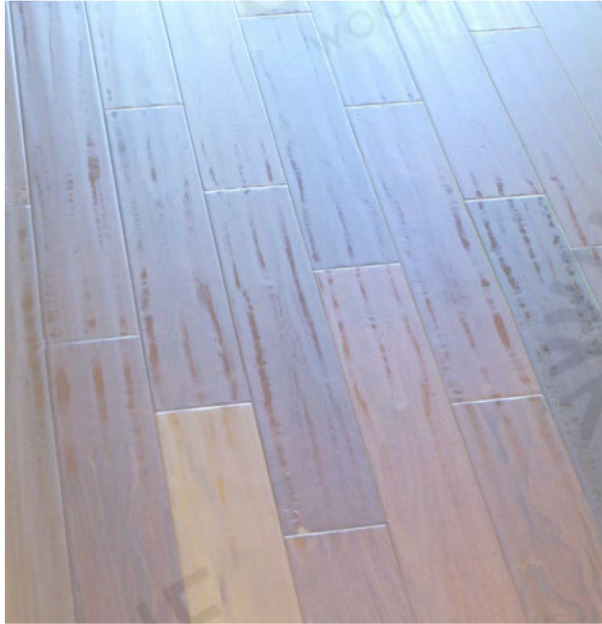
Cloudy Finish

DEFINITION: An unintended white, milky, or cloudy appearance of an otherwise transparent, clear finish.

- Maintenance-related:
 - Using cleaning products that are incompatible or are not recommended by the finish or flooring manufacturer.
 - A build-up of residue from improper cleaning products.

- Use of steam mops on wood flooring (forcing vapor moisture into, and between, boards).
 - Using abrasive cleaning pads.
- Solvent trap:
 - Applying finish over a sealer coat, finish, or stain that hasn't dried enough to be recoated yet, causing the solvents to become trapped within the coatings. This is commonly seen between gaps in the floor, resulting in cloudy lines between boards. This haze may be temporary or it may persist. (See White Lines.)

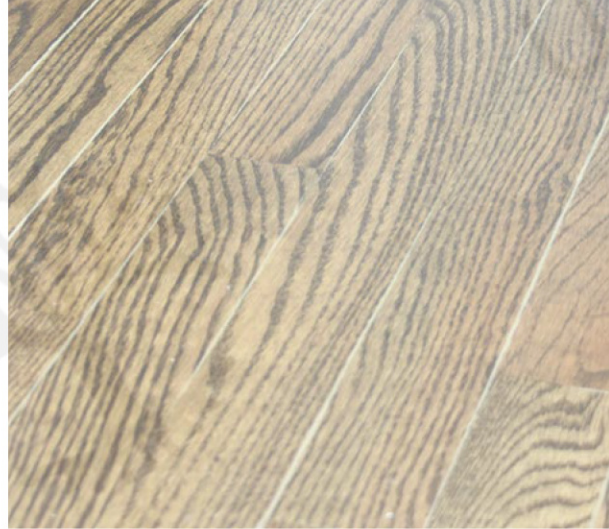
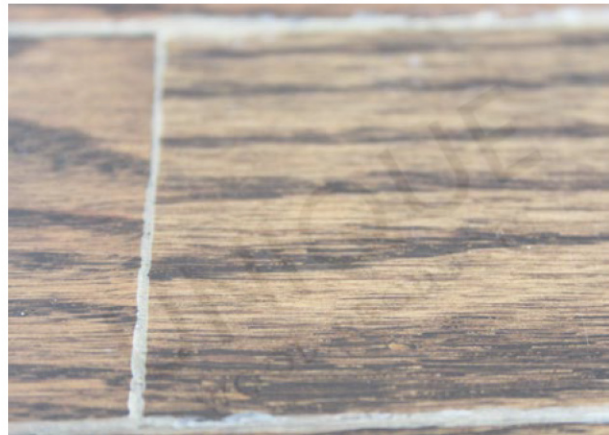
White Lines

DEFINITION: White lines appear between board edges of site-applied film-finishes.

- The optical result of finish or sealer that stretches, rather than breaks, along board edges or seams, with seasonal humidity and temperature fluctuations.
- Applying a more-elastic finish on top of a less-elastic one.
- Solvent-trap:
 - In areas between boards, cracks, seams, butt-joints, or filled knot holes where oil-based stain has penetrated and often pooled, the solvents take longer to evaporate, translating to longer dry times. When the floor gets coated, these solvents become trapped within the finish film at these sites.
 - Applying finish over a sealer coat, finish, or stain that hasn't dried enough to be recoated yet, causing the solvents to become trapped within the coatings. This is commonly seen between gaps in the floor, resulting in cloudy lines between boards. This haze may be temporary or it may persist.

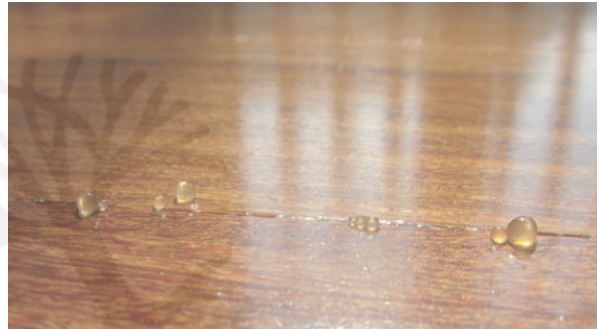
Poly Beads

DEFINITION: Small round balls that appear as beads, or “BBs” of finish, that form along the joints of the individual boards. They can be soft and sticky when first formed, and will become hard if left undisturbed. When these wet beads are stepped on, they can become unsightly smears along board edges.

- During finish application, where the finish collects in voids, such as gaps between boards, it cures at a much slower rate. Later, when the moisture content of the flooring increases (higher humidity levels), the uncured finish can squeeze out from between the boards appearing as small BBs. This is most common with oil-based urethane finishes, higher solids/more-viscous finishes, and conversion varnishes.

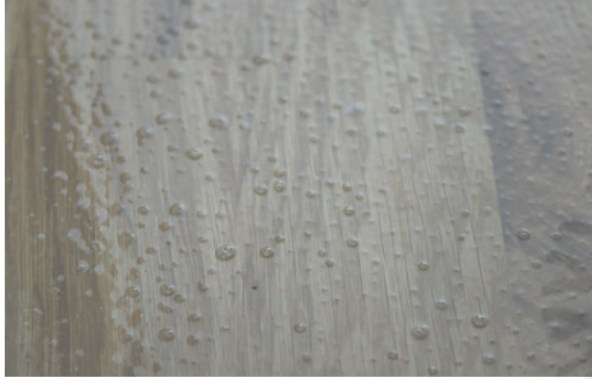
Bubbles

DEFINITION: Raised bumps, or air-filled bubbles visible in the film of the finish. These include both full bubbles and bubbles that have popped.

- Improper applicator used to apply the finish.
- Use of improper tacking solvents before or between coats.
- Overworking finish or sealer during application, creating air bubbles/foaming to develop within the applicator and finish.

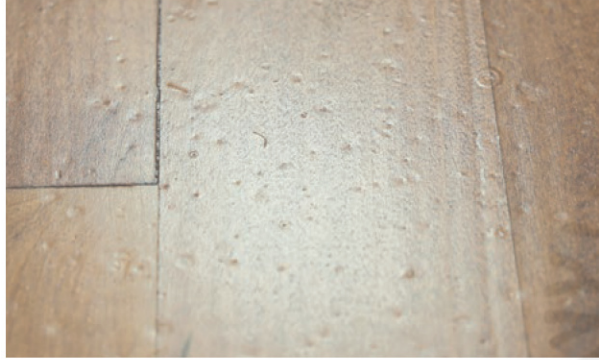
Pin Holes

DEFINITION: A visible finish imperfection where the surface of the finish film recedes from a very small area or areas of the surface.

- Finish coats applied too thick (outside of the manufacturer recommended coverage rates), resulting in too much film build, not allowing solvents to properly escape.
- Application of finish in high temperature environments.
- Finish coats applied over a previous coating that wasn't adequately dried, resulting in improper or incomplete drying and curing.
- Finish missing from a void area of the board, such as pin-worm holes, nail holes, open grain, or other natural characteristics within the wood.
- With factory-finished flooring, where heat (infrared) is used to dry the finish, it can sometimes cause the finish to dry too quickly, not allowing solvents to properly escape, resulting in pin holes.

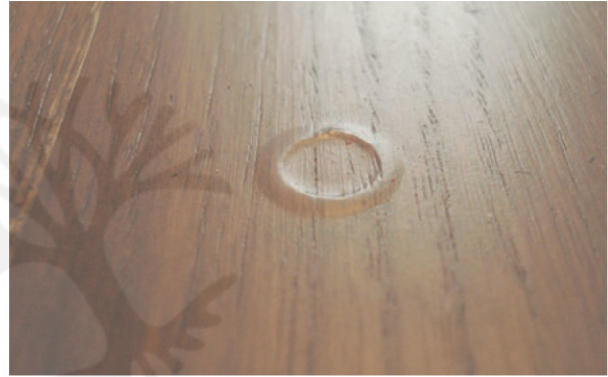
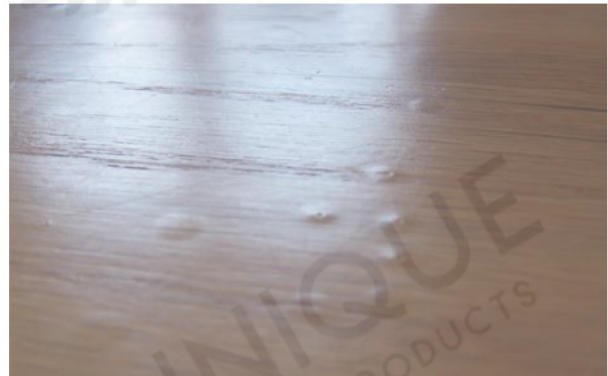
Craters/Fisheyes

DEFINITION: A visible finish imperfection that manifests by the crawling of wet finish film into a single area or pattern resembling small dimples or bowl-shaped depressions, sometimes accompanied by a particle in the center.

- Insufficient removal of already-existing fish eyes/ craters prior to subsequent coats.
- Trapped air or solvent bubbles that burst during the flow and leveling of the finish, but didn't have quite enough time to completely level out.

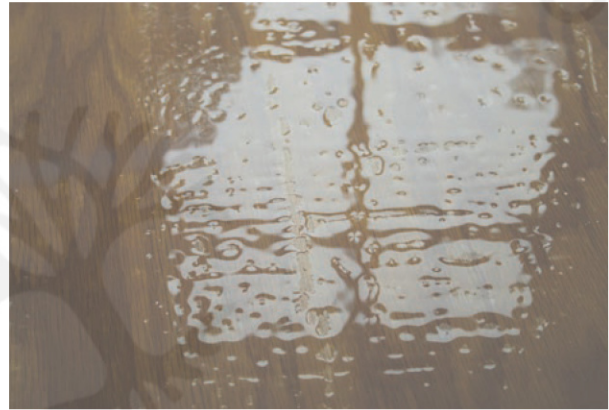
Crawling

DEFINITION: A visible finish imperfection where the finish film is repelled from areas of the surface, leaving the appearance of thin or uncoated affected areas. May be very long and oval shaped, and may vary in size.

- Insufficient removal of already-existing blemishes prior to subsequent coats.
- Contamination:
 - Contamination of the floor where foreign substances such as maintenance products, wax, grease, oils, polishes, soaps, overspray from other sources, or other contaminants are present before coating, or have been introduced between coats.

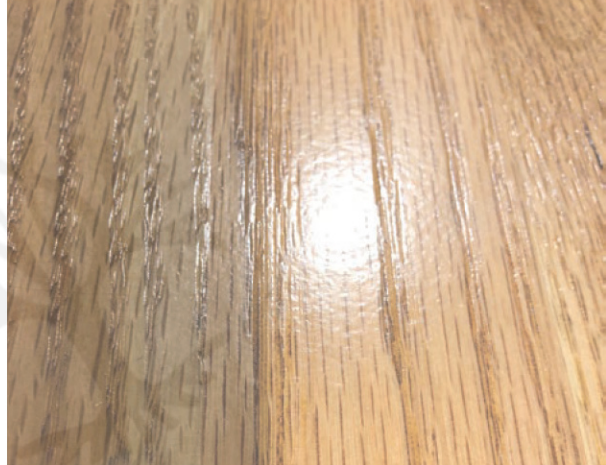
Orange Peel

DEFINITION: A visible finish imperfection where the surface of the dry finish film exhibits a flaw that resembles the texture of an orange peel.

- Application-related:
 - Using a roller to apply finish that is not suitable to be rolled, improper use of the roller, or use of improper-size nap roller sleeve.

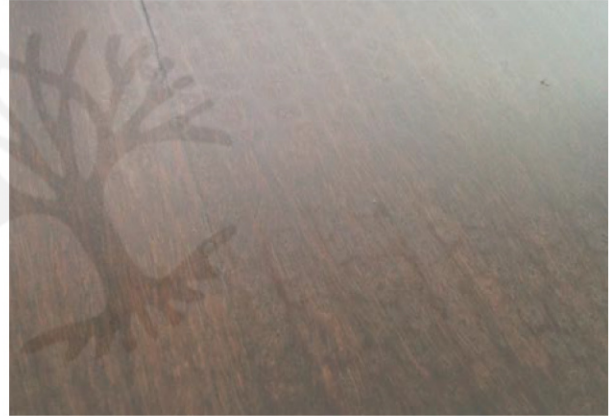
Benard Cells

DEFINITION: A visible finish imperfection resembling a pattern in the smooth finish film that resembles a clustering of "cells." They typically appear as less-glossy, often round, curvy, or geometrical (hexagonal, pentagonal) in shape, and may range in size from very small, up to 1". Benard cells are more common with lower sheen or pigmented finishes.

- As solvents evaporate from the drying film, convection currents, or "eddies" are caused, where less-volatile coating components like pigments or matting agents may concentrate in patterns in the dried film.
- Normally caused by a rapid escape of solvents from the applied finish (in high temperature and low RH environments).
- Solvent additives or dry-time-extending retarders added to the finish in an improper amount or outside of the finish manufacturer recommendations.
- Allowing finish to "sit" too long after mixing, before application.

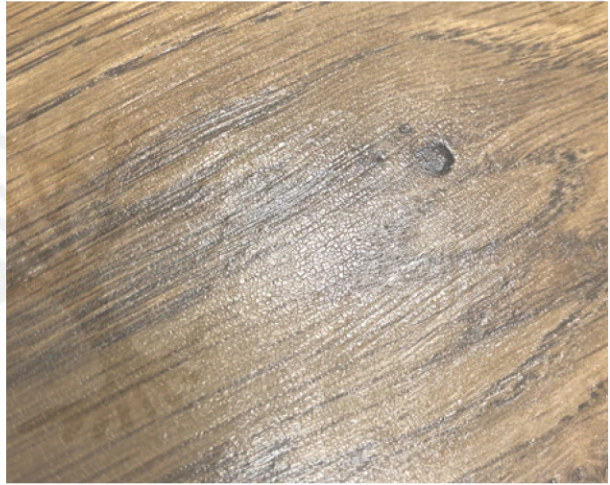
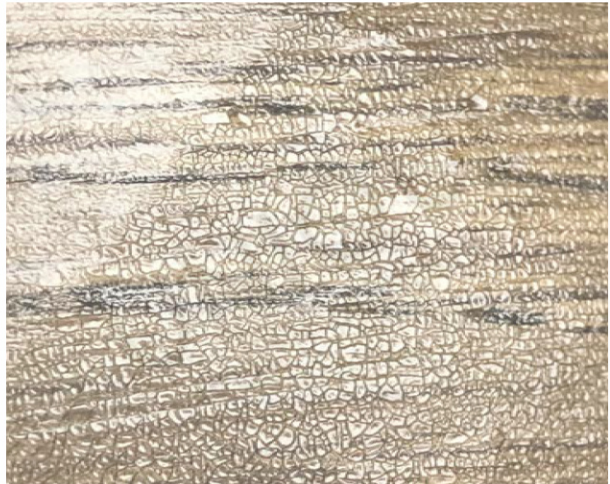
Crazing/Alligatoring

DEFINITION: A visible finish imperfection that appears as a network of very small, fine cracks or fissures in the surface of the finish film, which sometimes resembles the skin of an alligator or crocodile.

- A previous condition left in a previous coat that was not effectively removed prior to subsequent coats, telegraphing through the top-coat.
- The moisture content of the wood floor was too high at the time the coating was applied.
- Internal stresses in the top coat caused during the drying process where the top of the finish dries too quickly, causing the surface to dry and shrink faster than the full depth of the finish.
- Expired finish or catalyst/hardener.
- A water-based sealer or finish issue, wherein the film does not coalesce properly (usually due to insufficient solvent or solvent efficiency). This may be from manufacturing, or due to using product that has been expired, stored, exposed, or used at temperatures or humidity levels outside of manufacturer recommendations.

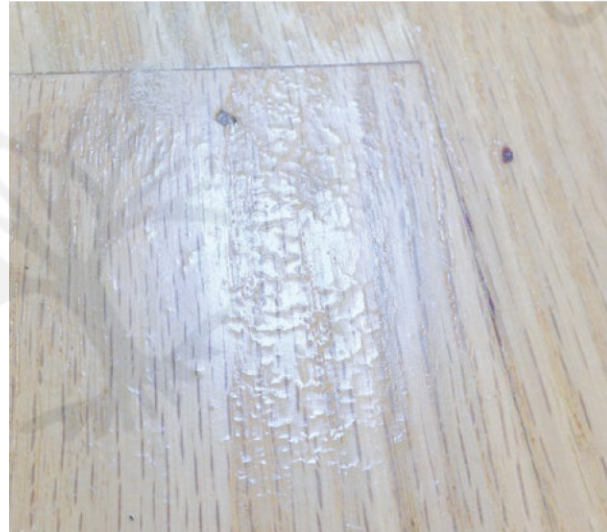
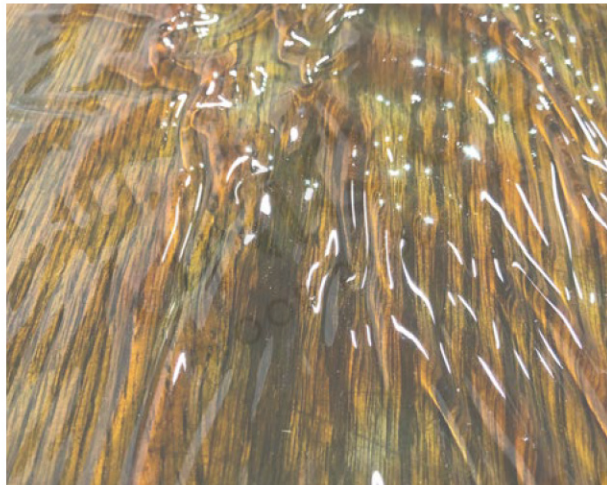
DEFINITION: A visible film-finish imperfection that appears as the skin of a dried prune. Wrinkling may happen with all types of film-finish, but is most common with oil-based urethanes.

- Wrinkling is a phenomenon that happens during the drying/curing process, caused by the top of a film drying before the bottom. As it dries, it contracts. Since the bottom is still liquid, it cannot prevent the contraction, resulting in wrinkling.
- Hot, dry air during the drying of the finish.
- A substrate that is too cold, accompanied with warmer air or air movement during finish application and drying.
- A finish coat applied too heavy, outside of manufacturer recommended coverage rates.
- Puddles or pools left in the finish coat often coincide with wrinkling of the finish.
