PROBLEMS, CAUSES, AND CURES

nwfa
National Wood
Flooring Association

Technical Publication No. C200 • Revised © 2018 | 3rd Edition

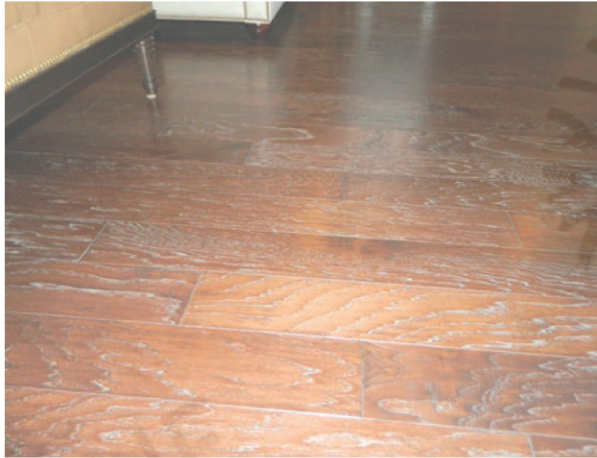
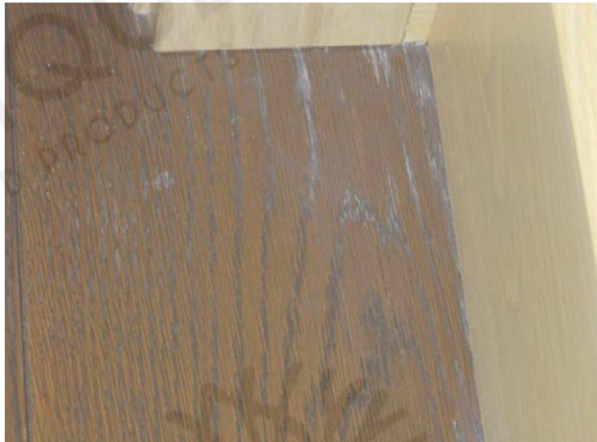
Open-Grain Contamination

DEFINITION: An accumulation of contaminants in open voids or characters, such as in textured wood, the soft grain/springwood, open knots, splits/checks, etc., on the surface of the installed floor.

- Any time drywall work has been scheduled post wood floor installation, the wood floor is susceptible to becoming exposed to drywall dust. Subsequent wetting/damp mopping of the surface will turn the drywall dust into a paste, which can be extremely difficult to remove from the exposed voids or characteristics of the flooring.
- Silt, salt residue, or other fine dust particles becoming embedded in the exposed voids or characteristics of the unprotected flooring.
- Paint, flooring adhesive, or other contaminants that have been spilled and subsequently cleaned from the surface, but remains in the exposed voids or characteristics of the flooring.

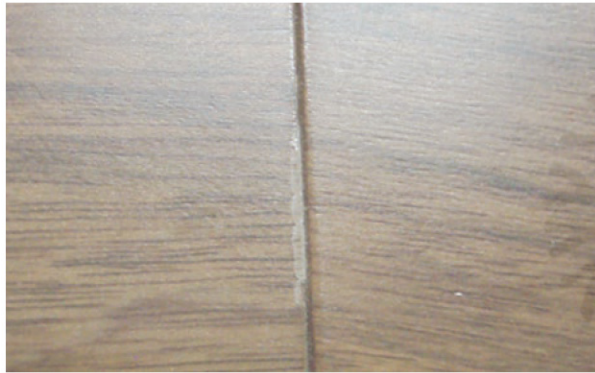
DEFINITION: The loss of film-finish adhesion to the flooring surface or between coating layers.

Chipping/Flaking Finish - The condition that occurs when a dried film of finish separates from the previously applied finish in the form of chips or flakes.

- Poor adhesion between coats.
- Surface contamination between coats.
- Not abrading or using too-fine of a grit abrasive between finish coats.
- Recoating a cured floor without proper preparation (either chemical or mechanical).
- Applying a subsequent coat of finish after the window to do so without abrasion (hot coating) has elapsed.

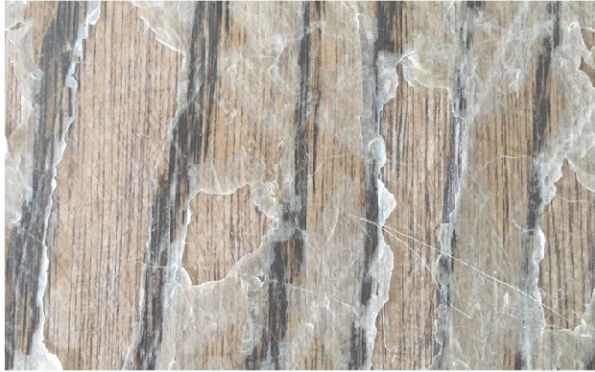
Finish Adhesion Failure

Peeling Finish - The condition that occurs when a dried film of finish separates from the underneath surface in the form of large pieces or sheets.

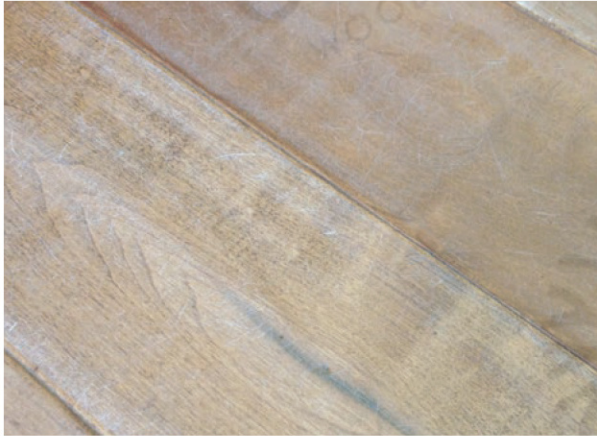
Finish Wear Discrepancies

DEFINITION: The performance of the surface coat of finish not meeting expectations.

- Maintenance-related:
 - Failure to fully remove grit from the floor's surface or shoe bottoms.
 - Worn, or inadequate floor protection under furniture.

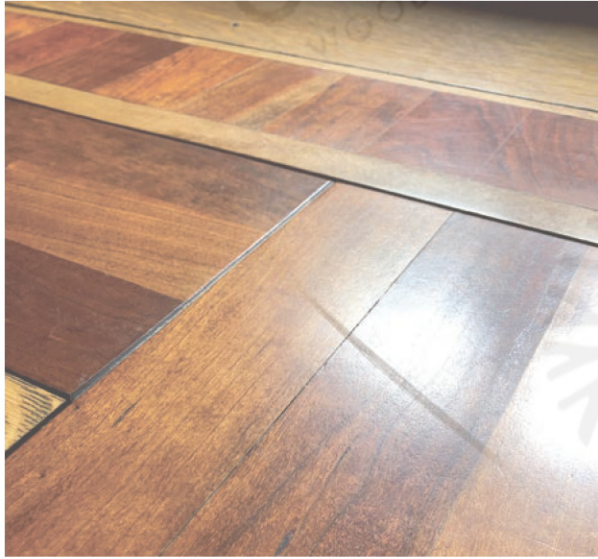
Scuffing

DEFINITION: Marks or abrasions left on a wood floor surface or finish.

- Maintenance-related:
 - Grit or debris rubbed across the floor's surface.
 - Non-manufacturer-recommended cleaning and maintenance products, which leave a residue or film on the surface of the wood floor, often have a tendency to scuff or become marred. These products are not designed to wear like a wood floor finish and can become unsightly with even the lightest foot traffic.

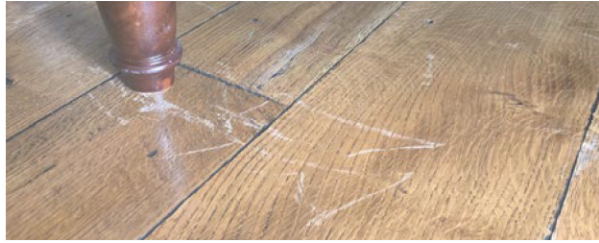
- **Scratches** - caused by applied horizontal and vertical forces.

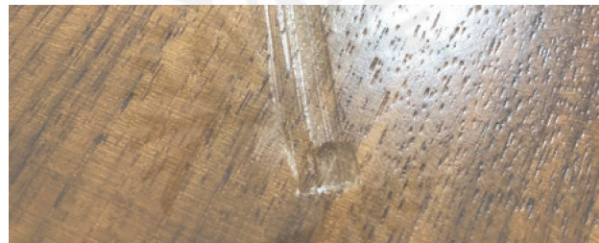
- Finish systems may be marred or scuffed, either from chemicals or from heat generated by sliding objects across them. These may look like scratches, but are not.
- Surface scratches are typically only in the finish coats. A fingernail can't feel the ridge.
- Deep scratches are typically through the finish coats and have torn the wood fibers.
- Cross-grain scratches are deep scratches, and are oriented perpendicular to the direction of the flooring, often crossing multiple board widths and have a higher probability of exhibiting wood fiber tear. Deep scratches, usually termed "gouges," are typically through the finish coats and have torn the wood fibers.
- As scratch damage increases in severity, so does the likelihood that the damage will also include denting.
- **Indentations** - notches, grooves or depressions on the surface of the flooring.

- Indentations are caused by applied vertical and/or horizontal forces on the flooring surface.
- When only vertical forces have been applied (dropping an object) these depressions are typically isolated to the shape of the portion of the dropped object that contacted the floor.
- Indentations may not always be accompanied with finish tear/fracture.

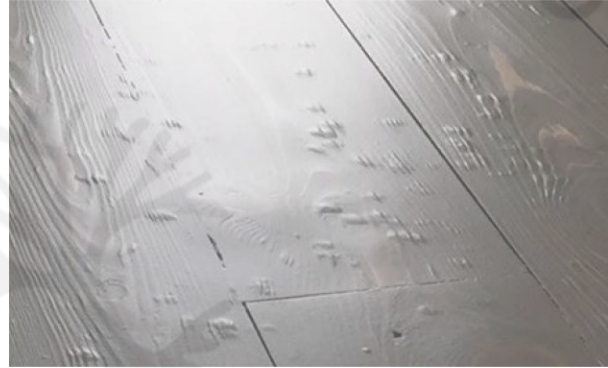
- **Wood bruises** - from a previous force or trauma to the surface of the boards that is not normally noticeable during the installation or handling of the product. This damage can become exposed with an increase in moisture, such as with the introduction of water through water-popping, water-based finishes, water-based stains, or similar reactive conditioners.

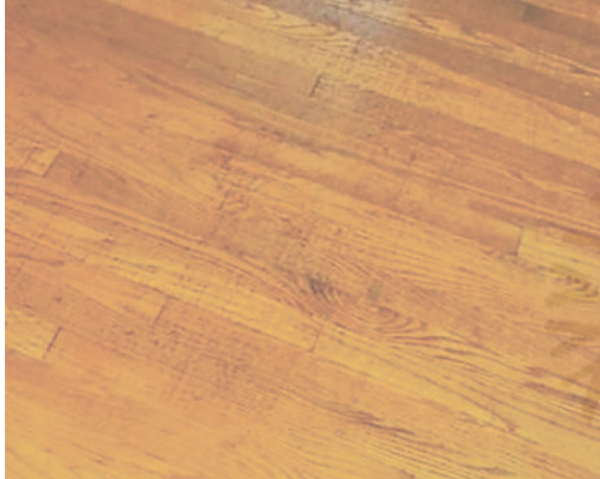
Surface Impressions

DEFINITION: A shape or pattern imprinted on the face of the board, which resembles an item or object that had been in direct contact with it.

- Various rug types or backing materials can leave an imprint in the floor finish system.
- Plasticizer migration from some non-slip backing pads used under area rugs can leave a waffle-like pattern etched into the finish system.

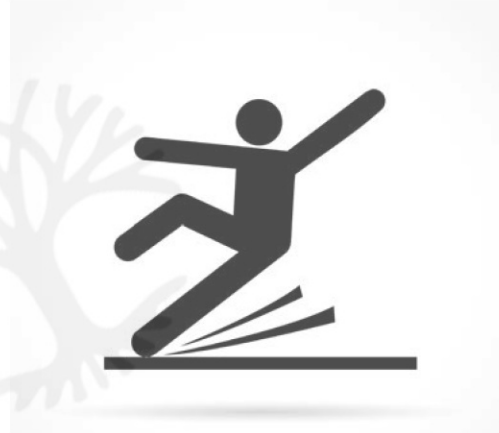
Slippery Floors

DEFINITION: The perception that the floor feels slippery. All wood floor finishes could be considered slippery with normal use. Most wood floor finishes are not usually considered to be slip-resistant, and some wood floor finishes feel slipperier than others.

- The type of footwear, a person's weight, stride length, gait, speed, etc., can affect the degree to which one slides across any flooring surface.
- Customer expectations.
- Maintenance-related:
 - Dust or debris on the floor surface.
 - Using cleaning products on the floor not recommended by the finish or flooring manufacturer.
 - Using old or soiled cleaning mop heads.
 - Tracking of contaminants from one floor surface onto the wood floor.
 - Overspray from using cleaning products on fixtures on or near the wood floor.
- Over-application of wax on a waxed floor (using too much wax).
- Adding non-manufacturer-recommended substances to the finish.
