## Gaps - Normal - Causes & Cures

# Gaps - Normal - Causes & Cures

## Abnormal Gaps

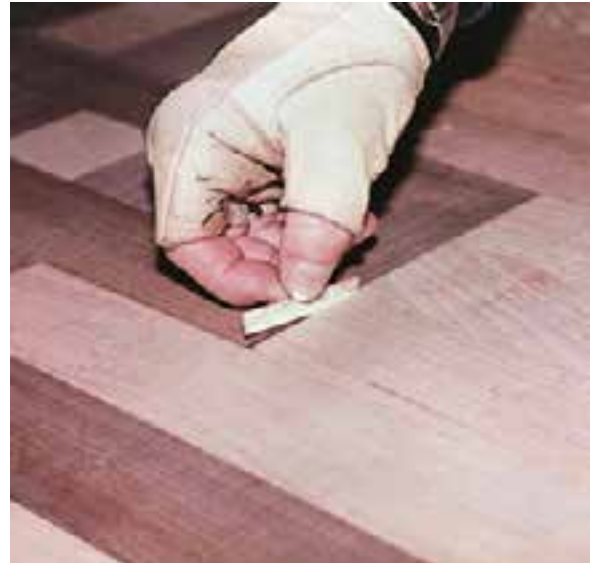
To repair this type of gap, the cause must be determined, eliminated, and humidity levels should return to normal living conditions. When the floor has stabilized, gaps up to 3/32" can be repaired using a compatible wood flooring filler. For gaps larger than 3/32", a sliver or Dutchman should be used to repair the gap.

Typically, seasonal gaps will appear when wood shrinks (winter) and disappear when wood swells (summer). As long as these gaps return to normal, there is no need for concern or for repair. Gaps of this nature may be more noticeable with wood floors that utilize wider width boards. In addition, gaps may be more noticeable with square-edged floors than with bevel-edged floors, and with light-colored species as opposed to dark-colored species.
